**PROBLEMS IN COOLING WATER SYSTEMS CAUSED BY POOR DESIGN, OPERATION
AND WATER TREATMENT – SOME CASE HISTORIES**

Jan E. Frantsen
Asbjorn Andersen
Soren Klinggaard

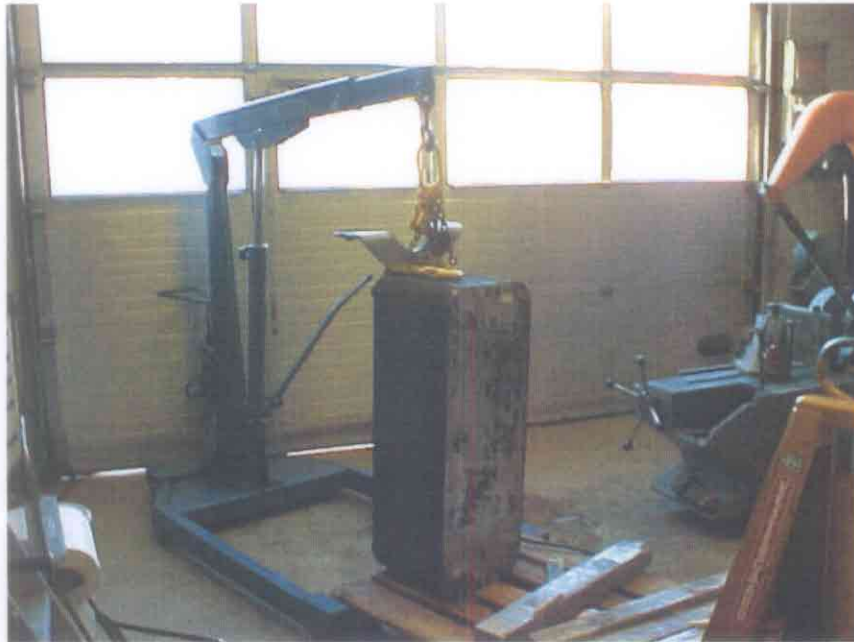
FIGURE 1 – Overview of the brazed plate heat exchanger that was investigated for an internal leakage.

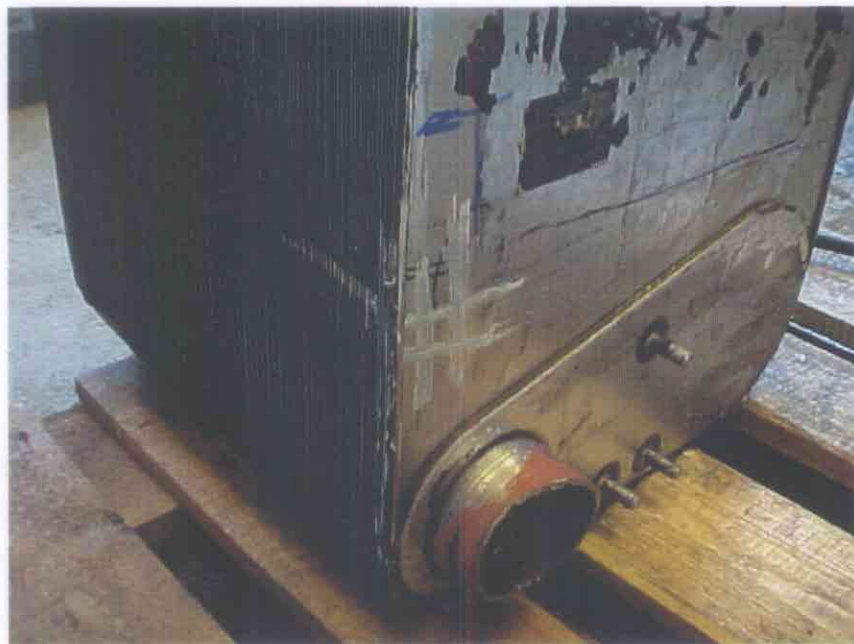
FIGURE 2 – An internal leakage in the heat exchanger was detected near porthole T4, i.e. near the pressure plate outlet of superheated vaporised refrigerant. This position corresponded to the observation of a bulge on the outside of the heat exchanger, see the white markings.

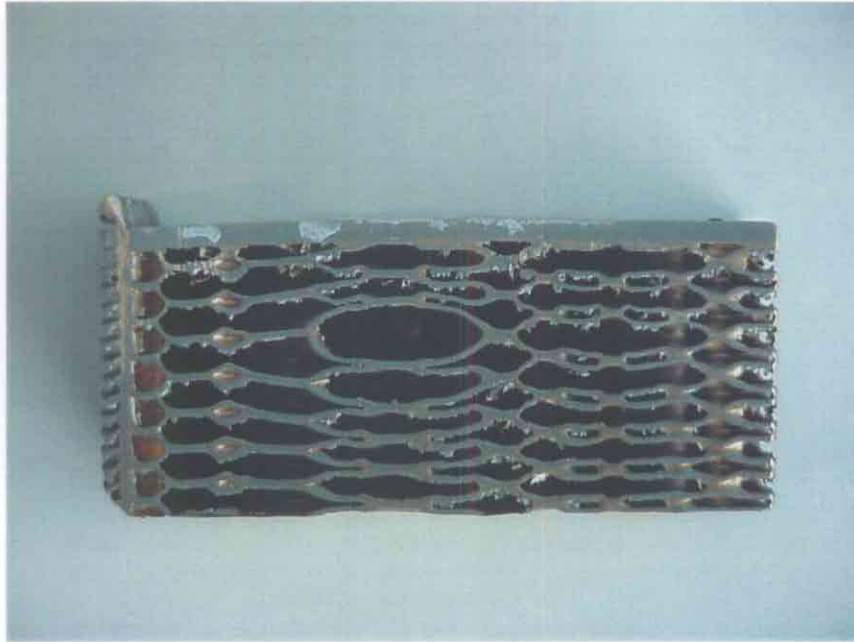
FIGURE 3 – A rectangular sample containing the leakage was cut out of the heat exchanger, see Figures 2-3.

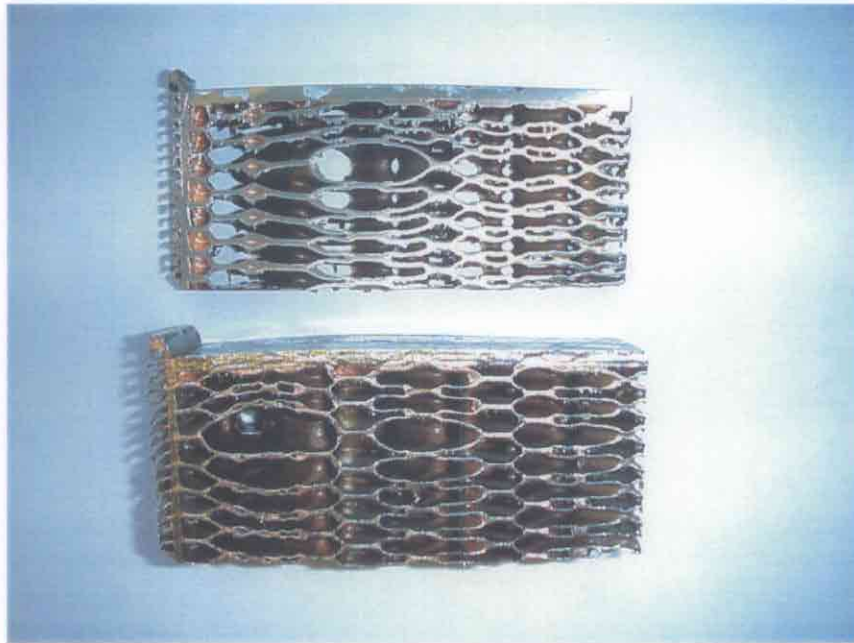
FIGURE 4 – In order to get a close view of the leakage, the rectangular sample shown in Figure 3 was further cross-sectioned.

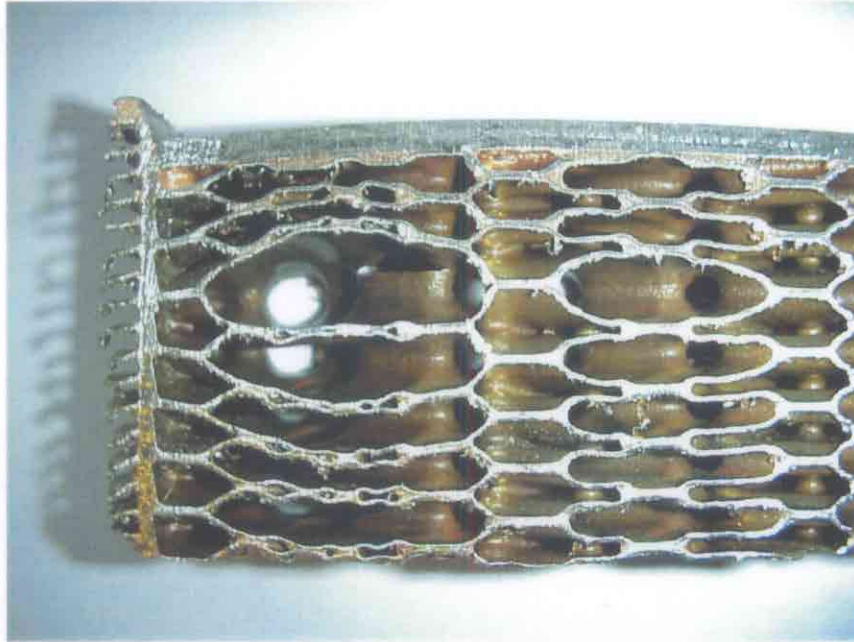
FIGURE 5 – Close-up of Photo 4.

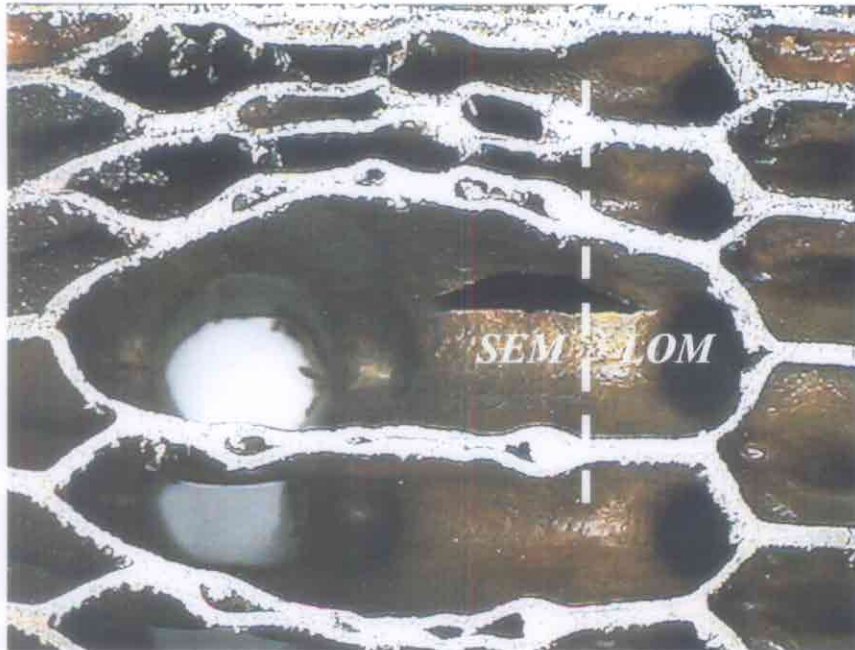
FIGURE 6 – Close-up of Figure 5. The “bloated” appearance of the fissure is a strong indication of freezing damage. The right side of the dotted line shows where the microsection in Figure 7 was taken whereas the upper surface of fracture to the left of the dotted line was examined by use of scanning electron microscopy (SEM), see Figure 13.

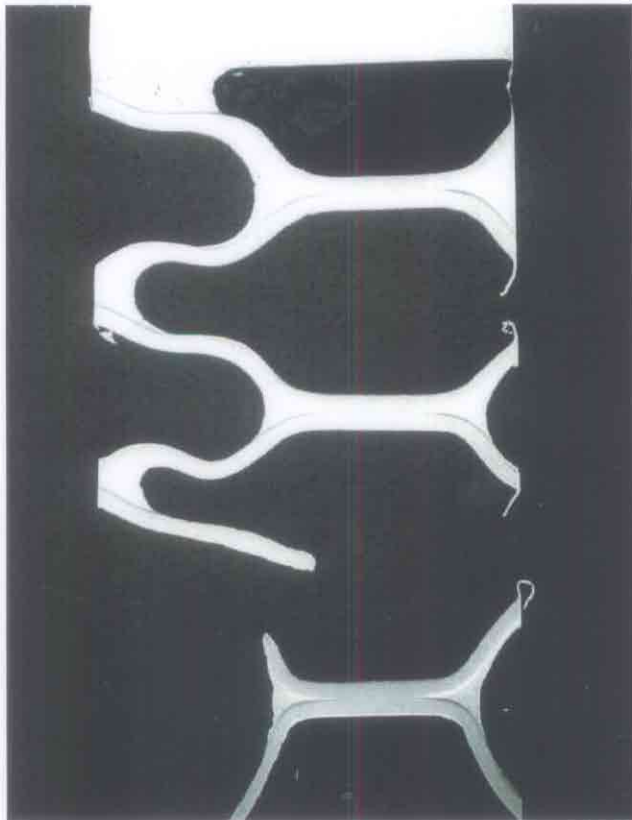
FIGURE 7 – LOM-micrograph of microsection taken across the fissure shown in Figure 6. Magnification 6.5x.

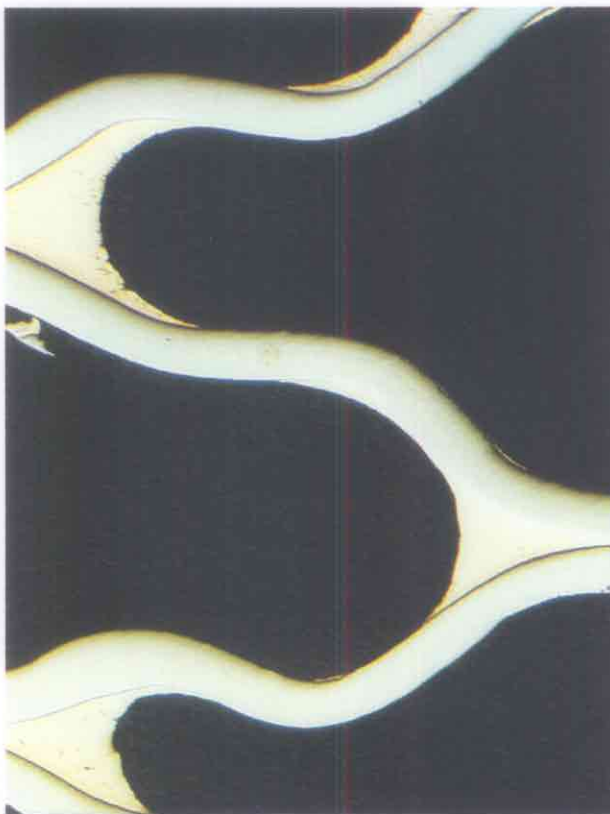
FIGURE 8 – Close-up of Figure 7. An undamaged cross-section of the brazed plate pack. Magnification 17x.

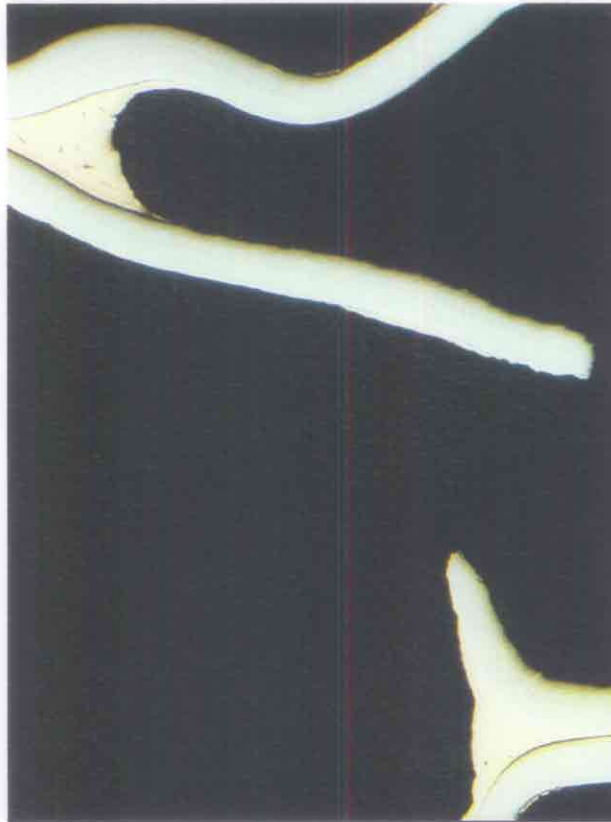
FIGURE 9 – Close-up of Figure 7. Cross-section of the fissure in the brazed plate pack. Magnification 17x.

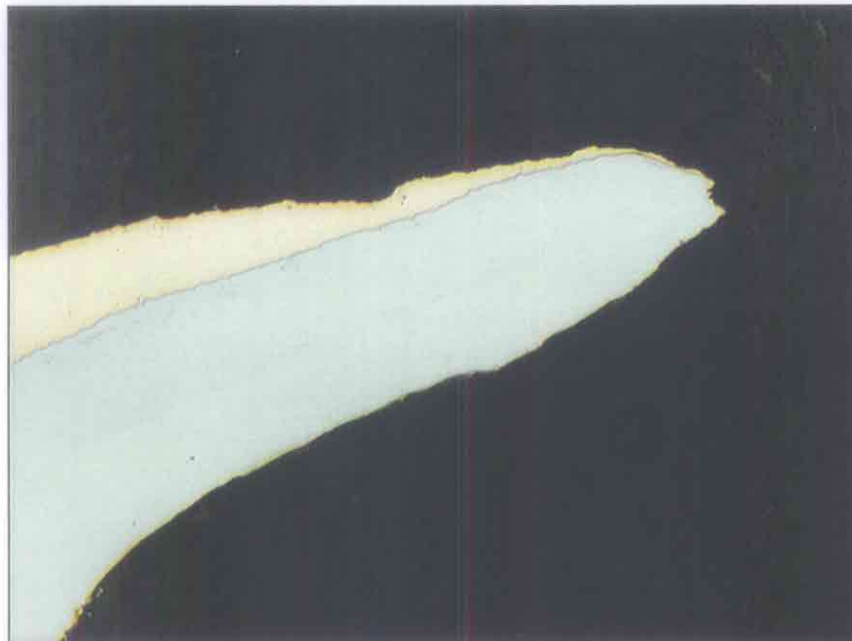
FIGURE 10 – Close-up of Figure 9. The ductile necking shows that the rupture was caused by mechanical overload. Magnification 90x.

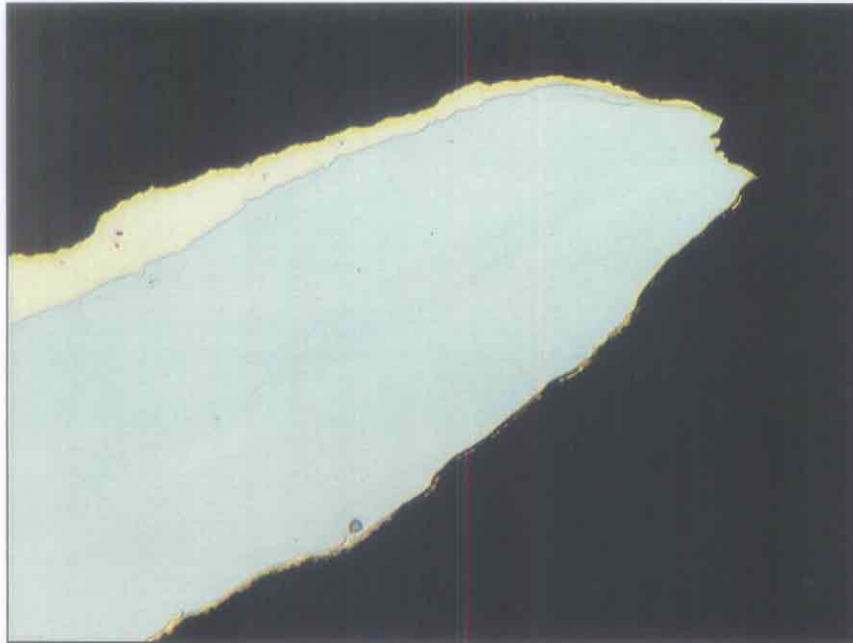
FIGURE 11 – Close-up of Figure 10. In addition to the ductile necking typical of a rupture caused by mechanical overload, it is important to note that no cracks are observed. Magnification 180x.

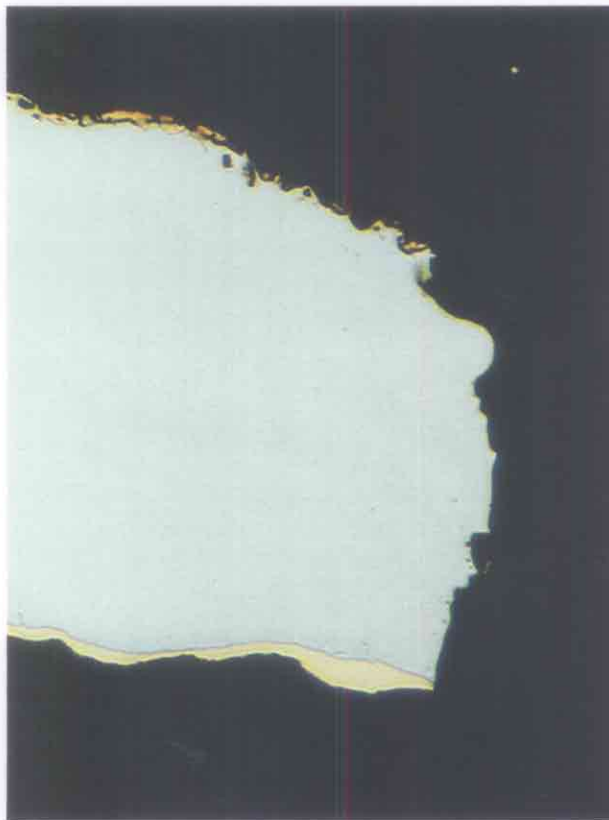
FIGURE 12 – Close-up of Figure 9. Same comments as for Figure 11. Magnification 180x.

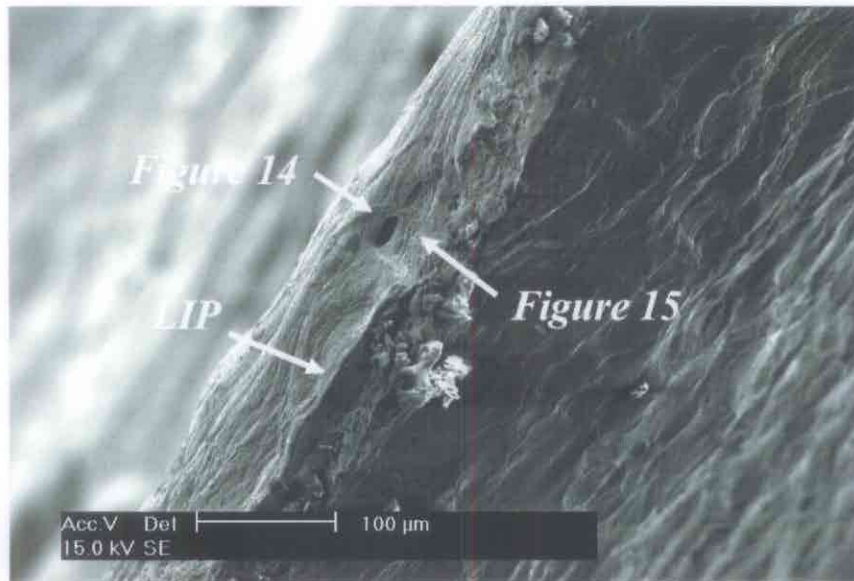
FIGURE 13 – SEM-micrograph of the surface of fracture indicated in Figure 6. The lip is typical of a ductile rupture caused by mechanical overload. The inserted text boxes refer to close-ups in Figures 14-15.

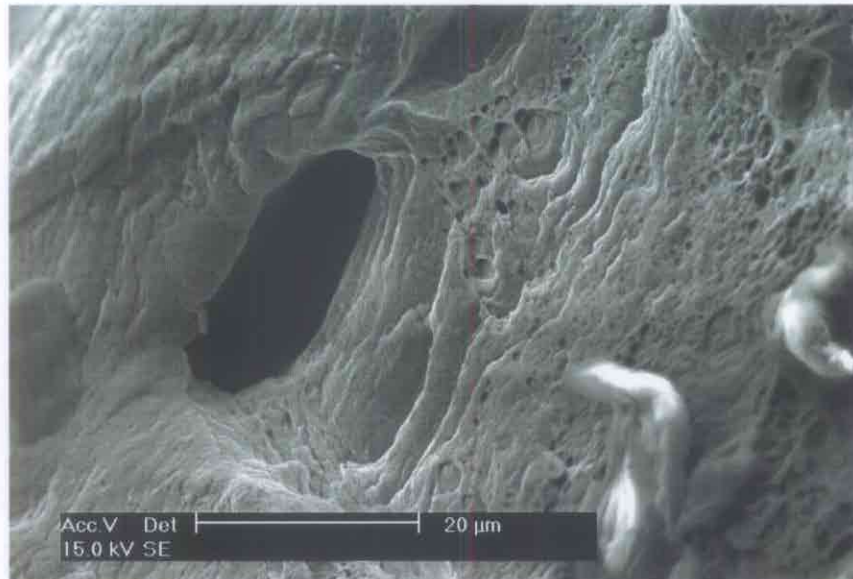
FIGURE 14 – Close-up of Figure 13. The large depression is a ductile rupture at the initiation stage. The many small cup-like depressions are dimples, i.e. a definite characteristic of a ductile rupture.

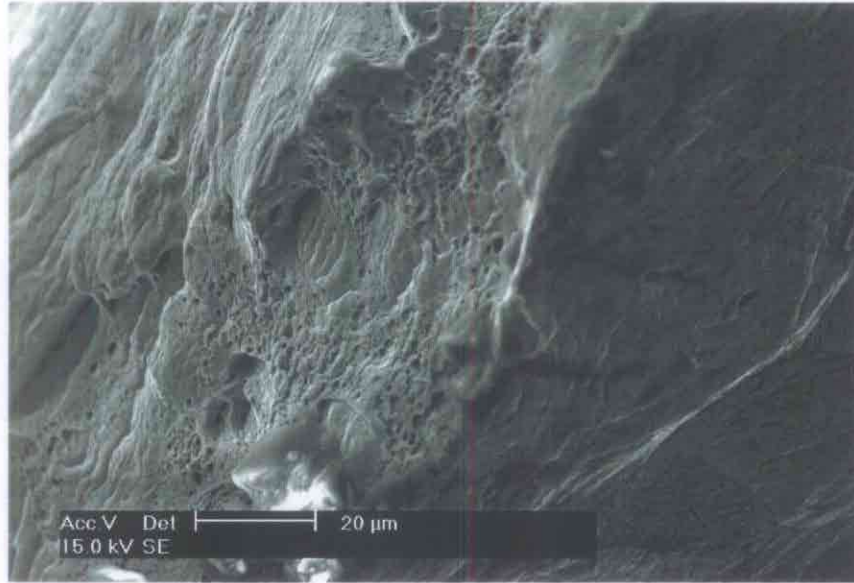
FIGURE 15 – Close-up of Figure 13. The many small cup-like depressions are dimples, i.e. a positive characteristic of a ductile rupture.

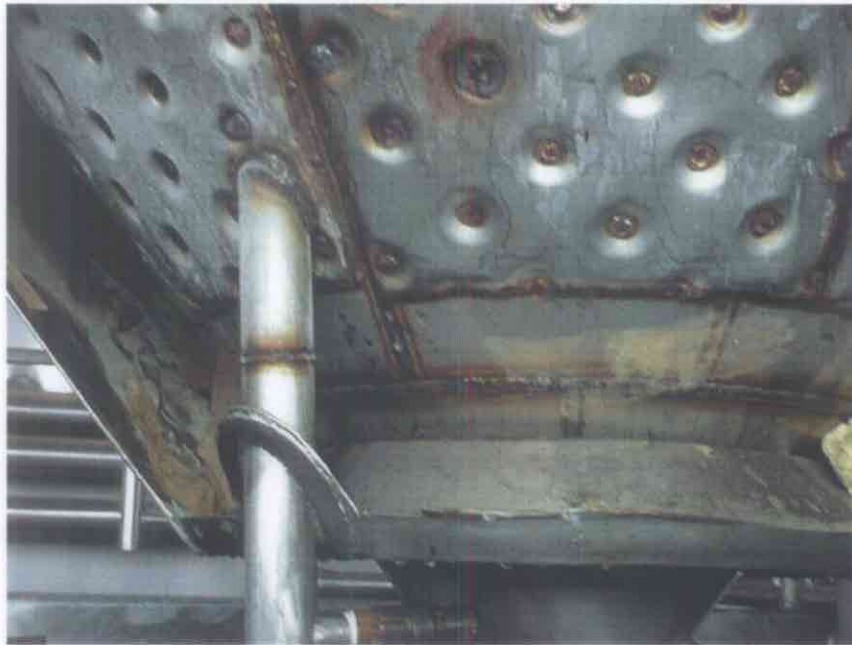
FIGURE 16 – Overview of the bottom of the yeast storage tank after removal of the insulating material. The great majority of the repair-welded dimples were observed in clusters. Unlike the original welds at the dimples between the jacket and the tank bottom, it seemed that the repair welding had been performed using filler material.

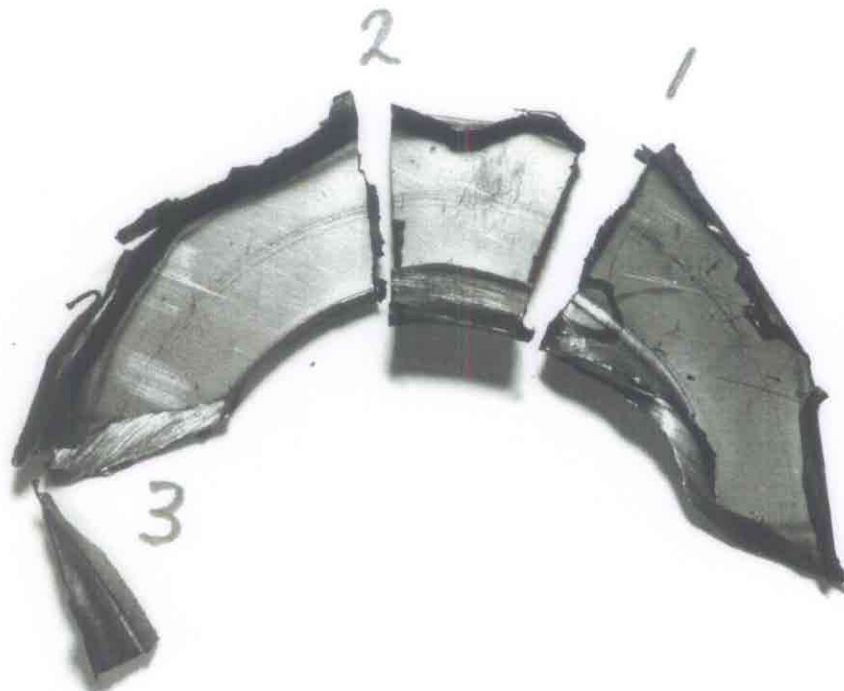
FIGURE 17 – Macrograph of damaged dimple plate with the internal side of cooling jacket uppermost. Crack was opened at position 3 so fractured surface could be studied. At cut 2, a microsection was taken. Magnification 2x.

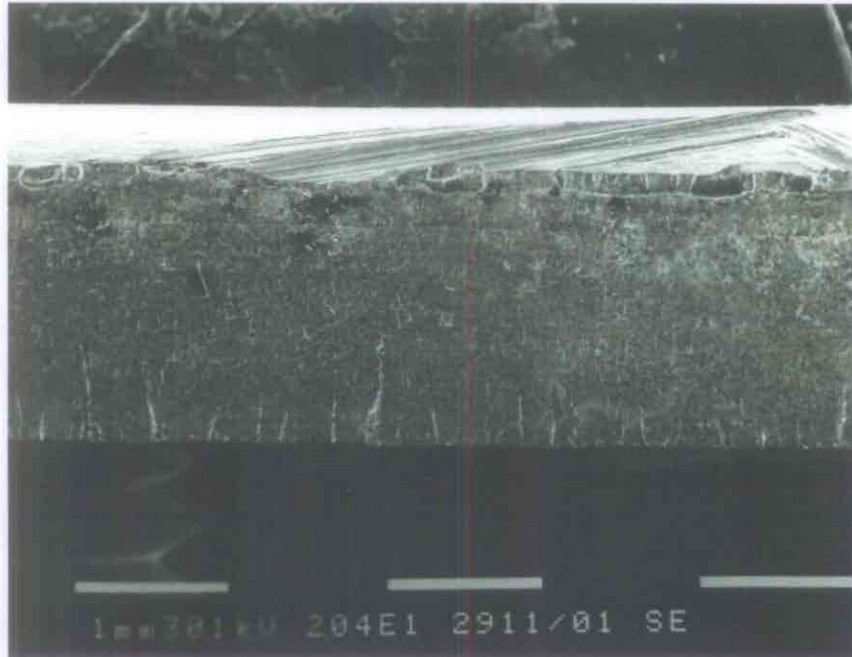
FIGURE 18 – SEM-micrograph of part of the fractured surface (see mark 3 on Figure 17) with internal side of the cooling jacket at the bottom of the micrograph. Note the presence of beach marks and steps (“notches”). Magnification 20.4x.

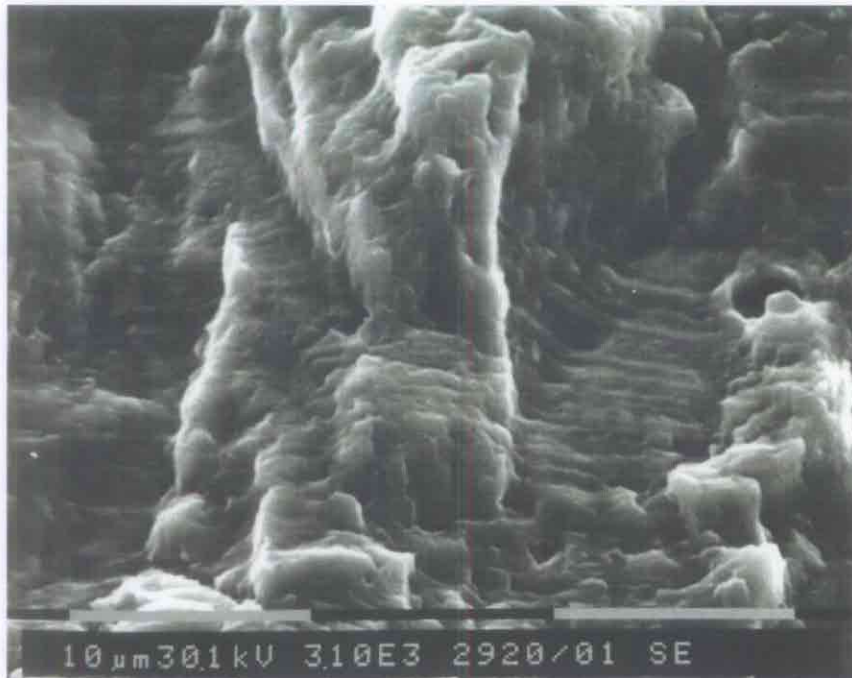
FIGURE 19 – SEM-micrograph at high magnification of fractured surface on Figure 18. Note the presence of striations. Magnification 3100x.

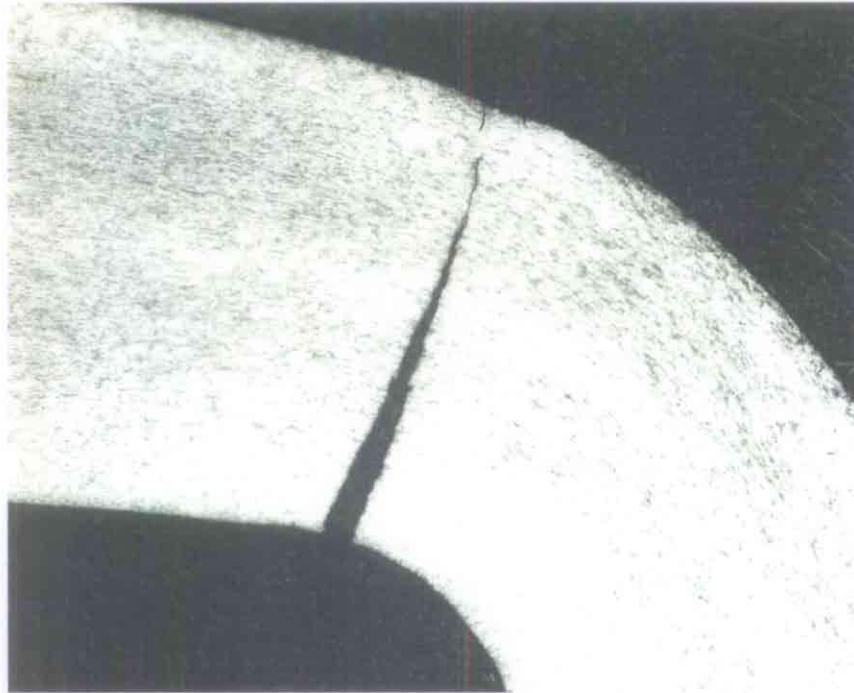
FIGURE 20 – LOM-micrograph of cross-section of cooling jacket, see cut 2 on Figure 17. The cracks are localized to the knuckle area of the dimple. The large crack enters from the internal side of cooling jacket. Magnification 3100x.

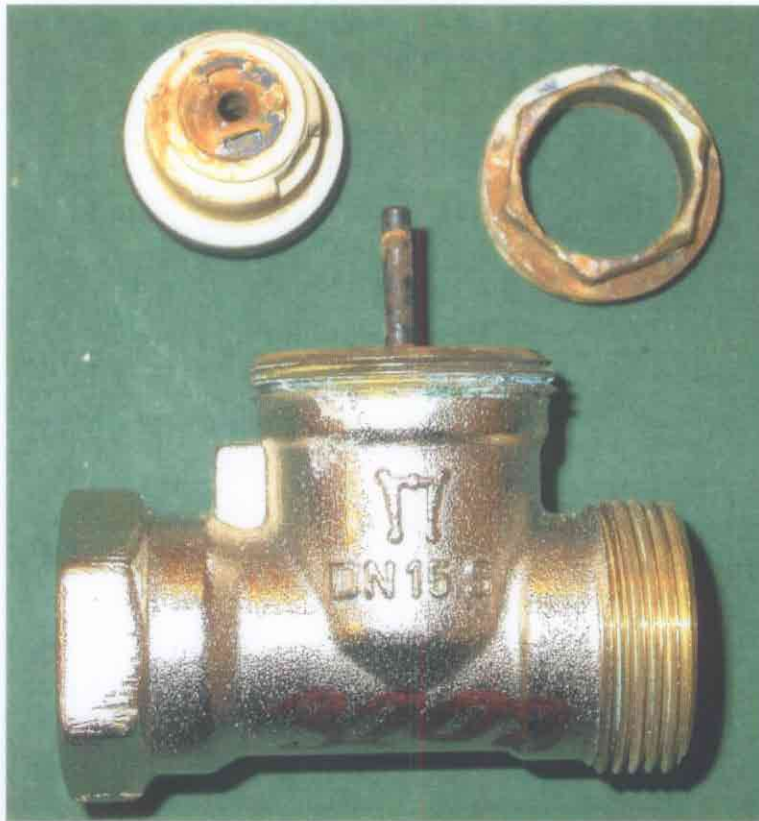
FIGURE 21 – Motor valve. Precipitated corrosion products and particles are seen at mechanical parts

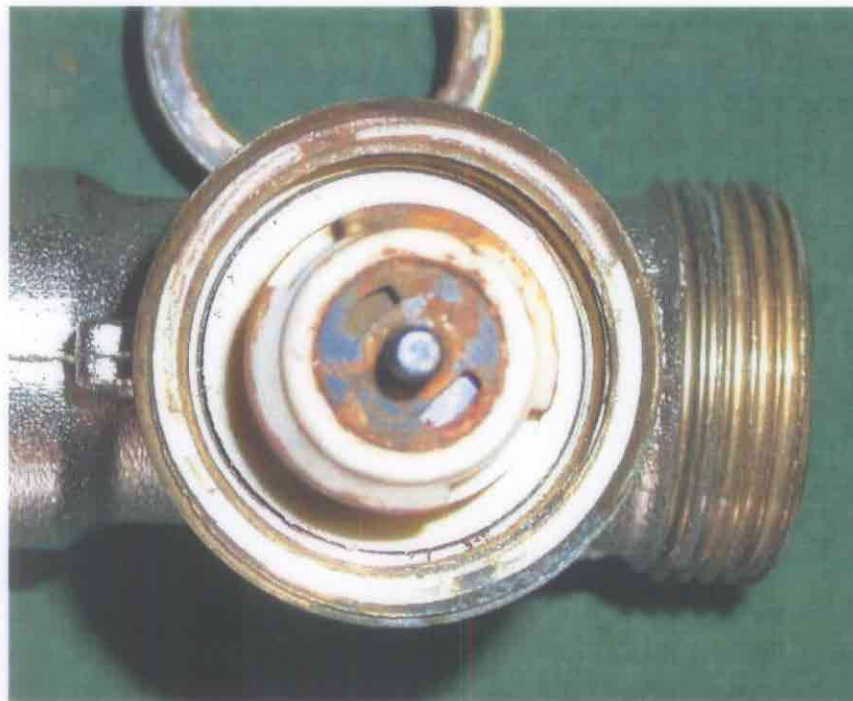
FIGURE 22 – Precipitated corrosion products and particles at mechanical parts in motor valve.
