Corrosion protection of offshore wind farm structures – present understanding and future challenges

A. R. Black, P. K. Nielsen, FORCE Technology, Brøndby/Denmark

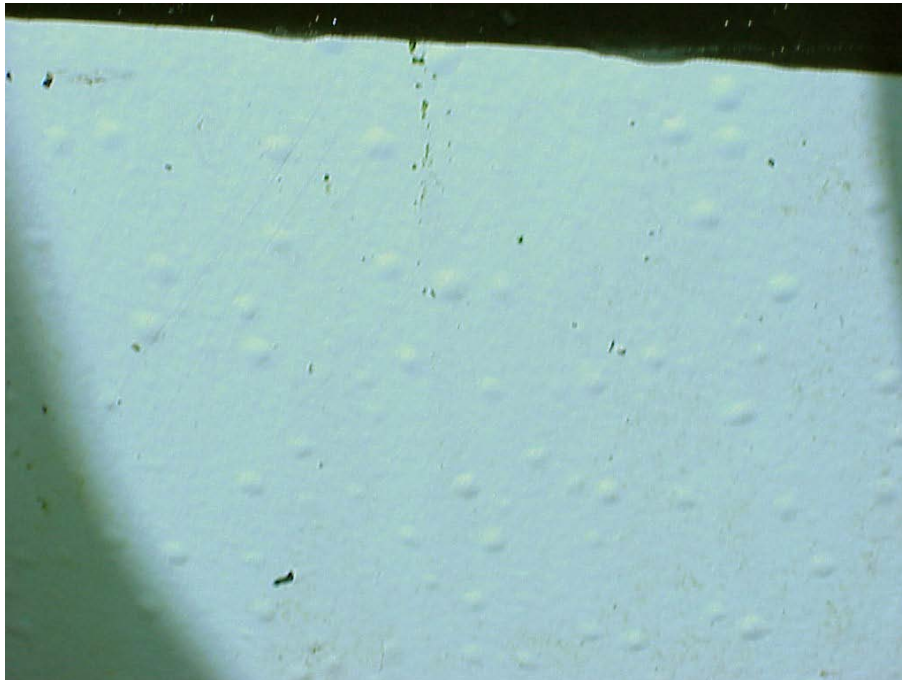
On one of the first offshore wind farms, a one-coat system was being applied in two passes on the TPs instead of the mentioned 3-4 coat systems in (3) and (4). The coating itself was an above-average, highly resistant epoxy. But even though it was applied in two wet coats at the same time, eventually minute pores appeared in the protective film that allowed access of salts and water to the steel surface. The result was blisters created by osmotic forces, which resulted in spotted corrosion attacks after 2-3 years of operation, photo 1:

Photo 1
After 2-3 years of operation, parts of the surface of some TPs had blisters, sized 5-10 mm. Later, the blisters busted, and the steel surface became open to corrosion attacks.

As a test, five of the TPs in the same farm were applied at the same time with a system similar to (4). These five TPs stand out today as highly visible reminders of the benefits of the multiple coat application. Their spotless appearance in a farm covered with more or less rusty structures is certainly significant to any visitor.

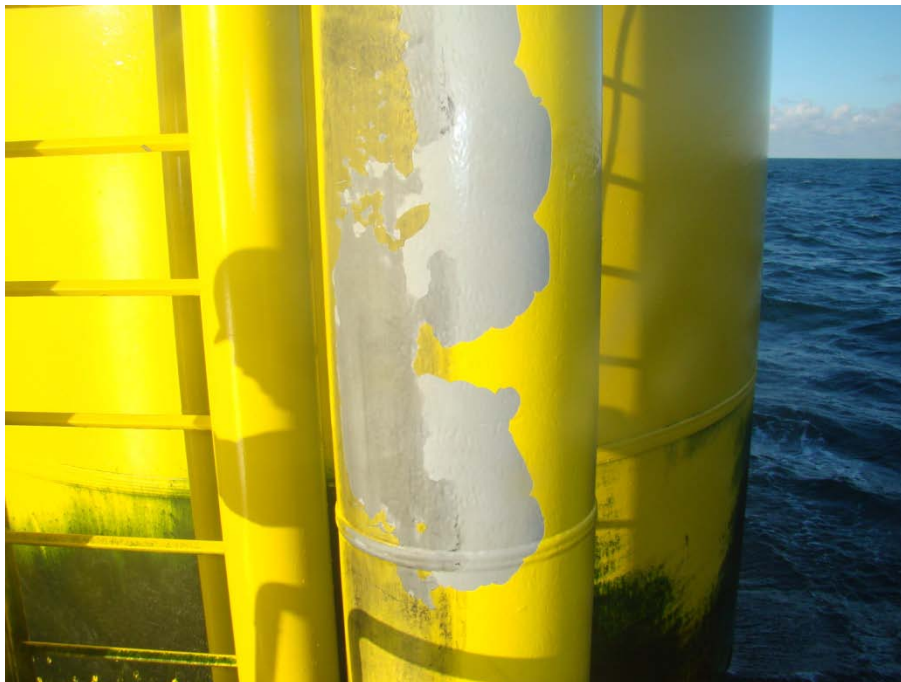
Photo 2

On an offshore windfarm, the top coat and its underlying primer detached in areas around the boatlanding. The structure had been painted with system (3), and the flaking thus took place between the second and the third coat of primer. However, the fault did only occur in or close to areas where the supply boats hit the boatlandings during off- and onloading, photo 2, or near the flanges of the TPs. The coats were firmly adhering in all other areas.

Flaking of top coats from a boatlanding due to root cause (b) described below. The light grey parts had been opened just before the photo was taken. The darker grey areas were from earlier operations.

The number of TPs with these faults was approximately 10 % of the total number of turbines.

After a detailed root cause investigation, which included chemical analyses of the underside of detached paint flakes and examination of daily logs from the painting operations, two independent causes, (a) and (b), of the fault were identified:

- a. The chemical analyses showed surprisingly high amounts of aluminium and zinc on the backside of the flake. As the underside of the TP flanges had been thermally sprayed (metallised) it was assumed that part of the boat landings had not been covered sufficiently during the metallising process. Sprayed metal dust had thus settled on the primed surface and not been removed prior to finishing.

- b. Painting operation records showed that, due to stops in the production, the faulty TPs with the mounted boat landings facing upwards had been stored partly painted in a horizontal position and outdoors for more than a month during hot summer periods. As the boat landings were positioned horizontally, their upper side faced the sun. When exposed to UV-light, the epoxy primers started to chalk and after months of hot exposure, their maximum recoat interval was surpassed. Thus, when they were overcoated, their surface was not somewhat sticky but instead chalky and very hard. An applied new coat did not adhere sufficiently to such a surface.

Often if platforms, ladders or boatlandings are to be repainted, they may beneficially be taken to proper painting shops on land and then reinstalled after painting, leaving only consoles or clamps to be painted offshore.

For the repair, surface tolerant solvent-free epoxy's are recommended.

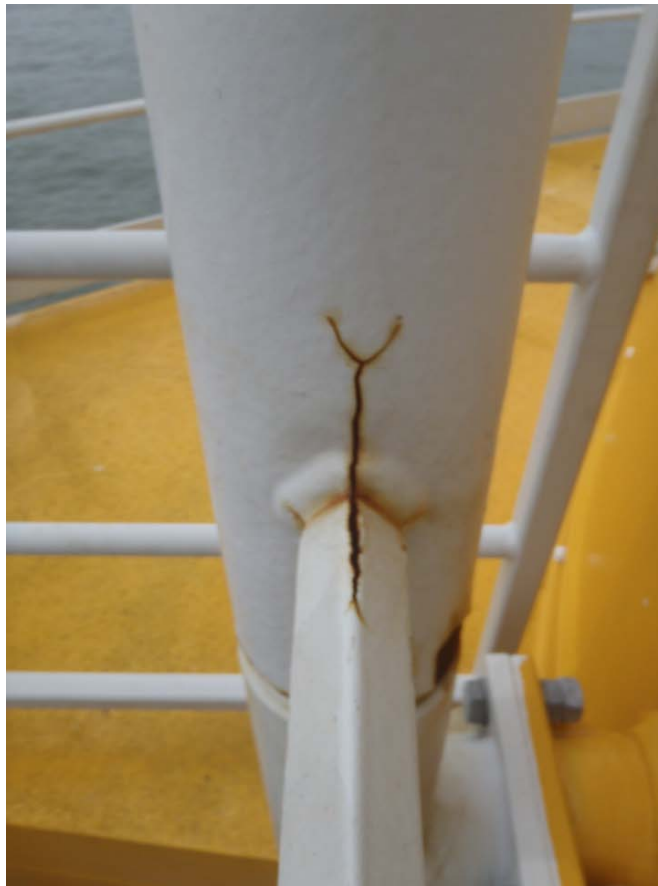
Epoxy paints, and in particular solvent-containing epoxy paints, have an upper critical application limit. If they are applied in coating thicknesses above their maximum limit, the coating may develop inner stress inside the coating film. The paint film may also entrap solvents because the evaporation of the solvents is hindered when the thick paint film cures to a solid coating.

In both cases, the physical properties of the coating film will be below standard. During service, and when exposed to climatic and physical impacts the film cracks and corrosion attacks follow, photo 3:

Photo 3
Cracks created by inner tension in the coating film give access to corrosion attacks.

To prevent this, a careful application is recommended with repetitive control of both the wet and dry film thicknesses during the process.
