Preventing Galvanic Corrosion in Drilling Risers and Subsea Equipment

Troels Mathiesen¹, Harald Osvoll², Peyman Mohseni³

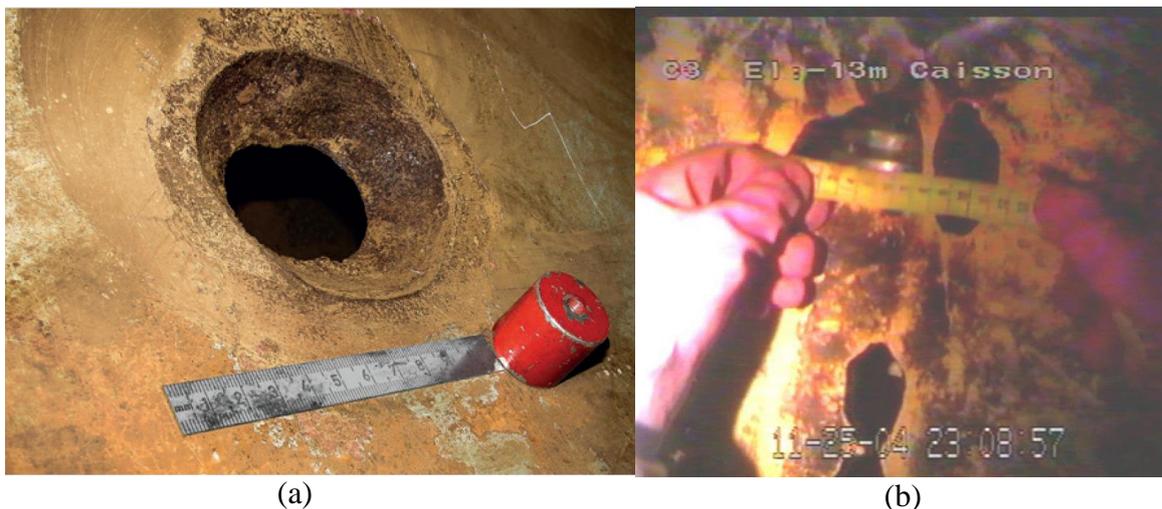
The galvanic corrosion in stern tubes, is facilitated by the electrical contact through the brush contact between the propeller shaft and the ship hull. This connection is part of the ship's grounding system. The propeller shaft is typically made from stainless steel or nickel-base alloy clad steel. Flowing seawater is at the same time used for cooling and lubrication of the bearings. Thus, a small defect in the paint coated stern tube will produce very rapid and localised corrosion, as shown in Figure 4a.

Extensive galvanic corrosion has also been observed in seawater pump caissons on oil rigs, both in the North Sea and the Persian Gulf. In this case, the stainless steel in the pump and riser arrangement acts as cathode, causing severe damage of the internal side of the paint coated steel caisson, Figure 4b [9]. The observed corrosion rate was 2-5 mm/yr for non-coated caissons while coated caissons showed corrosion rates up to 10 mm/yr in local coating defects.

Figure 4: Examples of severe galvanic corrosion of paint coated steel due to influence from corrosion resistance alloy; (a) stern tube in ship (b) seawater pump caisson [9].

The mentioned cases of galvanic corrosion were eliminated by installing sacrificial anodes or by applying paint coating on the noble metal, or by combining both. Mathematical modelling would usually be applied by using the SeaCorr™ software to verify the effect and lifetime of the chosen mitigation method [9].

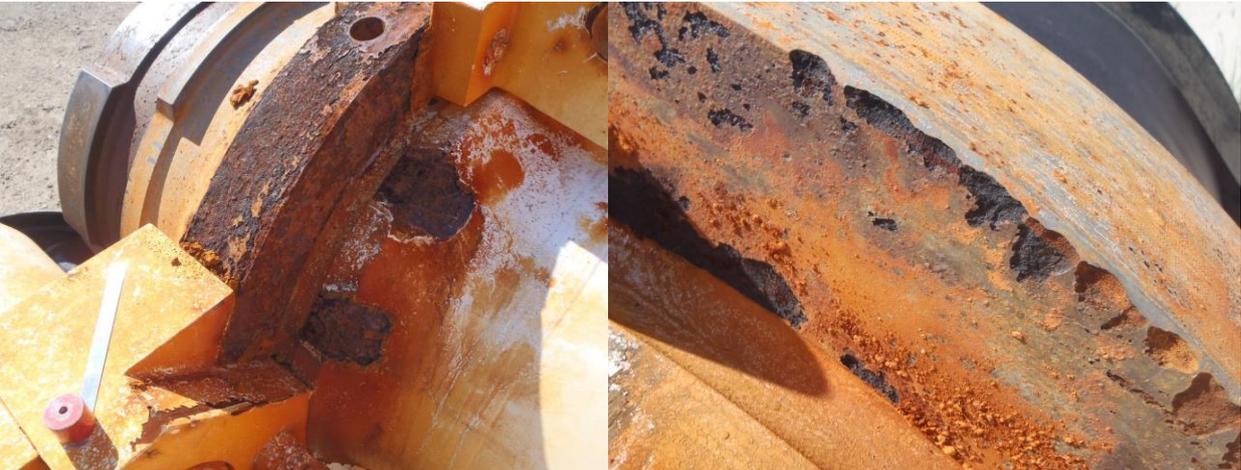
Figure 6: (a) Excessive corrosion on female connector and in spider contact area. (b) Excessive corrosion along edge of female connector.

In general, the corroded areas are caused by wear or damage of the protective coatings. Marine risers require frequent handling and must to some extent resist associated damage without causing severe corrosion. However, in the photos the corrosion rate exceeds the usual level (0.05-0.1 mm/yr) expected for unprotected steel in seawater. In some cases the local corrosion rate was far above 1 mm/yr and, obviously, the corrosion had been accelerated by extraordinary circumstances.

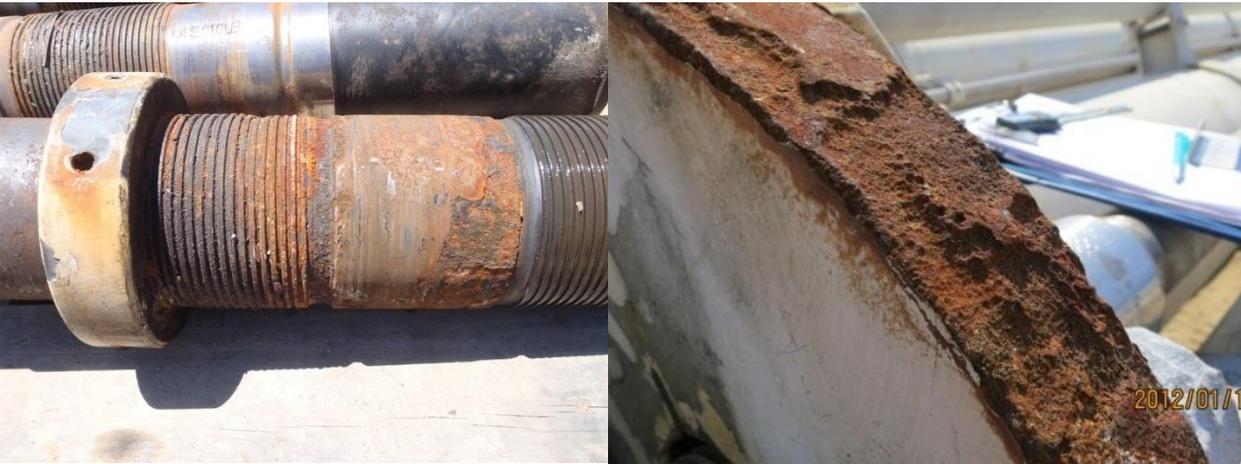
Figure 6: (a) Corrosion on pin for Choke & Kill line. (b) Excessive corrosion along edge of guide plate.

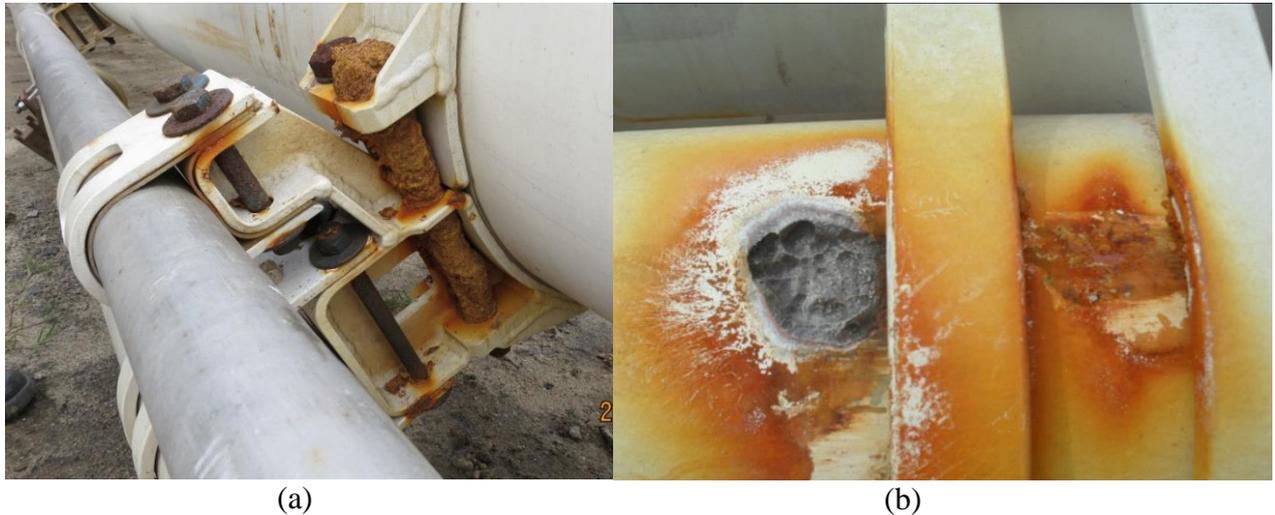
Figure 7: (a) Large variation in condition of bolts for clamps. (b) Excessive corrosion at clamp.

The distribution of corrosion on the low alloy steel components was not uniform or consistent. As an example, some bolts could show extensive corrosion whereas the adjacent ones show no corrosion. Likewise, severe corrosion is observed below some fixtures, but not all. Such deviations are possibly due to marginal differences in electrical resistance between components. Furthermore, when corrosion has started in one location the likelihood of corrosion becomes smaller for adjacent areas.

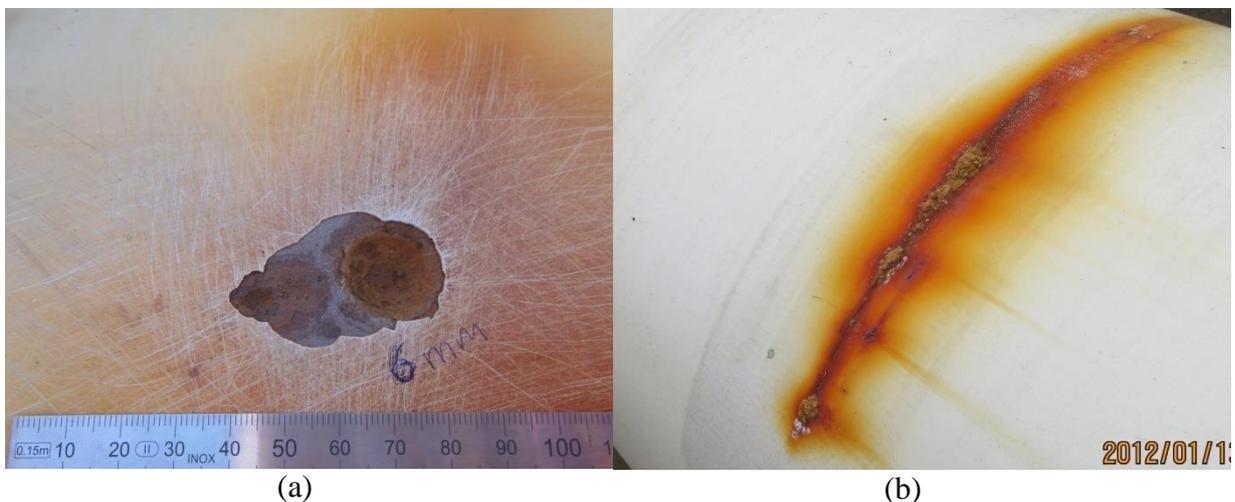
Figure 8: (a) Severe pin-hole corrosion on main pipe due to paint defect. The measured depth is 6 mm. (b) Line of coating defects on main pipe from contact with buoyancy module.

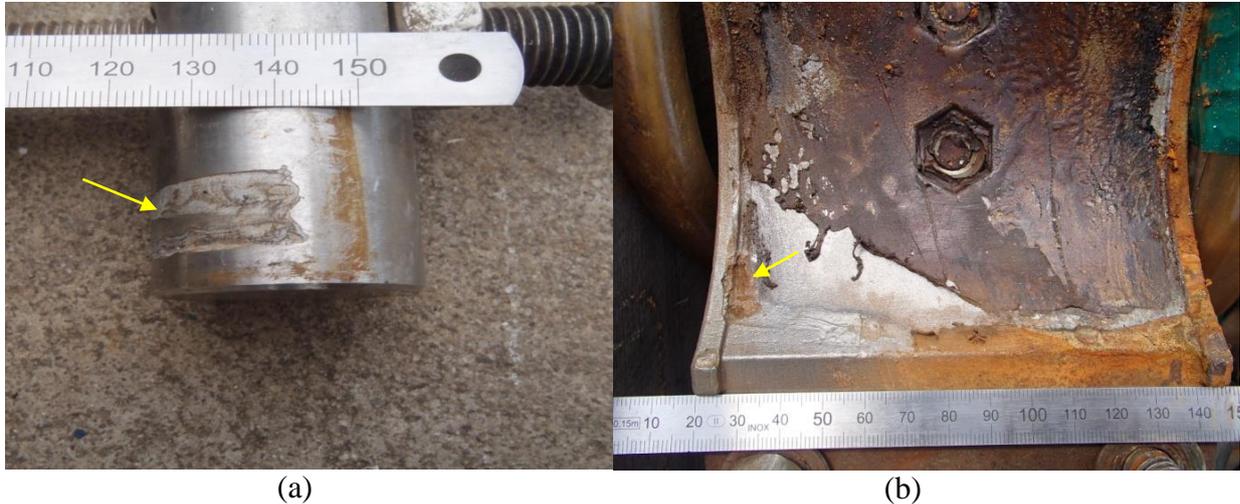
Crevice corrosion was observed on UNS S31603 stainless steel tensioners for straps, fixing the buoyancy modules, Figure 9a. This type of corrosion appeared on most tensioners from

projects in different regions. In some cases, crevice corrosion was also observed on clamps of UNS S31603 stainless steel. The attack was located below the rubber insert on the inward facing surface, Figure 9b.

In both cases the components were completely isolated from the structure, meaning that corrosion has been driven by the cathode reaction on the relatively small free component surface, without interaction from elsewhere.

Figure 9: (a) Crevice corrosion below strap on UNS S31603 tensioner for buoyancy module. (b) Crevice corrosion inside a clamp of UNS S31603.

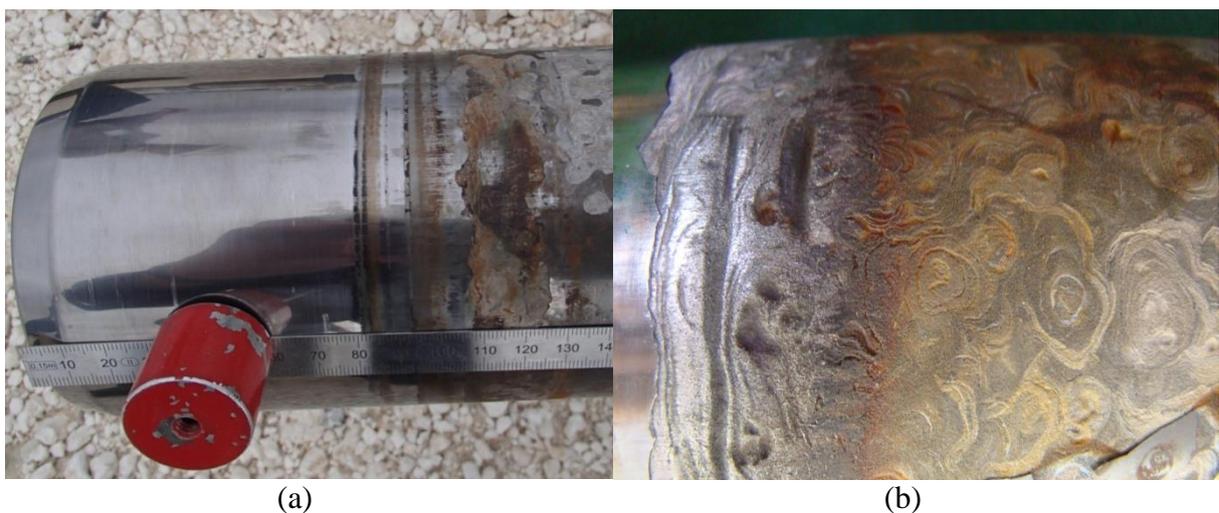
In a few cases, corrosion was observed on the hardface coating of pins, connecting the hydraulic tubing. Such hardfaces are typically made from thermally sprayed Co-Cr-WC or Cr-B-C coatings. Corrosion appeared on the freely exposed part through small pin-holes in the coating, Figure 10a. This caused circular propagation along the stainless steel substrate, and finally flaking of the coating, Figure 10b.

Figure 10: (a) Corrosion of freely exposed Co-Cr-WC hardfacing on pin. (b) Close-up of damage.

The applied hardface coatings provide reasonable corrosion resistance in seawater. Consequently, the observed corrosion failures were surprising. Corrosion tests were performed in the laboratory in order to simulate the failures. It was only possible to reproduce the failure mode by applying a strong anodic polarization that represents the effect typically caused by biofilm formation on stainless steel.

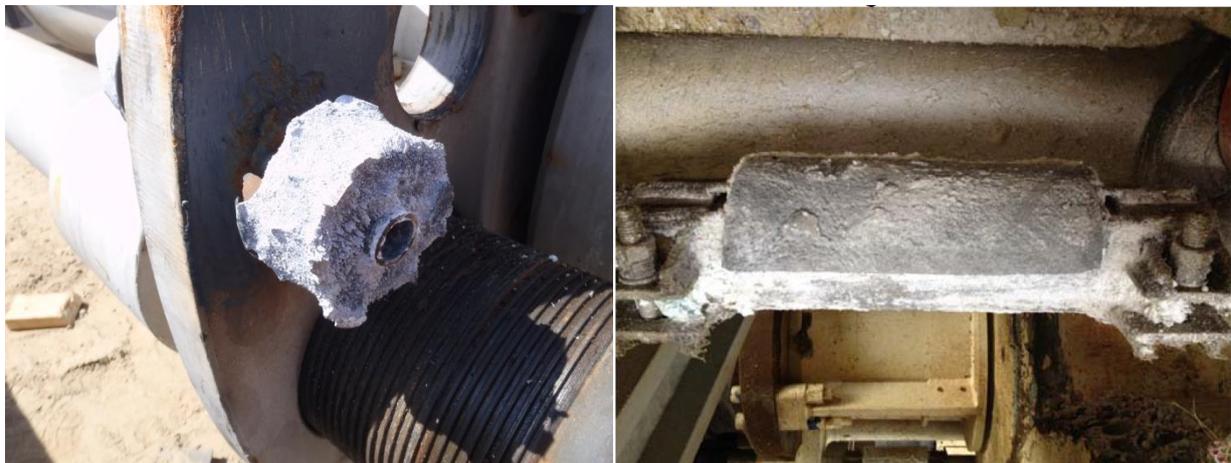
Another option involves mounting of bracelet anodes directly on the hydraulic lines, Figure 11b. The observed consumption of the anodes was in this case uniform and apparently independent of exposure depth. Initially, such anodes were made from aluminum-gallium alloy (i.e. low-voltage Al-Ga anodes) in order to exclude any possibility of Hydrogen Induced Stress Cracking (HISC) of the duplex stainless steel line11. Recent studies on stress levels and microstructure has shown that conventional aluminum or zinc anodes can be mounted on the hydraulic lines without any risk of HISC.

(a) (b)
Figure 11: (a) Aluminum anode on guide plate showing 30 % consumption after 340 days exposure. (a) Al-Ga bracelet anode mounted directly on duplex hydraulic line.
