Managing Corrosion Challenges with Drilling Risers and Subsea Equipment

Troels Mathiesen, Harald Osvoll
FORCE Technology
Park Alle 345
2605 Brøndby
Denmark

Peyman Mohseni, Borge Bjorneklett
MHWirth AS
Rolfsbukveien 4A
1364 Fornebu
Norway

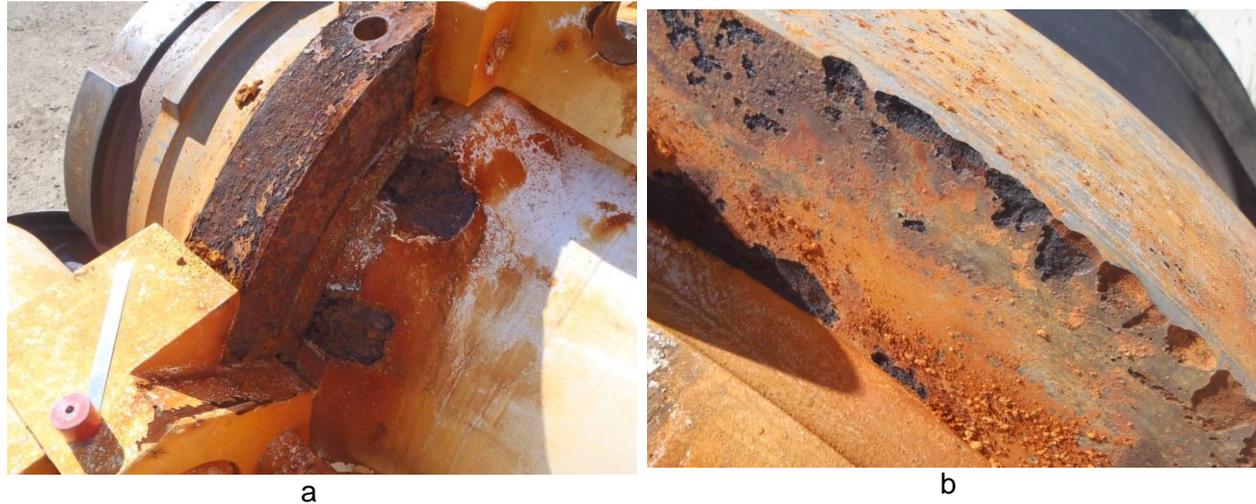
Examples of the observed corrosion on painted steel components are presented in Figures 5 to 8. The photos show extreme examples of excessive corrosion of carbon steel and should not be considered as the general condition of the inspected joints. Although corrosion appears severe and heavily localized, the integrity of the thick-walled riser components was not at risk at the time the problem was identified.

FIGURE 5: (a) Excessive corrosion on female connector and in spider contact area. (b) Excessive corrosion along edge of female connector.

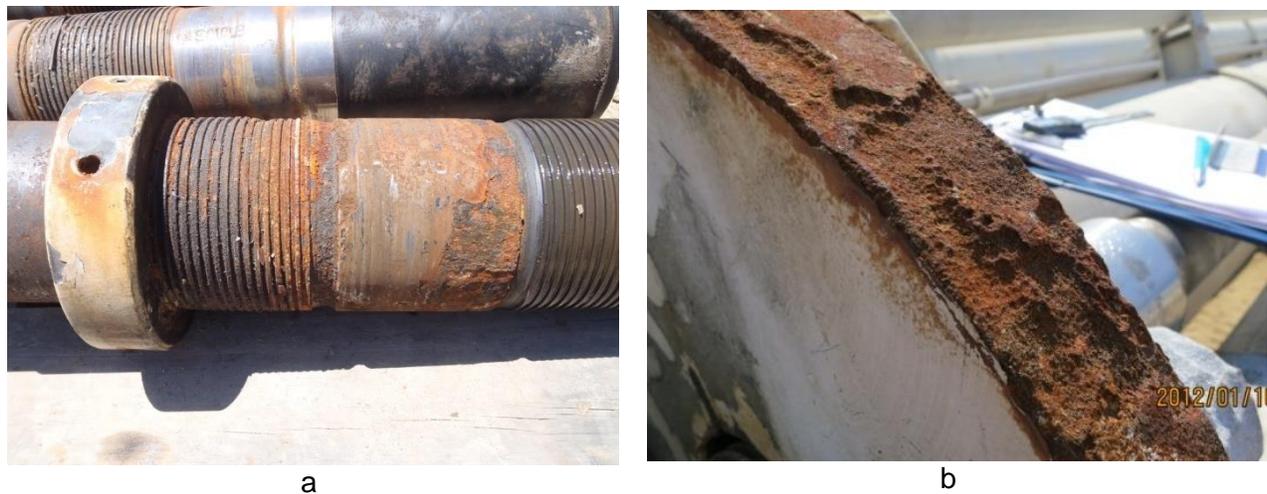
FIGURE 6: (a) Corrosion on pin for Choke & Kill line. (b) Excessive corrosion along edge of guide plate.

In general, the corroded areas are caused by wear or damage of the protective coatings. Marine risers require frequent handling and must to some extent resist associated damage without causing severe corrosion. However, in the photos the corrosion rate exceeds the usual level (0.05-0.1 mm/yr) expected for unprotected steel in seawater. In some cases the local corrosion rate was far above 1 mm/yr and, obviously, the corrosion had been accelerated by extraordinary circumstances.

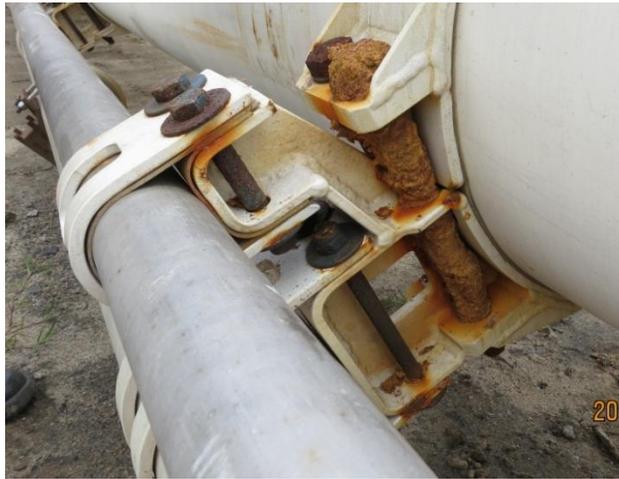
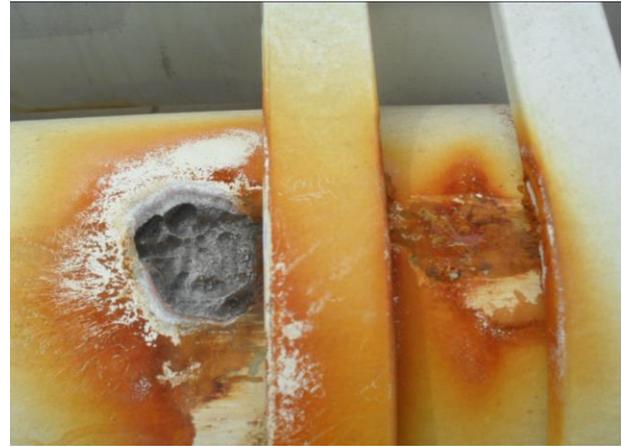
FIGURE 7: (a) Large variation in condition of bolts for clamps. (b) Excessive corrosion at clamp.

The distribution of corrosion on the low alloy steel components was not uniform or consistent. As an example, some bolts could show extensive corrosion whereas the adjacent ones show no corrosion. Likewise, severe corrosion is observed below some fixtures, but not all. Such deviations are possibly due to marginal differences in electrical resistance between components. Furthermore, when corrosion has started in one location the likelihood of corrosion becomes smaller for adjacent areas.

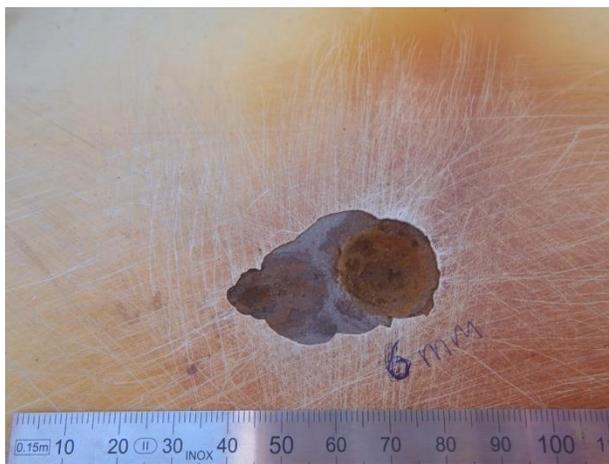
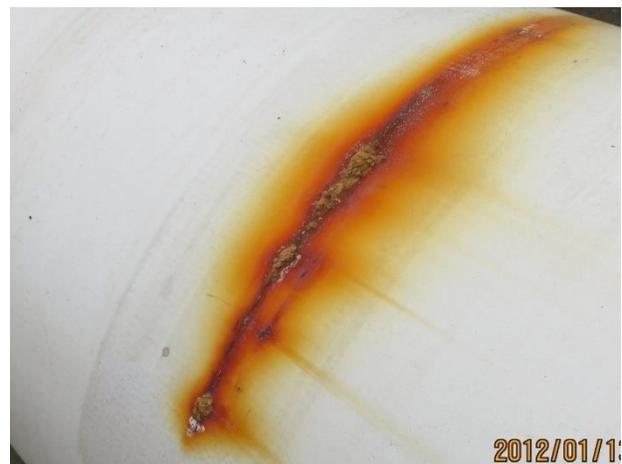
FIGURE 8: (a) Severe pin-hole corrosion on main pipe due to paint defect. The measured depth is 6 mm. (b) Line of coating defects on main pipe from contact with buoyancy module.

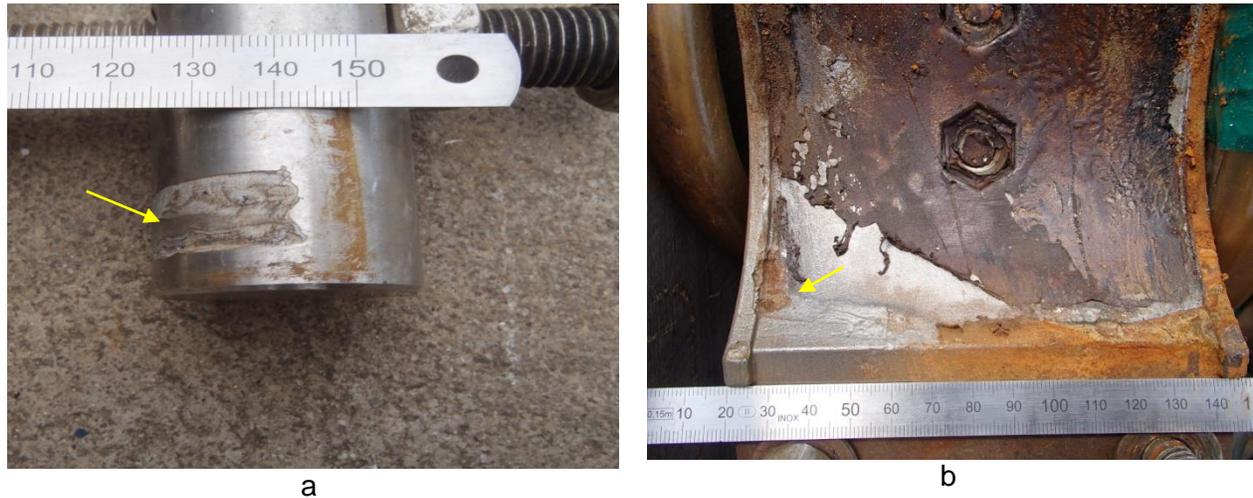
Crevice corrosion was observed on UNS S31603 stainless steel tensioners for straps, fixing the buoyancy modules, Figure 9a. This type of corrosion appeared on most tensioners from projects in different regions. In some cases, crevice corrosion was also observed on clamps of UNS S31603 stainless steel. The attack was located below the rubber insert on the inward facing surface, Figure 9b. In both cases the components were completely isolated from the structure, meaning that corrosion has been driven by the cathode reaction on the relatively small free component surface, without interaction from elsewhere.

FIGURE 9: (a) Crevice corrosion below strap on UNS S31603 tensioner for buoyancy module. (b) Crevice corrosion inside a clamp of UNS S31603.

Crevice corrosion was observed on various UNS 31603 stainless steel parts. Since these components are electrically isolated from the riser structure, the observed corrosion is not affected by any galvanic effects with carbon steel. Corrosion was not observed consistently on all parts, but most of them. This indicates that UNS 31603 is just at the threshold for localized corrosion when used in cold, biofilm-forming seawater, which is a well-known fact. This observation strongly also suggests that oxidizing conditions due to ennoblement occur despite of region. Furthermore, this assessment is supported by the corrosion occasionally occurring in hardfacing on the hydraulic lines. It was only possible to reproduce the failure mode of such coatings by applying conditions typically caused by biofilm formation on stainless steel.

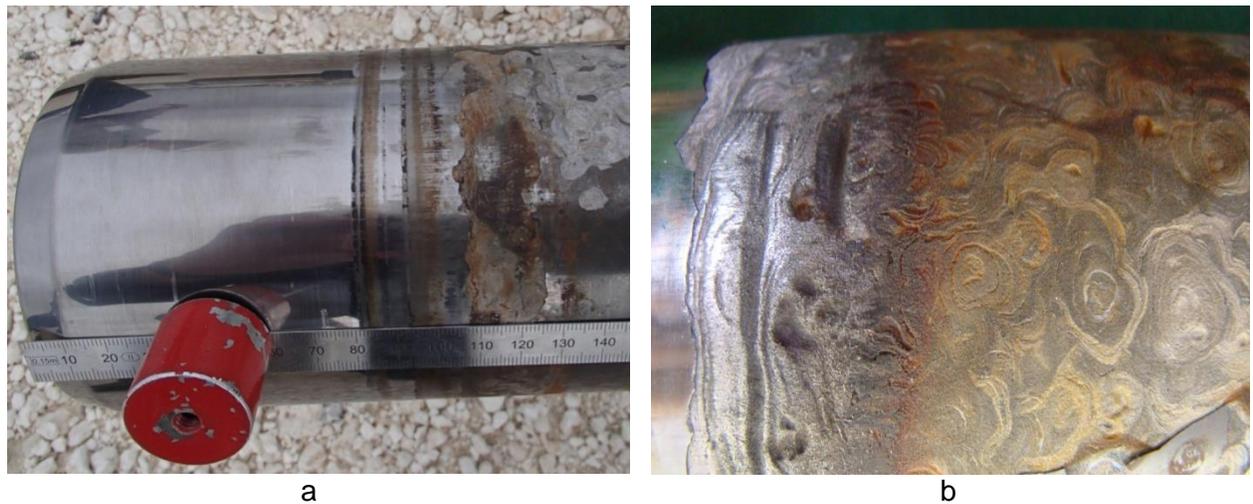
In a few cases, corrosion was observed on the hardface coating of pins, connecting the hydraulic tubing. Such hardfaces are typically made from thermally sprayed Co-Cr-WC or Cr-B-C coatings. Corrosion appeared on the freely exposed part through small pin-holes in the coating, Figure 10a. This caused circular propagation along the stainless steel substrate, and finally flaking of the coating, Figure 10b.

FIGURE 10: (a) Corrosion of freely exposed Co-Cr-WC hardfacing on pin. (b) Close-up of damage.

The applied hardface coatings provide reasonable corrosion resistance in seawater. Consequently, the observed corrosion failures were surprising. Corrosion tests were performed in the laboratory in order to simulate the failures. It was only possible to reproduce the failure mode by applying a strong anodic polarization that represents the effect typically caused by biofilm formation on stainless steel.

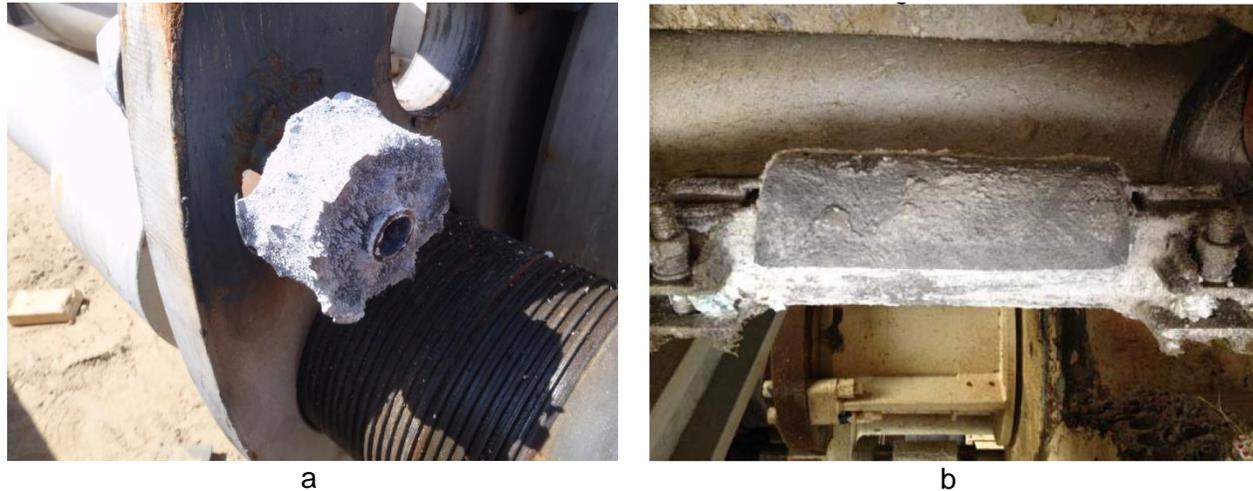
Different approaches for cathodic protection had been applied by the operators on some of the examined risers in order to minimize localized corrosion of the low alloy steel parts. Figure 11a shows an example of an aluminum anode welded to the guide plate. A large spread in anode consumption was observed for most options, indicating limited efficiency that depends on “random” electrical contact

from the anode to the affected parts. In line with this, no consistent or beneficial effect was observed on eliminating the corrosion types described above.

Another option involves mounting of bracelet anodes directly on the hydraulic lines, Figure 11b. The observed consumption of the anodes was in this case uniform and apparently independent of exposure depth. Initially, such anodes were made from aluminum-gallium alloy (i.e. low-voltage Al-Ga anodes) in order to exclude any possibility of Hydrogen Induced Stress Cracking (HISC) of the duplex stainless steel line¹¹. Recent studies on stress levels and microstructure has shown that conventional aluminum or zinc anodes can be mounted on the hydraulic lines without any risk of HISC.

FIGURE 11: (a) Aluminum anode on guide plate showing 30 % consumption after 340 days exposure. (a) Al-Ga bracelet anode mounted directly on duplex hydraulic line.
