New developments in coatings for extended lifetime for offshore wind structures

Claus Erik Weinell
FORCE Technology
345 Park Allé
DK-2605 Brøndby
Denmark

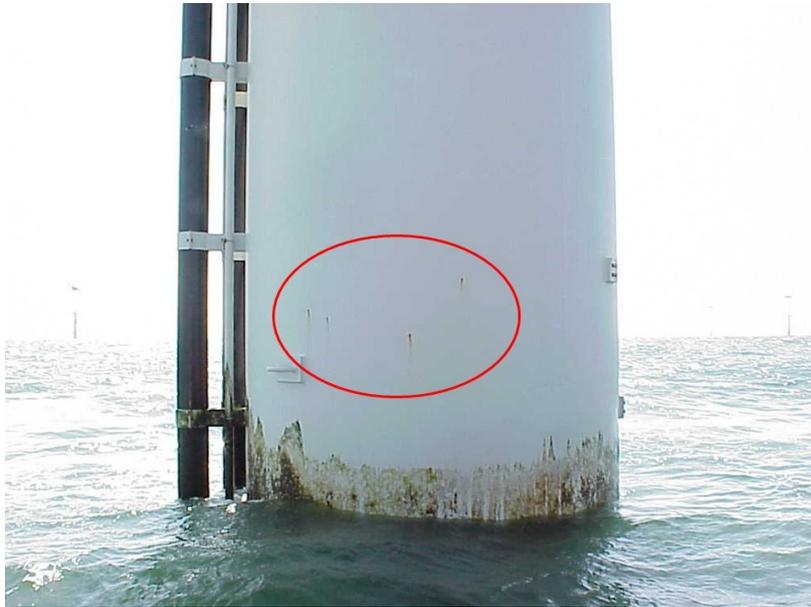
epoxy/polyurethane system, primed with thermally sprayed zinc/aluminium 85/15 coating. This system had a long and successful onshore track record – also in coastal areas. Within the first two years of service, pinpoint rusting (Rust Grade 9-P, SSPC-VIS 2) was observed on the TP's painted with the thin 350 µm two-coat epoxy system, see Figure 2.

Figure 2: The thin 350 µm coating system after 2 years of service (2004). Pinpoint rusting (Rust Grade 9-P, SSPC-VIS 2) has started.

The corrosion took place both in the atmospheric and splash-zone areas of the TP. A forensic investigation showed that the corrosion started as blistering on the coated surface, and as the blisters ruptured from wave- and tide movements, the rust attacks were activated. The cause of coating failures turned out to be the thin coating combined with insufficient dispersion (grinding) of the ceramic extenders in the paint. Microscopic analyses of coating flakes showed that the extenders had not been ground and dispersed sufficiently during the production of the paint. The low DFT of the coating and the oversized agglomerates in the thin film permitted pinhole access of salt water to the steel surface. Figure 3 shows a photo from 2014 (12 years of exposure) of one of the foundations applied with this coating system. Extensive rusting is appearing on the majority of the areas exposed to the splash zone. In 2016 (14 years of exposure) the same foundations were inspected again showing almost complete loss of coating exposing the rusting steel to the environment, see Figure 4. It should be noted that the boat landings were replaced after 5 years' service, applying the 2-coat solvent free epoxy system in 1000 µm. This explains why the coating system on the boat landings appears intact with only few minor mechanical damages.

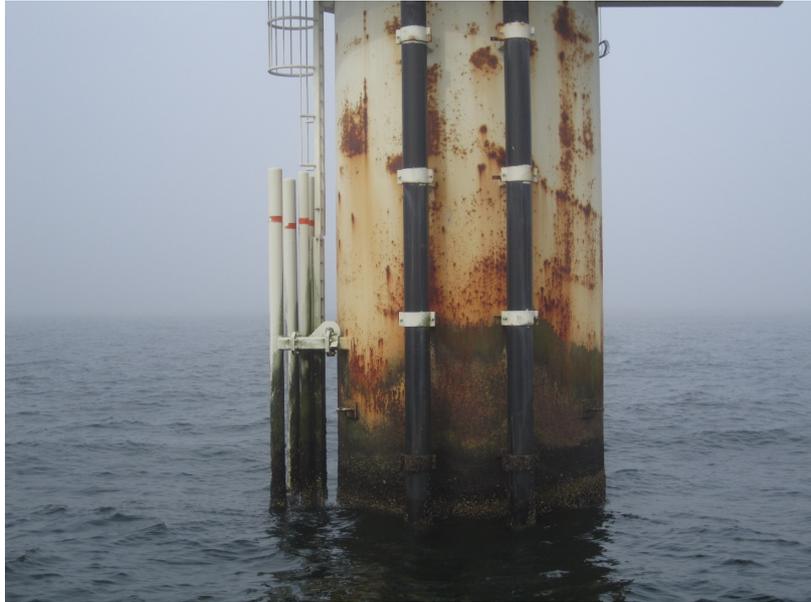
Figure 3: The thin 350 μm coating system after 12 years of service (2014). Extensive corrosion and coating breakdown is observed.

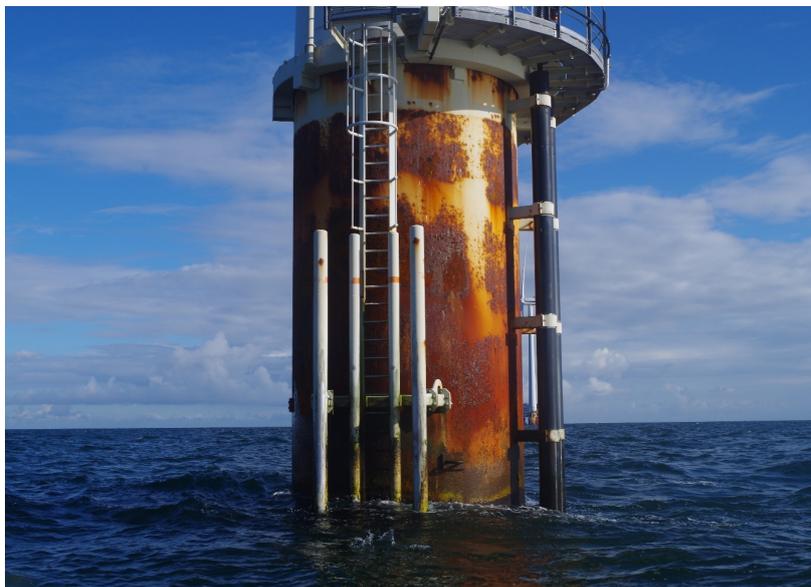
Figure 4: The thin 350 μm coating system after 14 years of service (2016). Extensive corrosion and almost complete loss of coating is observed.

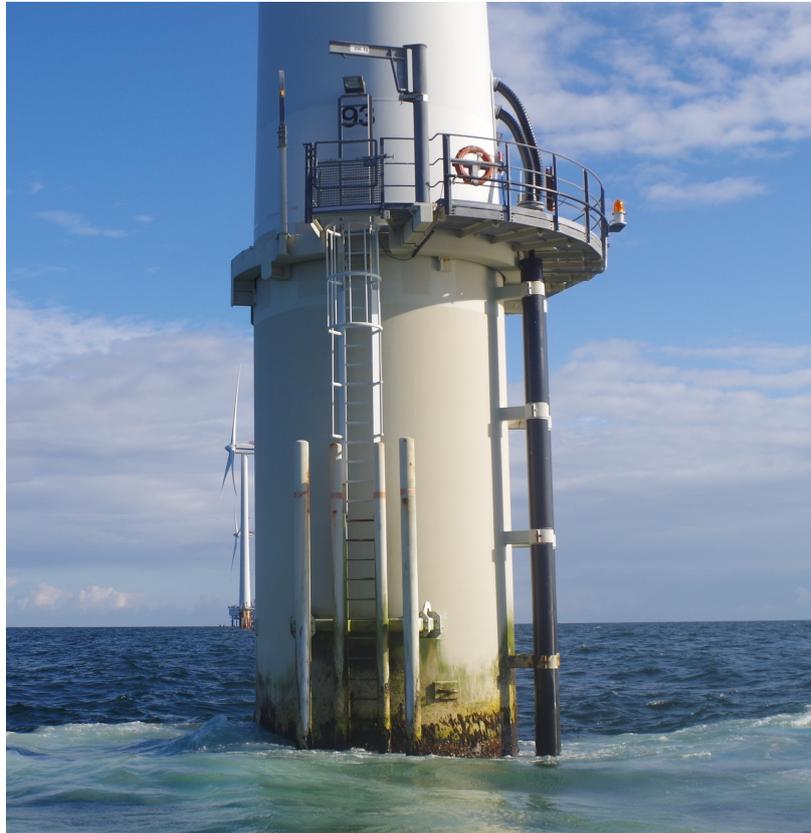
The two-coat solvent free epoxy system with 1000 μm on the last five of the Horns Rev 1 TPs has shown good and lasting resistance, apart from minor damages made by impacts from supply boats. For comparison Figure 5 shows a photo from 2016 (14 years of exposure) of one of the foundations painted with the 1000 μm 2-coat epoxy coating system. The coating system appears more or less intact with no visible corrosion. Consequently, this coating system became a starting point for suitable coating systems meant for future windfarm projects.

Figure 5: The 1000 μm , 2-coat solvent free epoxy coating system after 14 years of service (2016). Completely intact coating system and no visible corrosion is observed on the TP.

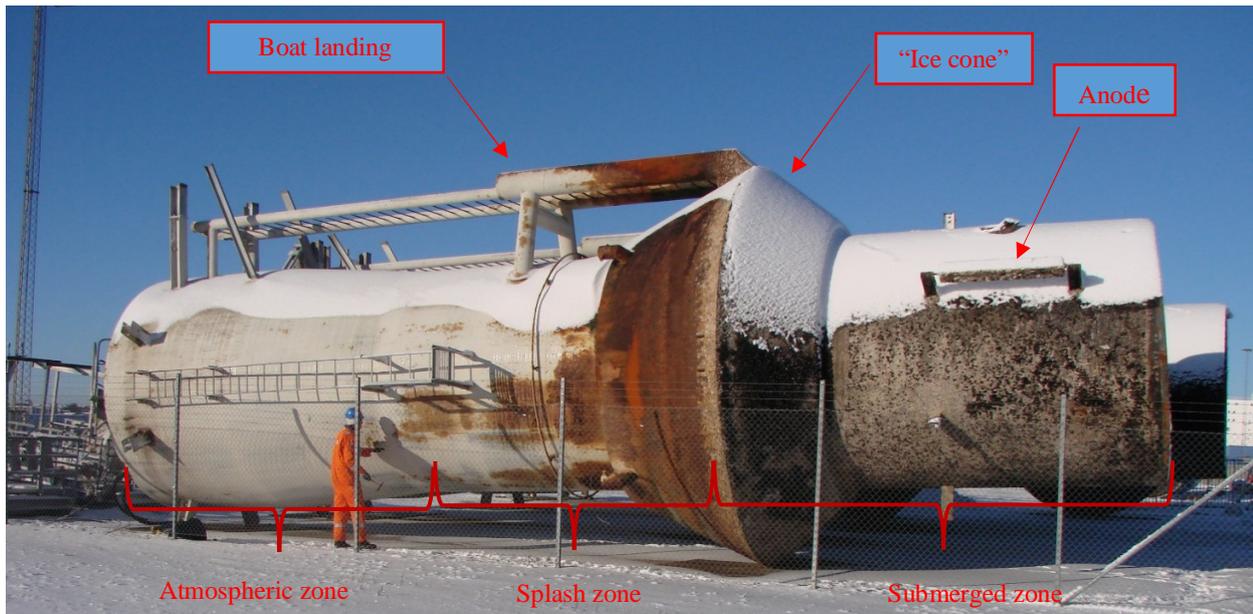
Figure 6. A decommissioned monopile (2016) from Yttre Stengrund in the Baltic Sea.

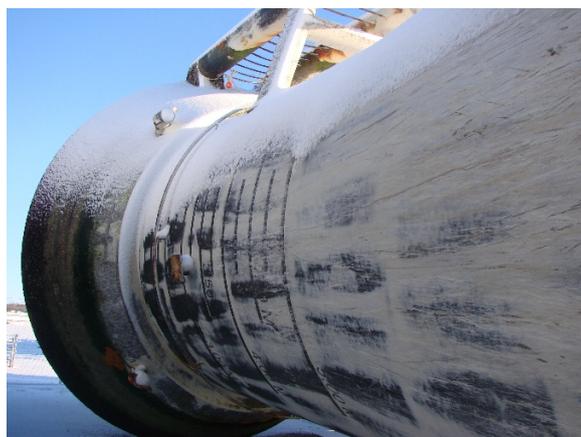
In the splash zone the coating on the ice cones was generally damaged and partly missing on all the piles and corrosion was on-going. In the splash zone above the ice cone, the coating on the monopiles showed an “erosion pattern”, see figure 7. The erosion is most probably due to the movement of ice during winter. In spite of the use of an abrasion resistant “ceramic epoxy”, significant wear of the coating top layer has occurred during the 15 years of service.

Figure 7. Erosion pattern of the top layer of the coating system in the splash zone.

Despite the fact that the coating system used on the monopiles in the Baltic Sea (Yttre Stengrund) was similar to the coating system used on Horns Rev 1 (the North Sea), the performance of the system used in the Baltic Sea was acceptable. One explanation to this is the different environment. In the Baltic Sea the water is more brackish, i.e. low saline water, and the cold climate with temperatures on an annual average somewhat lower than those in the North Sea may have contributed to the lesser corrosion. Another explanation could be that the paint used on Yttre Stengrund may not have had the same issues regarding poor dispersion of the pigments as seen in the paint for the structures in the North Sea. On the other hand, the Baltic Sea has sea ice during winter, exposing the coating systems on the monopiles to a higher mechanical wear than expected in an ice free environment.

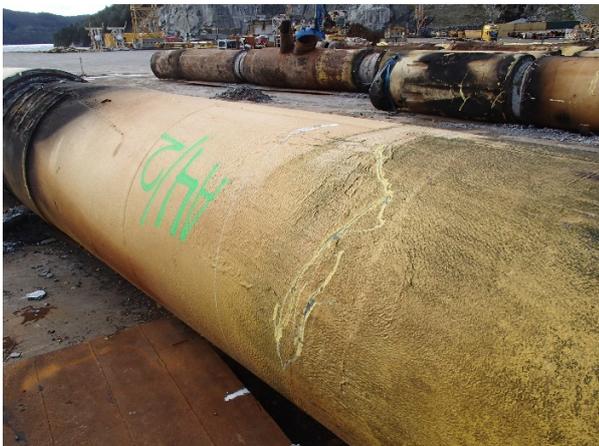
The glass flake polyester coating in the splash zone appeared to be intact over most of the surface. The adhesion was good when tested by scribing the surface with a slag hammer, Figure 8. The dry film thickness was measured in the range from typically 2 to 5 mm, however in some areas slightly lower.

Figure 8. Inspection of jacket legs from a 40-year old platform at a decommissioning yard. Good adhesion of splash zone coating is observed by scribing with a slag hammer.

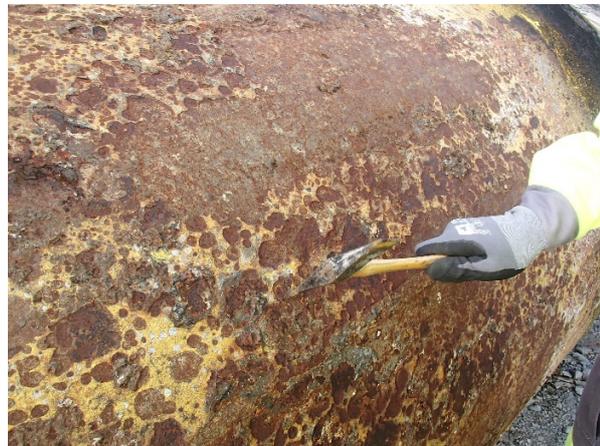
The only region revealing considerable, but not critical, corrosion was located in the lower part of the splash zone coating, Figure 9. The observed corrosion appeared to be the result of cathodic shielding due to the presence of an additional pipe section installed on the outside. This is a useful observation for evaluating the potential effect of inadequate corrosion protection in gaps or cavities of complex structures.

Figure 9. Corrosion on jacket leg in an area that originally had been shielded. The corrosion depth is 2-3 mm.
