Offshore Wind Farms Successful Corrosion Protection and Effective Quality Management

From *JPCL*, December 2016

By Peter Kronborg Nielsen, FORCE Technology

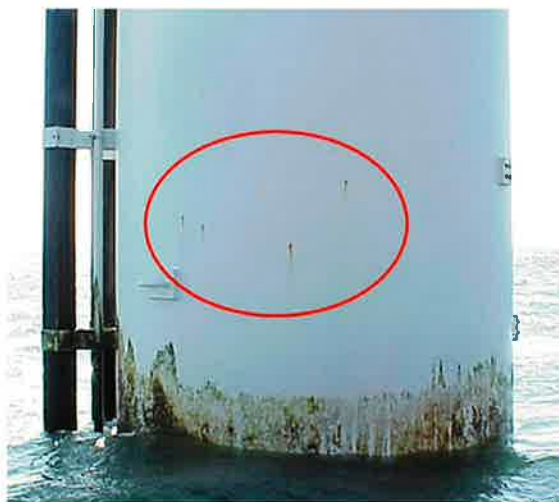
Within the first two years of service, pinpoint corrosion was observed on the TPs painted with the lean 350 µm two-coat epoxy system (Fig. 2).

The corrosion took place both in the atmospheric and splash-zone areas of the TP. A forensic investigation showed that the corrosion started as blistering on the coated surface and as the blisters ruptured from wave and tide movements, corrosion started. The cause of damage turned out to be the lean coating combined with insufficient grinding of the ceramic extenders in the paint. Microscopic analyses of pieces of paint flakes showed that the extenders had not been ground sufficiently during the production of the paint. This defect and the low DFT of the coating permitted pinpoint access of salty water to the steel surface. The surface (that is, the film) had become permeable (Fig. 3).

Cathodic disbondment of the coating system may also have contributed to the generation of blisters in the splash zone.

It should be added that at present, the corrosion damage is not considered to be detrimental to the TPs of HR1. Due to the original conservative corrosion allowance in the structure, the integrity of the wind farm is intact and therefore, the present owner of HR1, Vattenfall A/S, expects the farm to be in service as planned until the mid-2020s.

Fig. 2: At the Horns Rev 1 (HR1) facility, pinpoint corrosion is noted on TPs painted with the lean two-coat epoxy system, Photos, Figures 2-4, courtesy of FORCE Technology

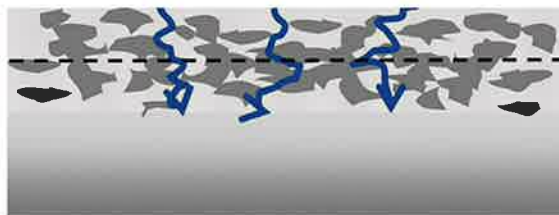
Fig. 3: Poorly ground ceramic extenders combined with a low DFT render a coating film permeable.

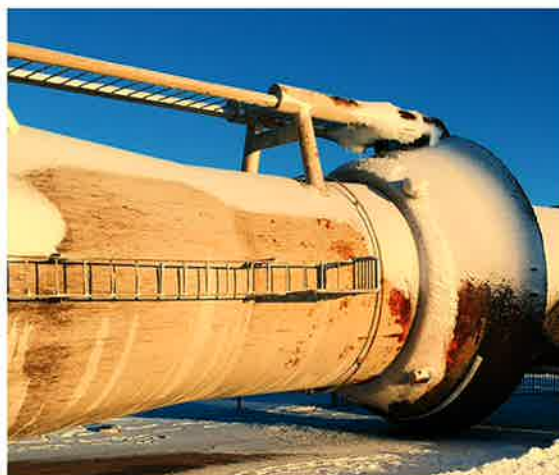
It should also be mentioned that ceramic-reinforced epoxy paint systems have shown relatively good protection over 15 years in the Swedish Yttre Stengrund decommissioned wind farm in the Baltic Sea (Fig. 4).

Fig. 4: This image shows a decommissioned TP from Yttre Stengrund Wind Farm, Baltic Sea, Sweden, after more than 15 years of service. The splash zone area has been attacked by ice, other impacts and general wear. The area above the splash zone is in fairly good condition. The brackish, low-saline water and the cold climate of the Baltic Sea may have contributed to the lesser corrosion.

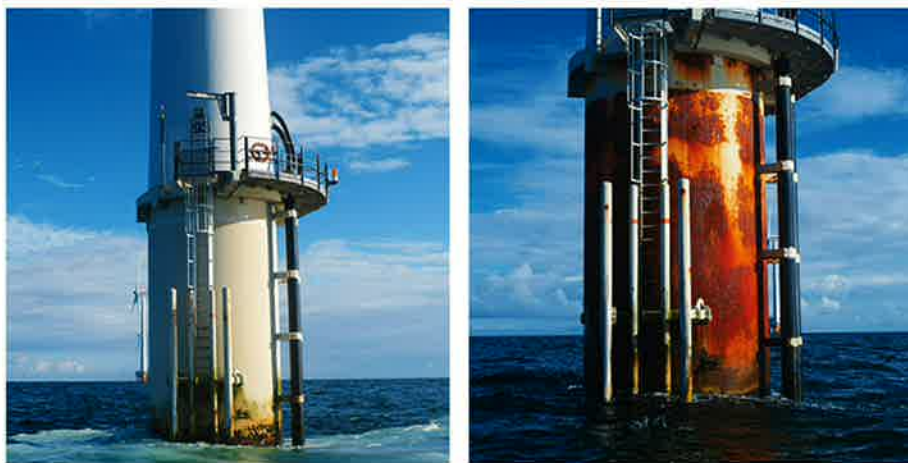
The two-coat epoxy system at 1,000-1,100 µm DFT on the last five of the HR1 TPs has shown good and lasting resistance, apart from damage caused by impact from supply boats, and the protection remains intact today, as shown in Figure 5. As a comparison, Figure 6 shows the corrosion attacks in 2015 on TPs coated with the lean 350 µm permeable coating system. Consequently, the two-coat solvent-free coating system with the high DFT became a starting point for suitable coating systems meant for future wind farm projects.

Fig. 5 (left): The two-coat epoxy system at 1,000-1,100 µm DFT on the last five of the HR1 TPs has shown good and lasting resistance, apart from damage caused by impact from supply boats, and the protection remains intact today. Fig. 6 (right): This photo shows the corrosion attacks in 2015 on TPs coated with the lean 350 µm permeable coating system. Photos courtesy of Morten Mortensen, Hempel A/S

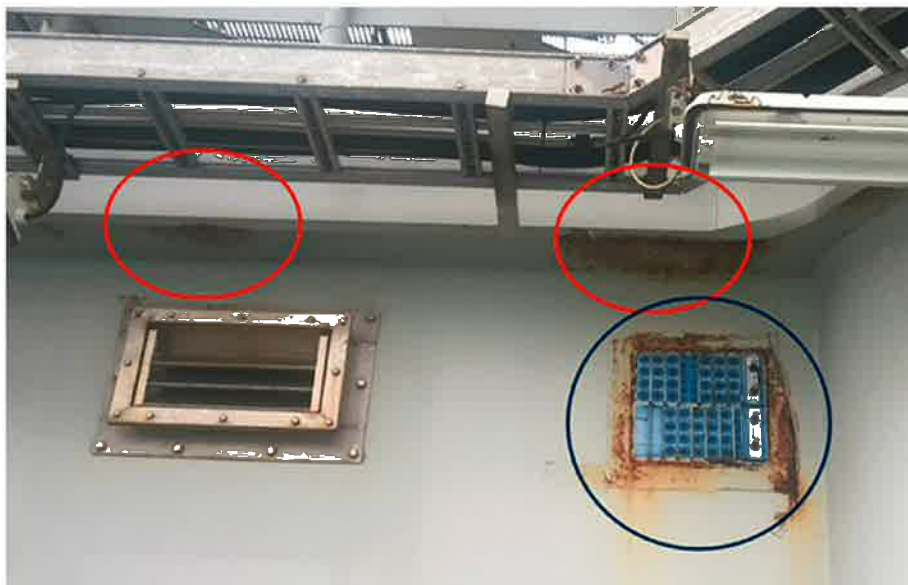
Treatment (grinding) of weld spatter, weld slag, undercuts and weld porosity must be carried out prior to abrasive blasting. Likewise, all edges must be rounded. If not, the areas could be starting points for corrosion attacks.

Fig. 7: This image shows an offshore transformer station. Two typical faults in the surface treatment process that initiate corrosion attacks are noted. The red circles show the lack of rounding of edges (chamfering) on part of the steel bar. The blue circle shows a poorly mounted and painted light accessory after installation of the station. The intact ventilation duct on the left side of the photo has been mounted correctly during the manufacture of the station. *Photo courtesy of Dong Energy*

Frequently, accessories such as lamps, clamps and the like have to be attached to the finished structures. Sometimes these activities happen offshore. As the mountings are often performed by non-painters and out of the hand of the main contractor, early corrosion attacks may happen on the structures (Fig. 7).

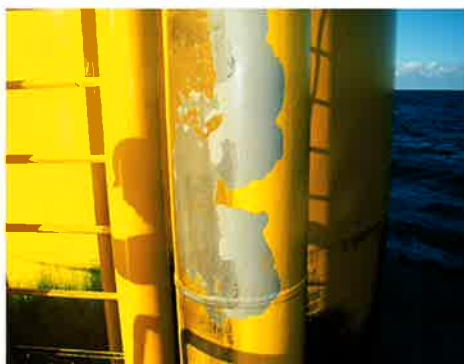
Fig. 8: The flaking of the topcoat and the penultimate intermediate coat on this boat landing was caused by aluminum dust originating from an adjacent thermal spray application during construction and from exceeding recoating intervals. *Photo courtesy of FORCE Technology*

Epoxy and PU paints have a recoat window. If the maximum recoating interval has been infringed upon, the subsequent coat may have adhesion problems. Similarly, a greasy or dusty surface may deter adhesion of the following coat and can result in flaking³ (Fig. 8).

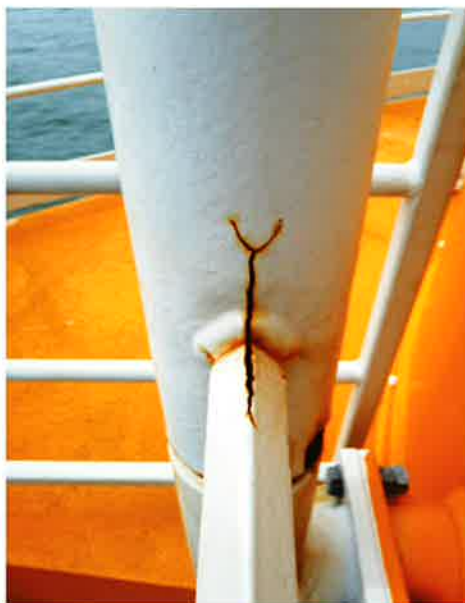
When painting the boat-landing constructions, occasionally unacceptably high DFTs are registered on weld assemblies and corners. Total DFTs of more than 2,000 μm (79 mils) have been observed, if the master painter has been inattentive. The high thickness values create inner tensions in the paint film after drying, which may lead to cracking of the coating film down to the steel surface and then to subsequent corrosion attacks (Fig. 9). A careful check of the DFTs is mandatory, especially in these areas.

Fig. 9: The flaking of the topcoat and the penultimate intermediate coat on this boat landing was caused by aluminum dust originating from an adjacent thermal spray application during construction and from exceeding recoating intervals. Photo courtesy of FORCE Technology
