Offshore windfarms – successful corrosion protection combined with effective quality management

Article presented in *The Journal of Protective Coatings & Linings, JPCL*, December 2016

Following an uncertain start, the present offshore coating systems for windfarms have shown fine durability against the aggressive marine environment. Positive features from the first windfarms with more than 15 years of service are described, and the importance of quality management is explained.

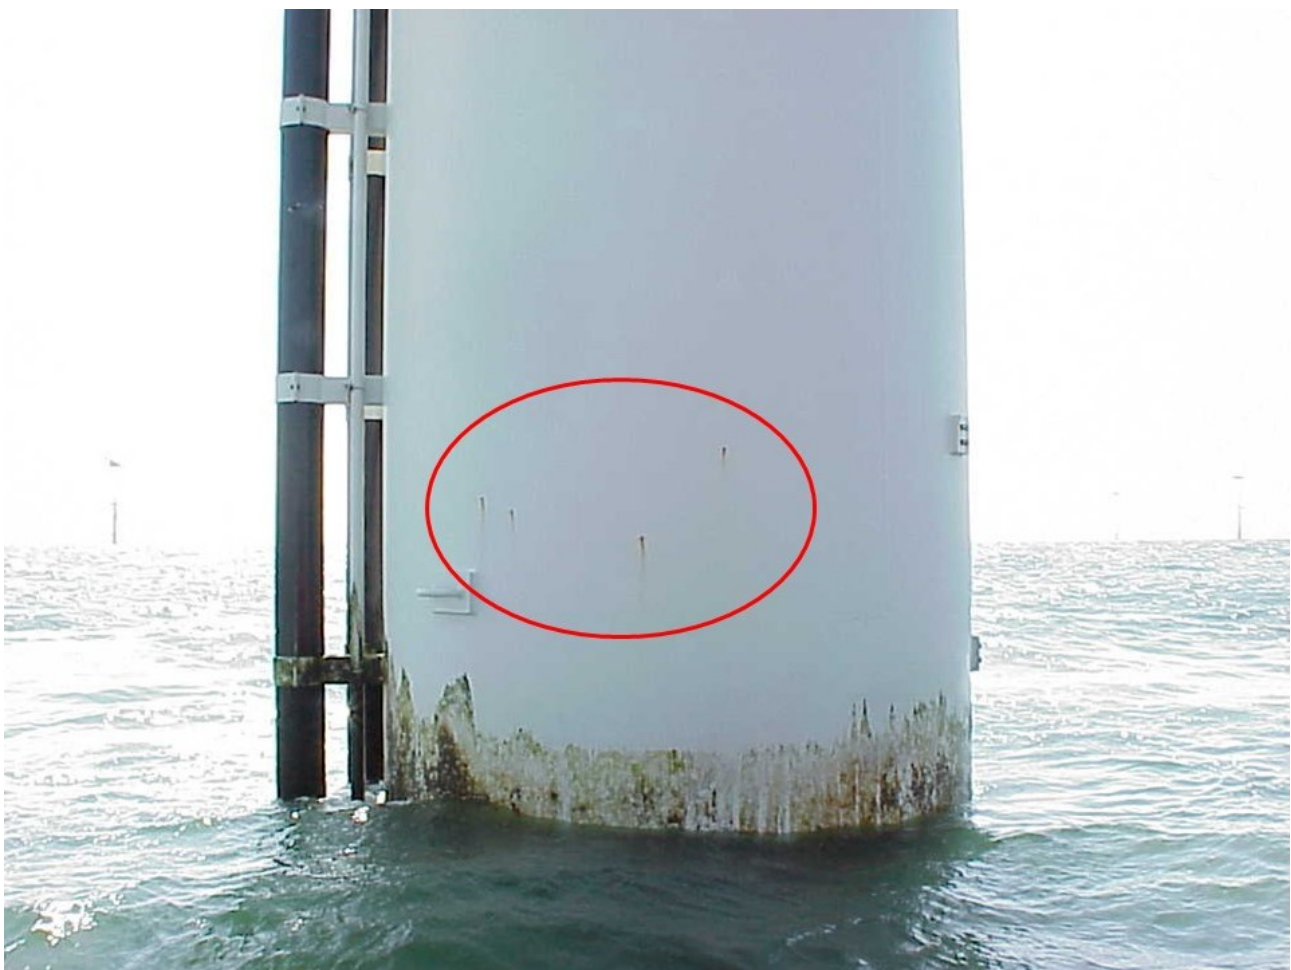
Within the first two years of service, pinpoint corrosion was observed on the TP's painted with the lean 350 μm two-coat epoxy system, Figure 2.

Figure 2. Horns Rev 1. Pinpoint corrosion on TPs with the lean two-coat epoxy system after two years of service.

The corrosion took place both in the atmospheric and splash-zone areas of the TP.

A forensic investigation showed that the corrosion started as blistering on the coated surface, and as the blisters ruptured from wave- and tide movements, the rust attacks were activated. The cause of damages turned out to be the lean coating combined with insufficient grinding of the ceramic extenders in the paint. Microscopic analyses of pieces of paint flakes showed that the extenders had not been ground sufficiently during the production of the paint. This defect and the low DFT of the coating permitted pinpoint access of salty water to the steel surface. The film had become permeable, Figure 3.

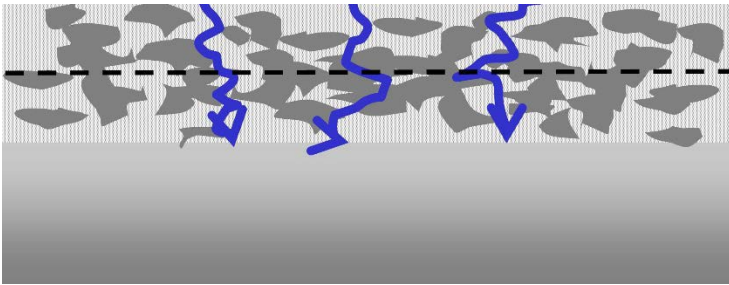
Figure 3. Model. Poorly ground ceramic extenders combined with a low DFT make the coating film permeable.

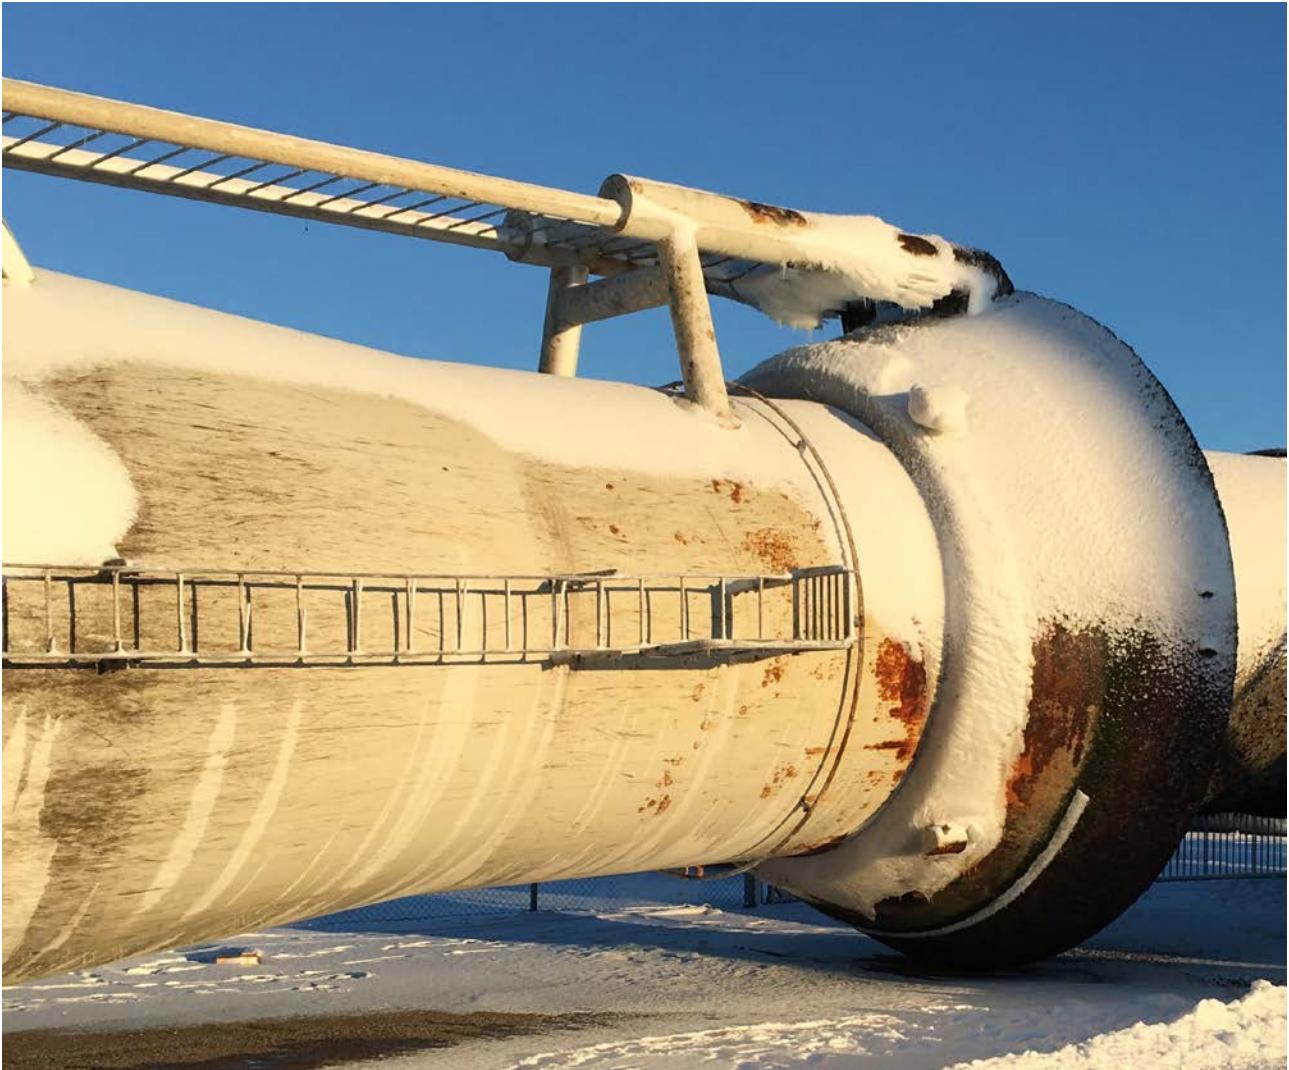
It should also be mentioned that ceramic reinforced epoxy paint systems have shown relatively good protection over 15 years in the Yttre Stengrund (Sweden) decommissioned windfarm in the Baltic Sea, Figure 4.

Figure 4. Decommissioned TP from Yttre Stengrund Windfarm, Baltic Sea, Sweden, after more than 15 years of service. The splash-zone area is attacked from ice and other impacts and general wear. The area above the splash-zone is in fairly good condition. The brackish, low saline water and the cold climate of the Baltic Sea may have contributed to the lesser corrosion.

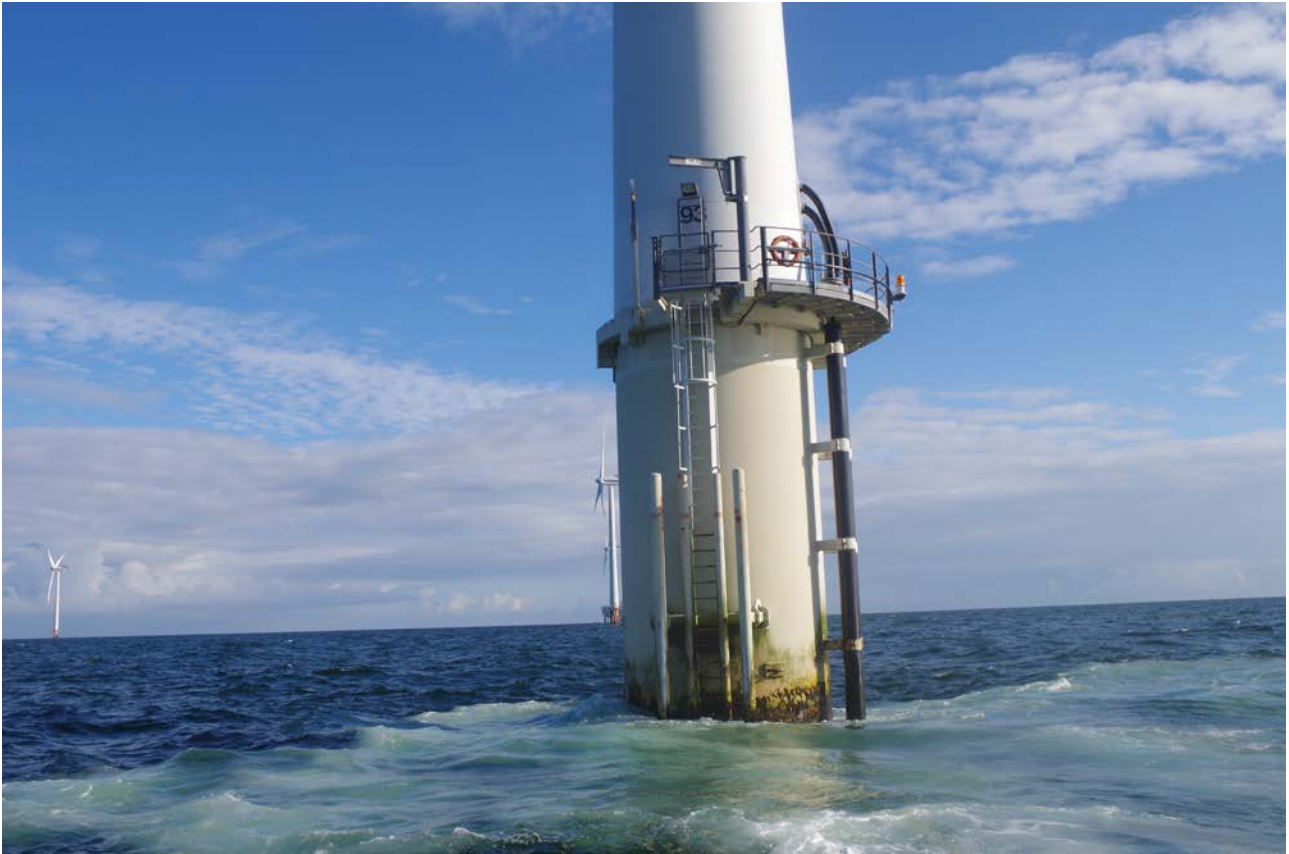
The two-coat epoxy system with the DFT of 1000-1100 μm on the last five of the HR1 TPs has shown good and lasting resistance, apart from damages made by impacts from supply boats. The protection is intact today as shown in Figure 5. As a comparison, Figure 6 shows the corrosion attacks in 2015 on TPs coated with the lean 350 μm permeable coating system.

Figure 5. HR 1 in 2015. TP painted with the high DFT solvent free epoxy system 1000-1100 μm after 14 years of service. The protection of the coating system is intact.

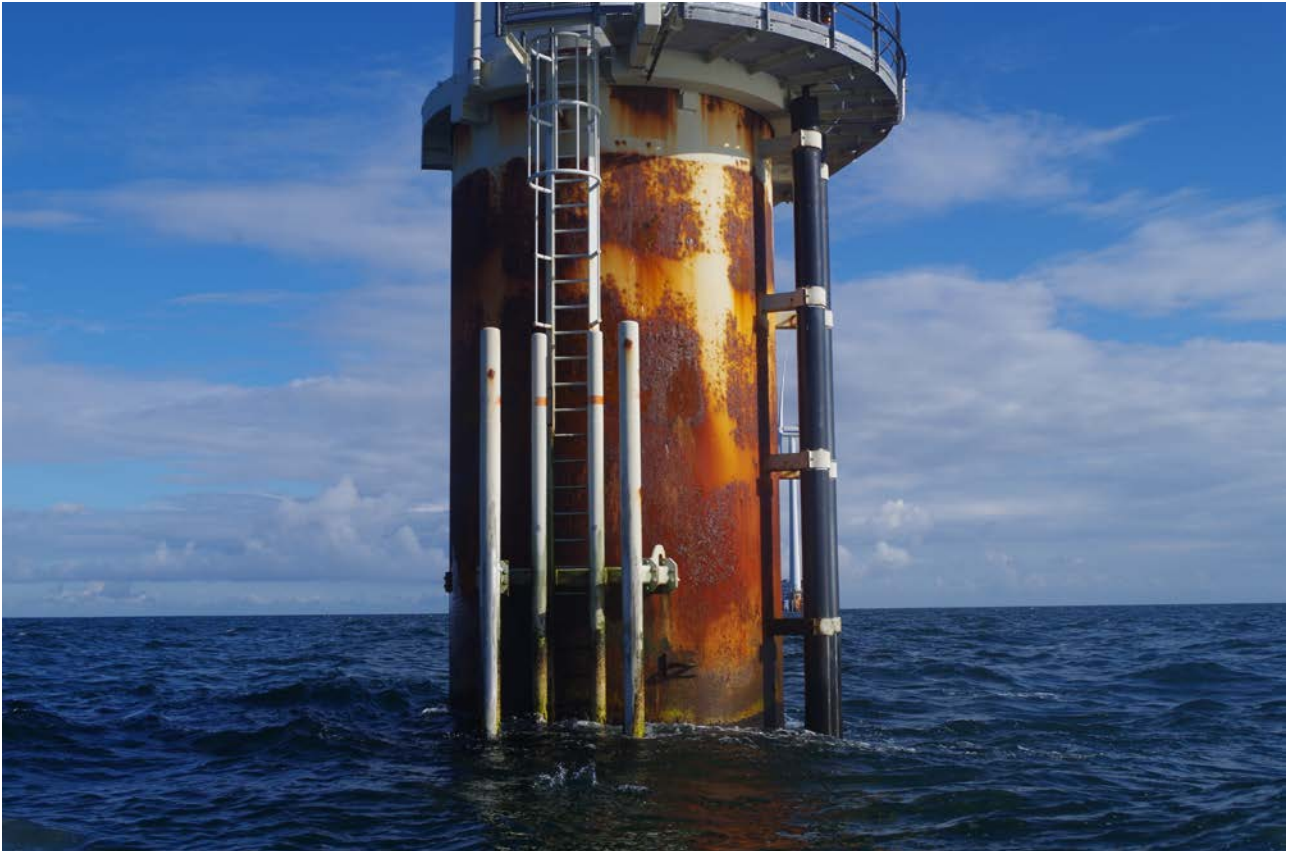
Figure 6. HR 1 in 2015. TP painted with lean and permeable coating system after 14 years of service. Compare the corrosion progress with Figure 2.

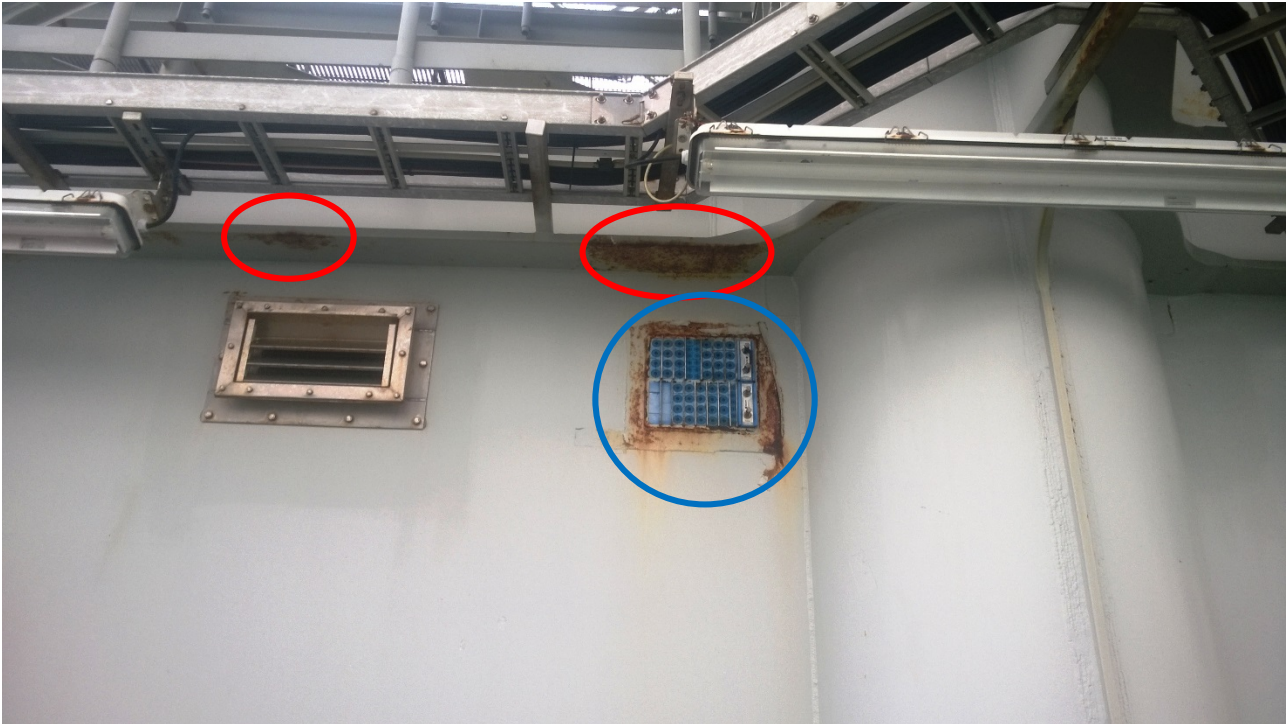
Treatment (grinding) of weld spatter, weld slag, undercuts and weld porosity must be carried out prior to abrasive blasting. Likewise, all edges must be rounded. If not, the areas could be starting points for corrosion attacks, such as seen in Figure 7.

Frequently, accessories such as lamps, clamps and alike have to be attached to the finished structures. Sometimes these activities happen offshore. As the mountings are often performed by non-painters and out of the hand of the main contractor, early corrosion attacks may happen on the constructions, cf. Figure 7.

Figure 7. Offshore transformer station. Two typical faults in the surface treatment process that initiate corrosion attacks: Red circles: Lack of rounding of edges (chamfering) on part of the steel bar. Blue circle: Poorly mounted and painted light accessory after installment of the station. See also the intact ventilation duct on the left hand side, which has been mounted correctly during the manufacture of the station.

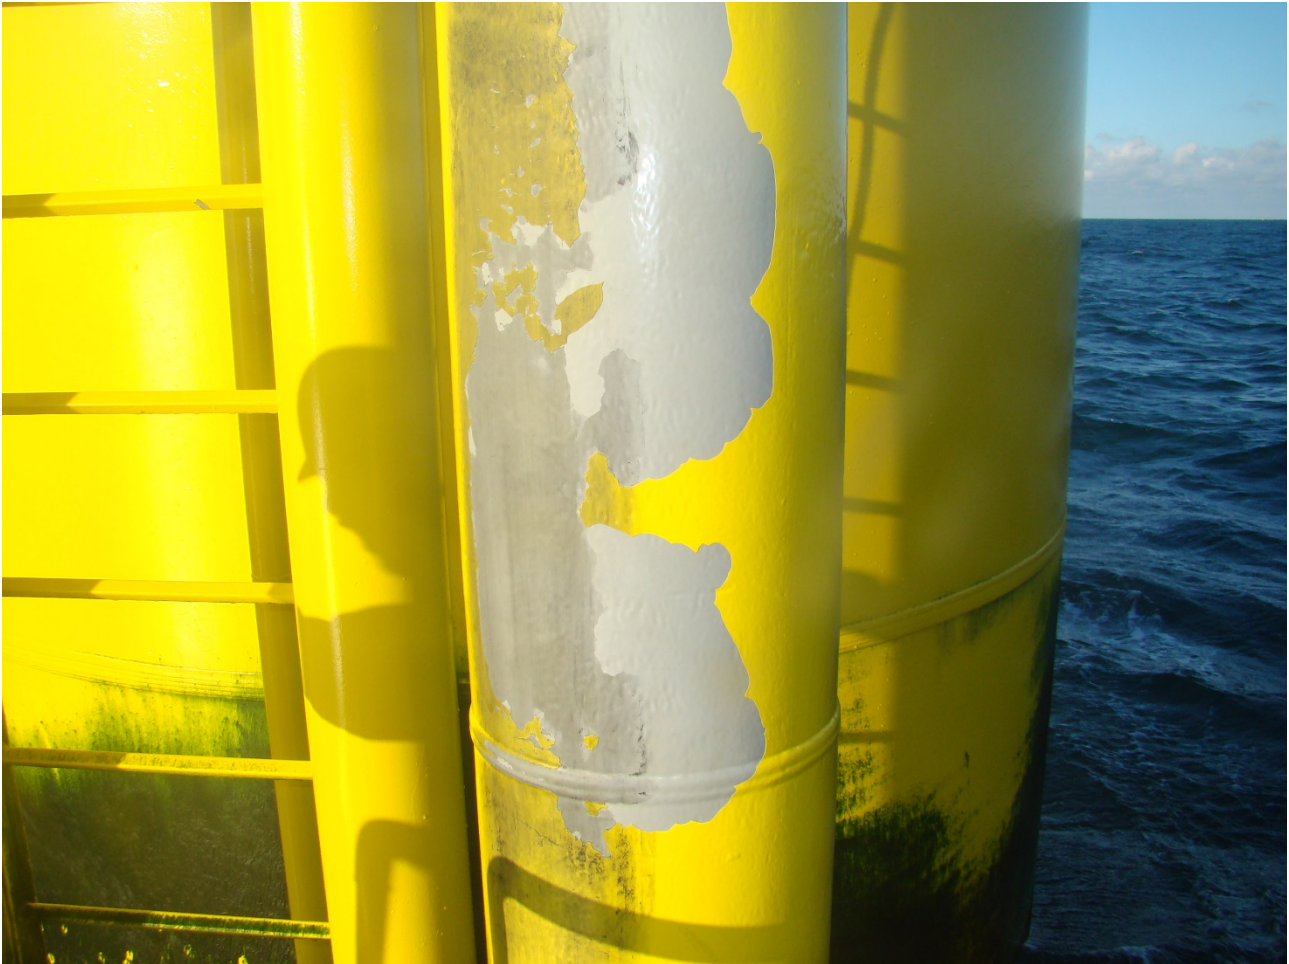
Epoxy and PU paints have a recoating window. If the maximum recoating interval has been infringed, the subsequent coat may have adhesion setbacks. Similarly, a greasy or dusty surface may deter adhesion of the following coat. The result is flaking, Figure 8. A more detailed description is found in ³.

Figure 8. Flaking of topcoat and penultimate intermediate coat on a boat landing. The flaking was caused by aluminium dust, originating from adjacent thermal spray application during construction, and from exceeding recoating intervals.

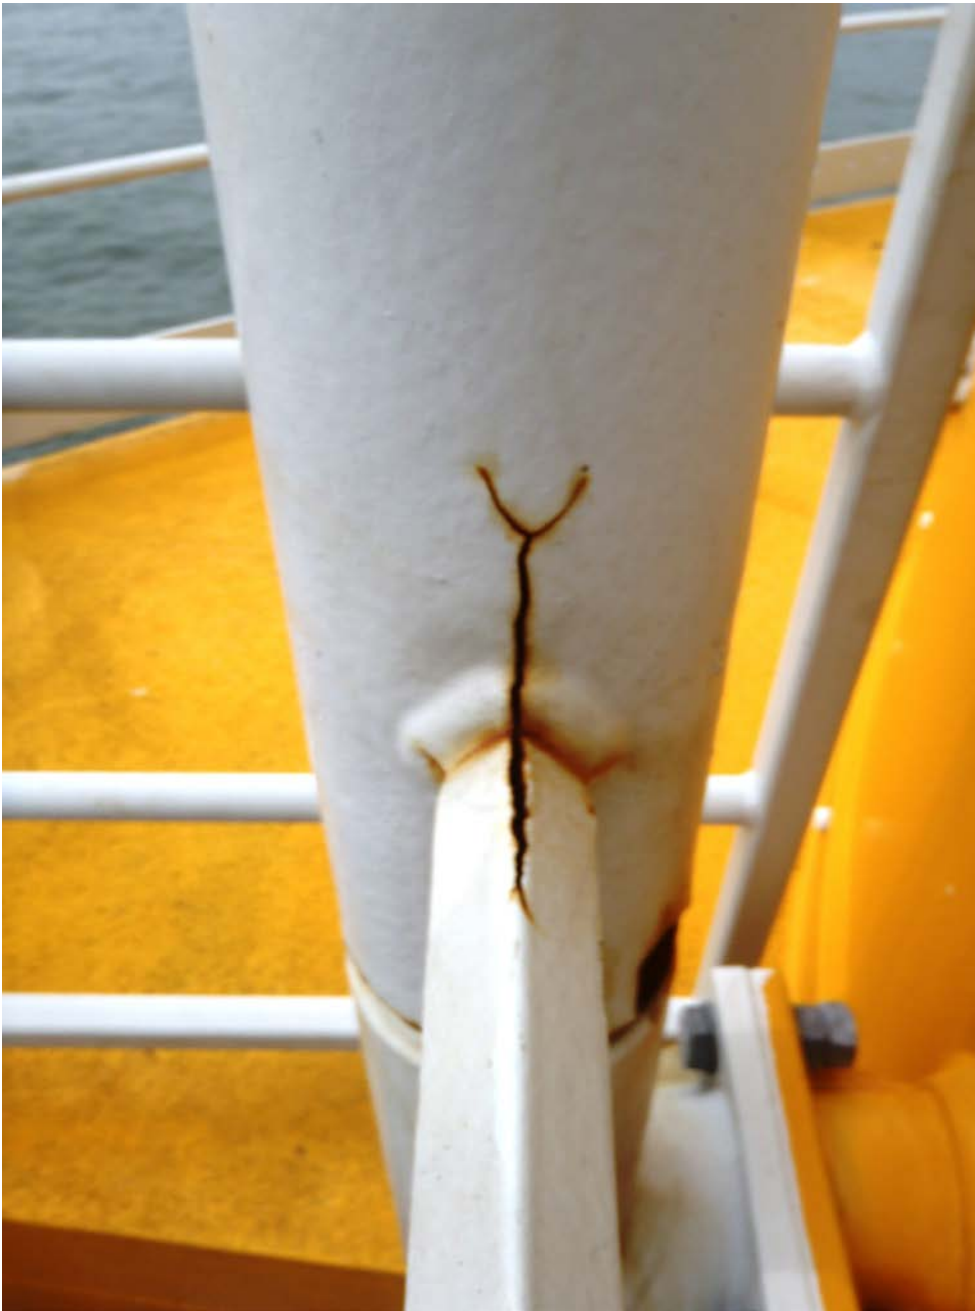
When painting the boat landing constructions, occasionally too high DFTs are registered on weld assemblies and corners. Total dry film thicknesses of more than 2000 μm have been observed, if the master painter has been inattentive. The high thickness values create inner tensions in the paint film after drying,

which may lead to cracking of the coating film down to the steel surface and subsequent corrosion attacks, Figure 9. A careful check of the DFTs is mandatory, especially in these areas.

Figure 9. Cracks in a coating film caused by inner tensions in the coating film from excessive DFT.
