Article presented at the GfKORR, Gesellschaft für Korrosionsschutz, ANNUAL CONFERENCE 2018 - Corrosion Protection of Offshore Wind Power Plants, Bremerhaven, 6-7 November 2018.

Corrosion issues and monitoring techniques for offshore wind turbine foundations

Lars Nøhr-Nielsen, Troels Mathiesen, FORCE Technology

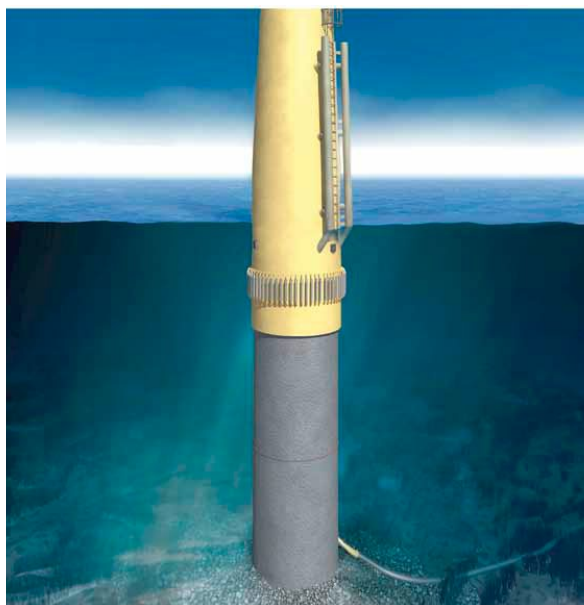
Figure 1: A principle sketch of a monopile-based design. The grey part is the monopile, the yellow part is the transition piece.

The monopile foundation is a combination of a monopile (MP) to be rammed into the seabed and a transition piece (TP) that is mounted on the MP to act as support and alignment for the tower. The two parts are fixed to each other via a grouted connection or a bolted flange. The monopile is fully submerged in the water whereas the TP is only partially submerged. This type of foundation is presently used for water depths up to around 35 m. For deeper waters, other types of foundation will often be considered.

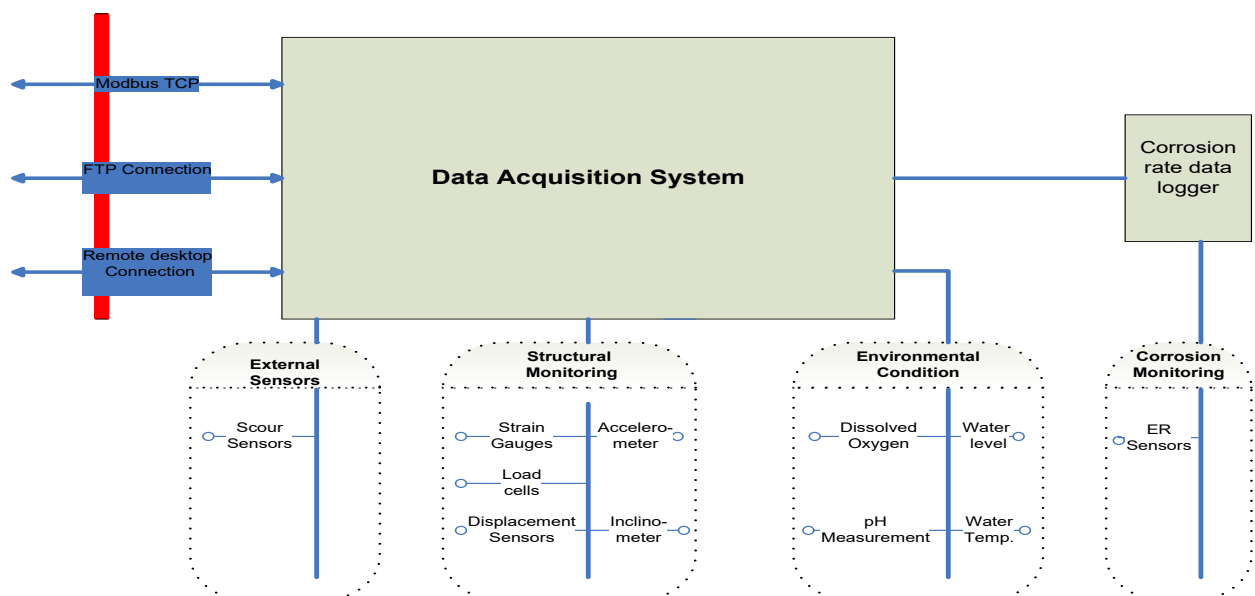
Figure 3: An example of a connected monitoring system for surveillance of an offshore monopile foundation.

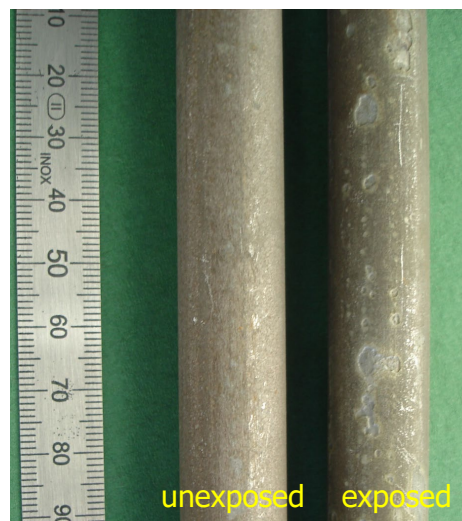
Figure 6: Cleaned surface of full-length coupon showing only minor corrosion after 1 year of exposure.

Figure 6 shows close-up photos of an unexposed and an exposed coupon after 1 year of exposure. At this site, only superficial corrosion was observed.

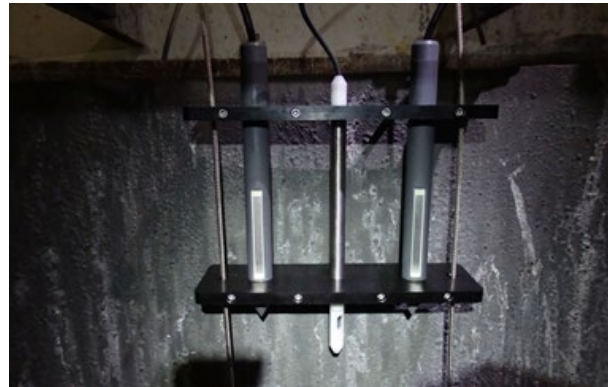
Figure 7: An ER probe installed on the monopile wall.

The ER probe is a fixed sensor type for real-time corrosion rate measurement. It measures the change in electrical resistance (ER) over a steel element with temperature compensation by a non-exposed reference element. Any corrosion in the sensors' steel element leads to decreased thickness of the element and hence increased resistance which, compiled with time, is converted to a corrosion rate. Apart from the corrosion rate, the ER probe also provides the current density in structures protected by CP.
