Monitoring and Inspection Options for Evaluating Corrosion in Offshore Wind Foundations

Troels Mathiesen, Anders Black, Frits Grønvold
FORCE Technology
Park Alle 345
2605 Brøndby
Denmark

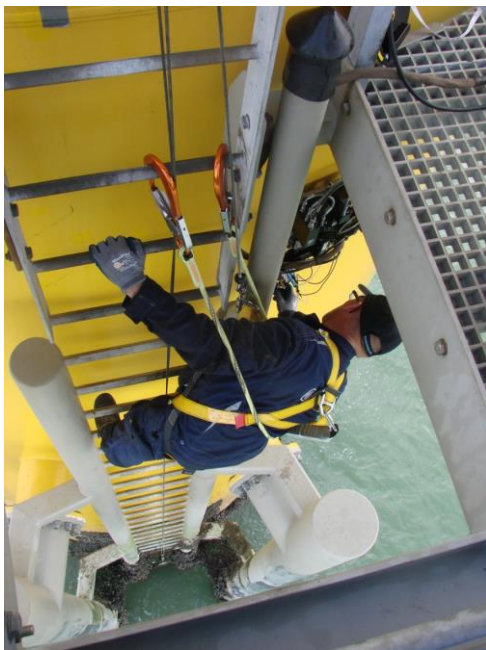
FIGURE 3: Manual inspection is complicated and presents logistical and safety challenges.

Offshore inspections are extremely expensive due to the special circumstances associated with this kind of work, Figure 3. The weather-window for embarking the foundations is small as a result of the harsh and windy environment ideal for offshore wind farms. Furthermore, working offshore implies large logistical and safety challenges. Entering the confined space, adds additional requirements for safety, backup personnel and certification. Many operators also prohibit use of divers, leaving remotely operated vehicles (ROVs) as the only option for subsea inspections.

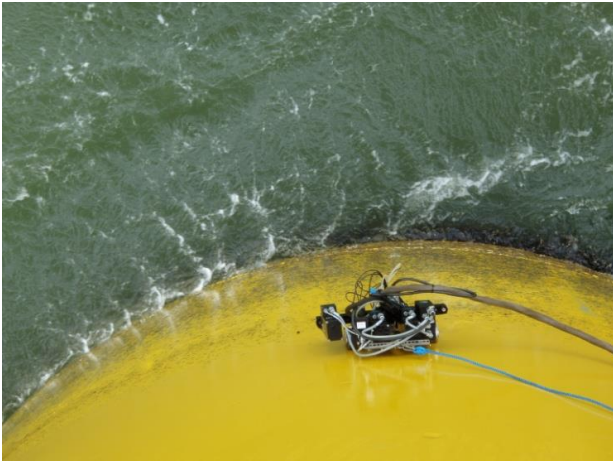
FIGURE 7: Thickness measurement by UT-crawler on the external side of transition piece by remotely controlled equipment.

Another approach is using a UT crawler for measuring wall thickness from the outside, Figure 7. The magnet-mounted UT crawler can be used for thickness measurement of the TP wall for the section above mean water level. Subsea equipment may also be applied. Figure 8 shows an example of obtained data. The scan at the left scan shows pitting at a depth up to 2.8 mm appearing just below the waterline on the internal side. However, most of the examined surfaces did not show considerable corrosion, as indicated in the scan at the right.

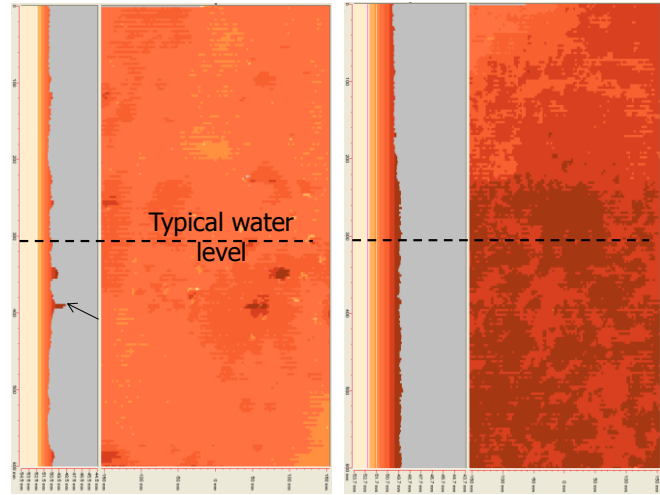
FIGURE 8: Results obtained with UT-crawler in two positions at the waterline. A maximum pit depth of 2.8 mm is observed on the inside in the left scan.

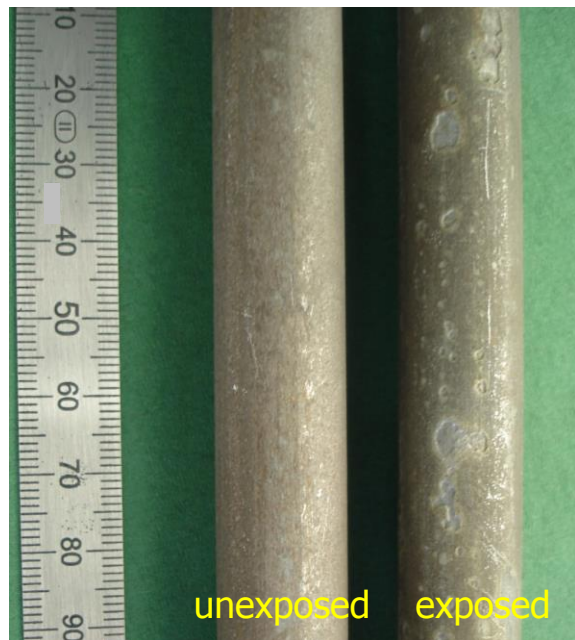
FIGURE 10: Cleaned surface of full-length coupon showing only minor corrosion after 1 year' exposure.

the authors for wind foundations comprising a full-length cylindrical corrosion coupon covering the height from the service platform to 0.5 m deep into the mud zone. This approach simulates the localized corrosion observed on the vertical MP wall, focusing on the risk of mud line corrosion. In contrast to conventional coupons, the full-length coupon includes macro galvanic effects and provides a more detailed picture of the corrosive conditions. The full-length coupon is supplied as a kit for easy transport and assembly on-site. Figure 10 shows close-up photos of an unexposed and an exposed coupon after 1 year's exposure. At this site, only superficial corrosion was observed.

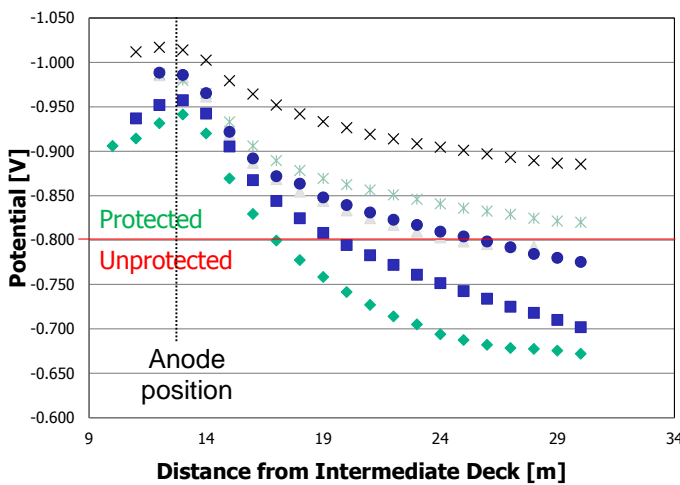
FIGURE 11: Example of drop-cell measurements obtained in a wind farm, where some of the foundations initially were under-protected.

Drop-cell measurements have frequently been used for assessing the CP system protecting the external side of monopile foundations. Figure 11 shows an example of such data obtained in a wind farm, where some of the foundations initially were under-protected near the seabed. This issue was related to inadequate CP design guidelines that account for the particularly harsh conditions, which apply to monopile foundations located in shallow waters with high tidal variation.^{9,10}

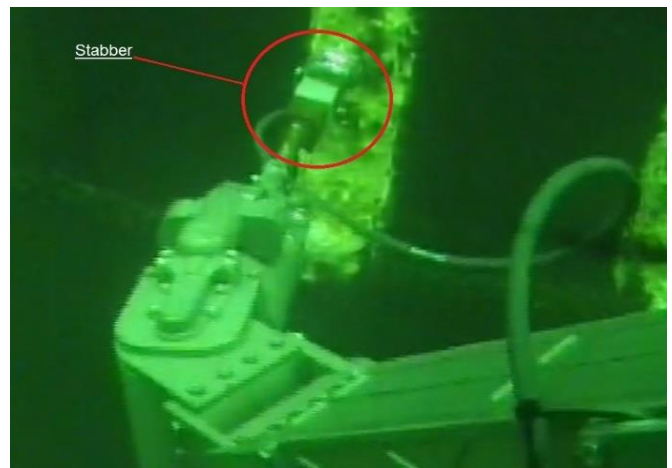
FIGURE 12: Potential measurement using a stabber (contact reference cell) mounted on a ROV.

In some cases, drop-cell surveys performed by non-experienced staff have produced odd results that questioned the validity of the entire campaign. Such errors are often related to poor electrical connections. Consequently, it is advisable that a corrosion specialist either supervises or performs such surveys. In case of any doubt, verification must be performed by contact/stab measurements, which represents a safer but more costly method than drop-cell surveys, Figure 12.

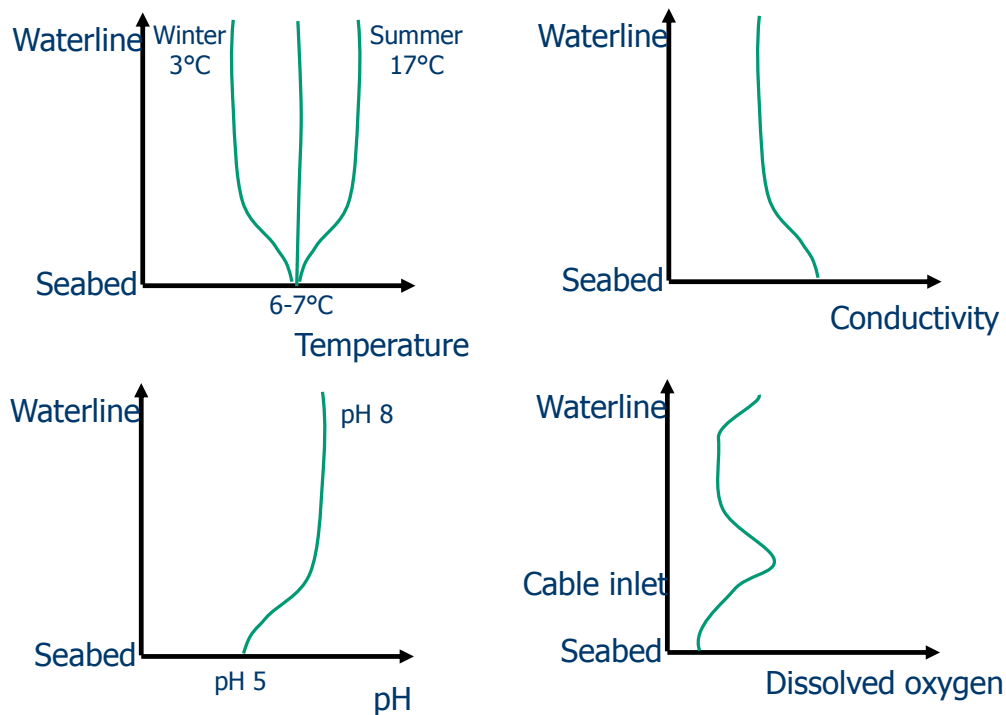
FIGURE 13: Trends observed using a drop-cell rack for environmental monitoring inside monopiles.

Figure 13 shows some trends observed using a lowerable rack of probes for environmental monitoring inside monopiles. When CP is installed, such surveys also include measurement of the protection potential with a drop-cell.

Seasonal variations in temperature are seen during a year in the water column, whereas the temperature just above the seabed remains fairly constant. Similar to inland lakes, such temperature variations may cause stratification (layering) or promote convection at sudden temperature shifts. It is also thinkable that slight heating from the power cables may cause local convection. Moreover, ingress of seawater through the cable entry will promote such variations depending on the water exchange rate from tidal variations.

Generally, a fairly constant conductivity is expected within the water column. However, the water temperature strongly influences this parameter. In one project, the conductivity had more than doubled in the period from winter to summer. In another project, a local high conductivity was observed in the water between the seabed and vent holes for forced exchange of seawater.

Dissolved oxygen (DO) has a strong influence on corrosion or the current demand when applying CP. Large variations have also been observed for this parameter. Without CP, the DO level is largest at the cable entry (in case of a leaking gasket) and at the waterline. For foundations having CP installed, the variations in DO are more complex.

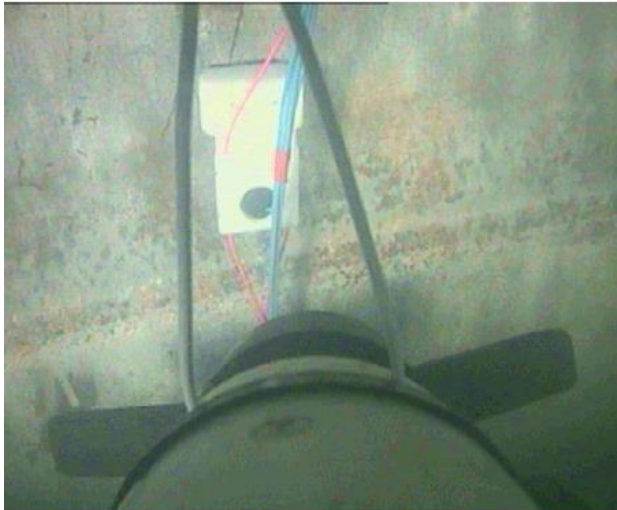
FIGURE 14: Magnet mounted zinc reference electrode seen from the actuator used for installing the probe inside the monopile.

In one project, a large number of sensors were mounted with magnets at different levels in the closed compartment that is being protected with galvanic anodes, Figure 14. The recorded data included potential, pH, DO, anode current and temperature. Quite large variations were observed with depth similar to the data presented in the previous section. But most importantly, the monitoring system showed the time dependent performance of the CP system, thereby facilitating adjustments and optimization of the CP system.^{14,15}
