Accelerated crevice corrosion testing of 6Mo stainless steel flanges with different gasket materials in seawater

Troels Mathiesen, Henrik Bang, FORCE Technology, Brøndby/Denmark

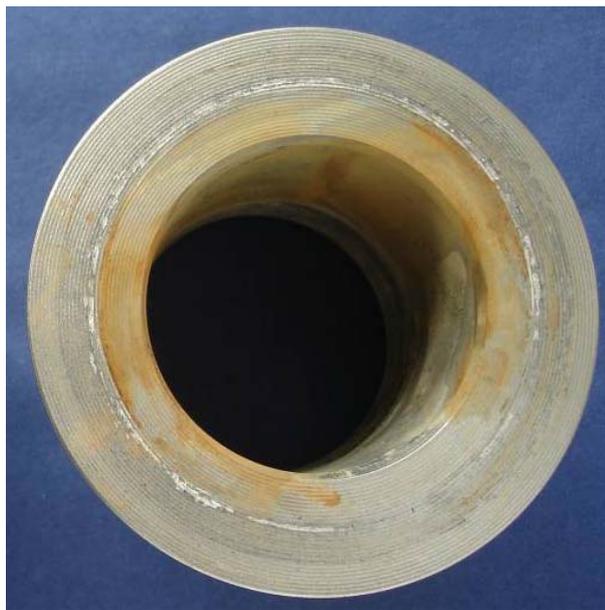
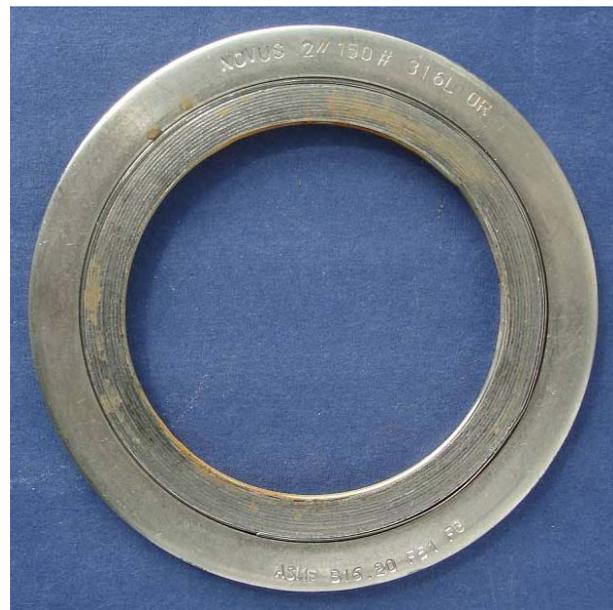
Figure 5: Overview of flange face (a) and graphite gasket (b) after test.

The parts from the graphite gasket tests showed the most distinctive corrosion attacks. In both cases, the duplex spiral suffered severe corrosion; especially at spot welds at the end of the spiral and along the outer windings. In addition, corrosion could be seen on the outer 2-3 mm of the covered part of the 6Mo flange.
