Monitoring and Inspection Options for Evaluating Corrosion in Offshore Wind Foundations

Troels Mathiesen, Anders Black, Frits Grønvold
FORCE Technology
Park Alle 345
2605 Brøndby
Denmark

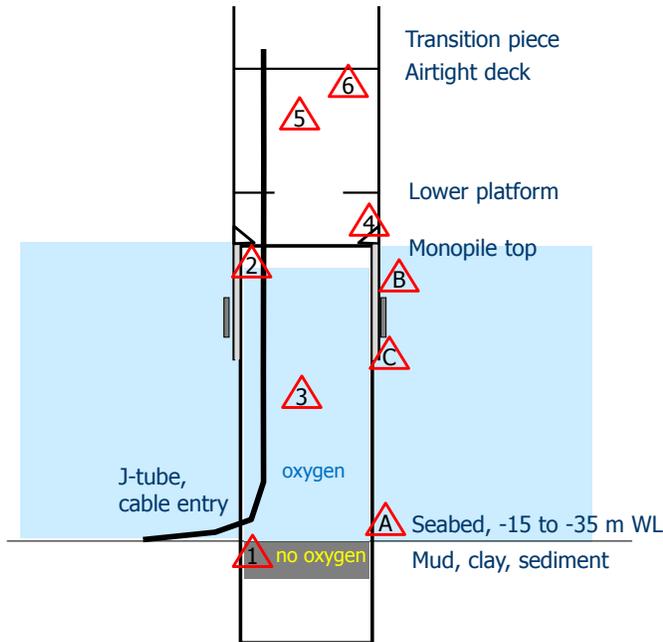
FIGURE 1: Risks related to corrosion in the monopile foundation design.

The monopile foundation presents certain challenges in regard to corrosion control. Figure 1 shows the principle of the design that consists of a monopile (MP) driven into the seabed. On top of this, a transition piece (TP) is mounted with a grouted connection between the two structural members.

In order to define a good strategy for inspecting and monitoring corrosion, the potential “hot-spots” must be identified. Figure 1 depicts such areas of concern for the internal and external side with reference to the two lists below.

Internal side:

1. Mud zone, risk of macro galvanic element (differential aeration), microbiologically influenced corrosion (MIC) and hydrogen induced stress cracking (HISC)
2. Waterline, risk of localized corrosion due to macro galvanic element (differential aeration)
3. Large stagnant water volume, large environmental variations
4. Weld defects, hardness, quality vs stress corrosion cracking and corrosion fatigue thresholds at critical details such as brackets, stoppers, cable entry etc.
5. Acidifying, especially if galvanic aluminum anodes are installed
6. Accumulation of gasses: H_2S , H_2 and CH_4

External side:

- A. Insufficient CP due to distance from anodes and high current demand
- B. Splash zone, requirement for 20 years’ lifetime of coatings
- C. Grouted connection, possible ingress of oxygen or aerated seawater

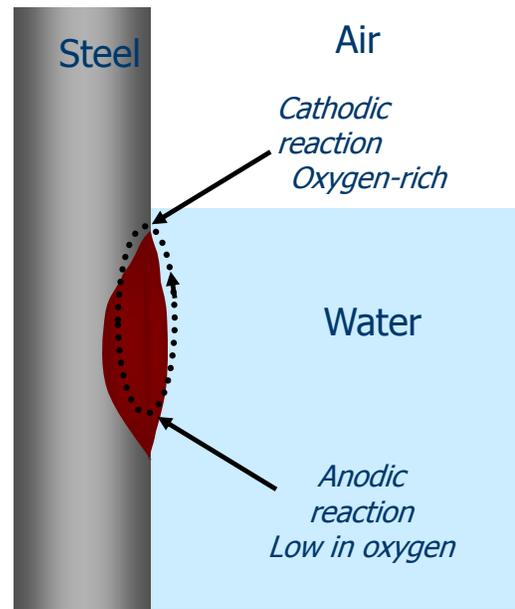
FIGURE 2: Example of localized corrosion mechanism at the waterline inside the monopile.

As an example, the waterline in the closed compartment could cause highly localized corrosion, especially if the water level remains constant and ingress of oxygen occurs, Figure 2. In case of tidal variations, this area could also be vulnerable to accelerated low water corrosion (ALWC). Similar corrosion mechanisms can be expected at the mud line, where the presence of sulfate reducing bacteria (SRB) may promote localized corrosion additionally by MIC.⁸

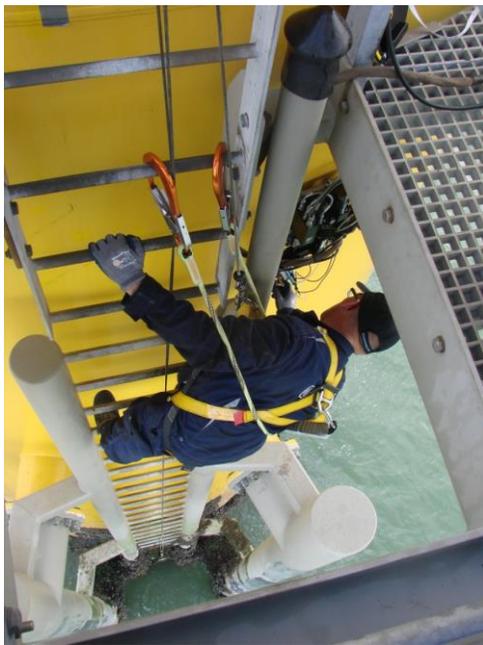
FIGURE 3: Manual inspection is complicated and presents logistical and safety challenges.

Offshore inspections are extremely expensive due to the special circumstances associated with this kind of work, Figure 3. The weather-window for embarking the foundations is small as a result of the harsh and windy environment ideal for offshore wind farms. Furthermore, working offshore implies large logistical and safety challenges. Entering the confined space, adds additional requirements for safety, backup personnel and certification. Many operators also prohibit use of divers, leaving remotely operated vehicles (ROVs) as the only option for subsea inspections.

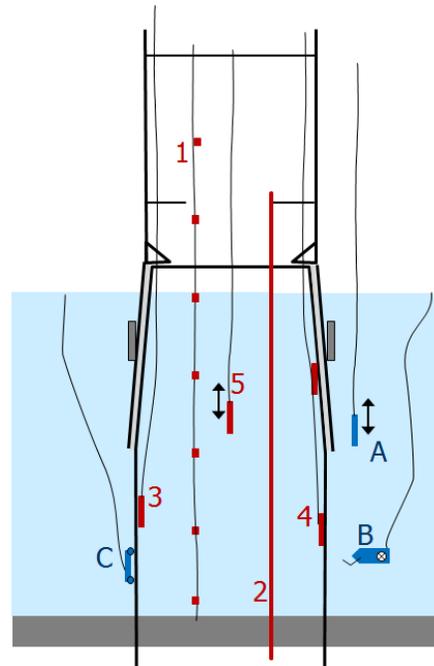
FIGURE 4: Overview of techniques for evaluating corrosion in- and outside monopile foundations.

Internal side:

1. Corrosion coupons for visual evaluation and weight loss determination
2. Full-length corrosion coupon that includes macro galvanic elements and mud zone
3. Electrical resistance (ER) probe for real-time measurement of the corrosion rate
4. Magnet-mounted reference electrodes measuring the protection potential in projects with CP
5. Lowerable rack of sensors including potential, pH, dissolved oxygen, temperature and resistivity

External side:

- A. Drop-cell (reference cell) measuring protection potential of CP
- B. Stabber (contact reference cell) mounted on ROV for measuring the protection potential of CP
- C. UT crawler (ultrasonic testing) for measuring wall thickness

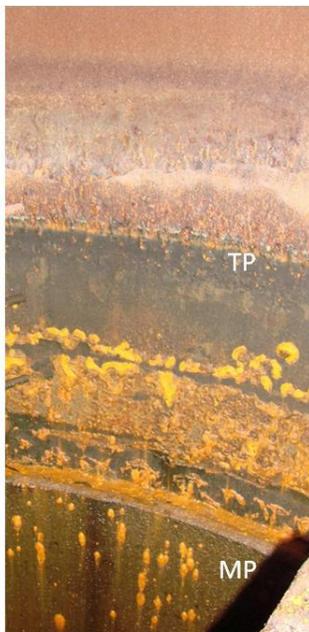
FIGURE 5: Appearance of corroded surface inside a monopile.

In the early projects, problems with displacement at the grouted connection were observed in several cases. Although, the expected effect on corrosion by this is limited, the associated repair work raised some concerns about the general condition of the internal compartment. As an example, Figure 5 shows the visual appearance at the waterline. It turned out that the initial assumption of a completely water-tight and oxygen-depleted compartment could not be fulfilled due to leakages at the cable entry in several projects. Consequently, the exchange of aerated seawater was considerable, which facilitates continuous corrosion.

Visual inspections of the closed compartment have been performed in several projects to examine corrosion at the water level. From the first impression in Figure 5, corrosion appears quite substantial. However, removal of mill scale, cleaning and closer inspection usually shows a less dramatic picture of the condition, Figure 6. Pitting may be observed, but the depth is typically not more than 2-3 mm, which equals a localized corrosion rate of 0.5 mm/yr. However, if pitting becomes too extensive it may act as stress raisers and initiate fatigue cracks if located at a critical position. It must then be investigated which degree of pitting corrosion can be tolerated in order to not compromise the structural integrity. Crack examination of critical parts may also be conducted in cleaned areas by ultrasonic testing (UT) and magnetic particle inspections (MPI).

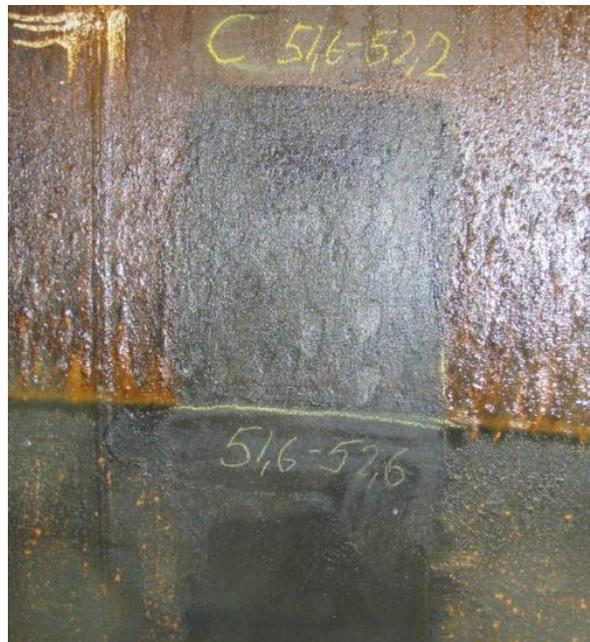
FIGURE 6: Thickness measurement of inside surfaces cleaned from scale.

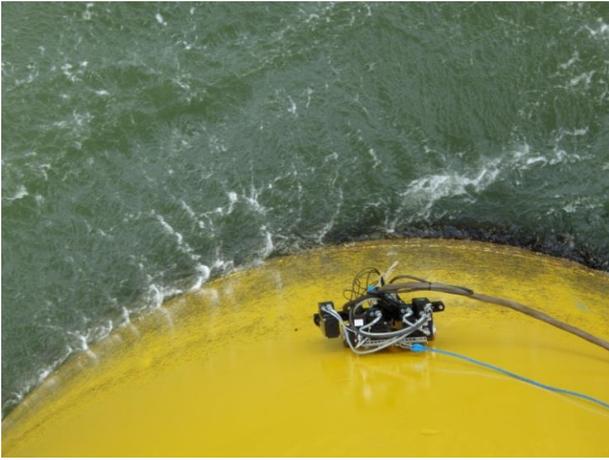
FIGURE 7: Thickness measurement by UT-crawler on the external side of transition piece by remotely controlled equipment.

Another approach is using a UT crawler for measuring wall thickness from the outside, Figure 7. The magnet-mounted UT crawler can be used for thickness measurement of the TP wall for the section above mean water level. Subsea equipment may also be applied. Figure 8 shows an example of obtained data. The scan at the left scan shows pitting at a depth up to 2.8 mm appearing just below the waterline on the internal side. However, most of the examined surfaces did not show considerable corrosion, as indicated in the scan at the right.

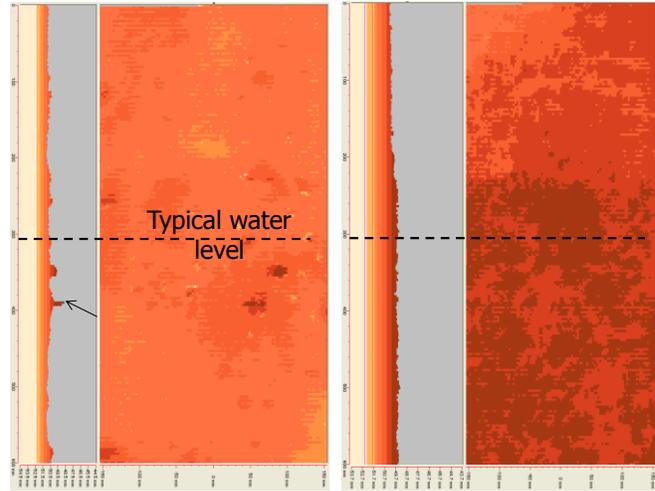
FIGURE 8: Results obtained with UT-crawler in two positions at the waterline. A maximum pit depth of 2.8 mm is observed on the inside in the left scan.

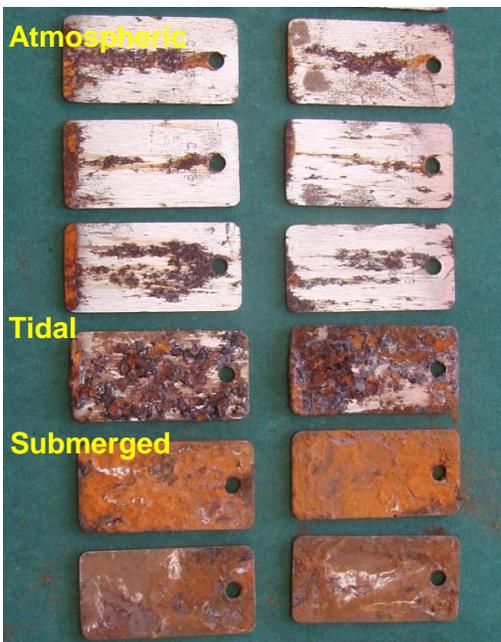
FIGURE 9: Corrosion coupons exposed inside monopile in three different corrosion zones.

Coupons (weight loss) are the direct technique providing reliable data of corrosion rate including the option of examining deposits and corrosion attacks. The drawbacks are the need for retrieval to obtain data, slow response rate, and that only historical data are obtained, not real-time data. Figure 9 shows an example of exposed coupons covering three different corrosion zones inside a monopile. Corrosion is most pronounced in the region at the waterline, where wet/dry cycles occur due to tidal variations.

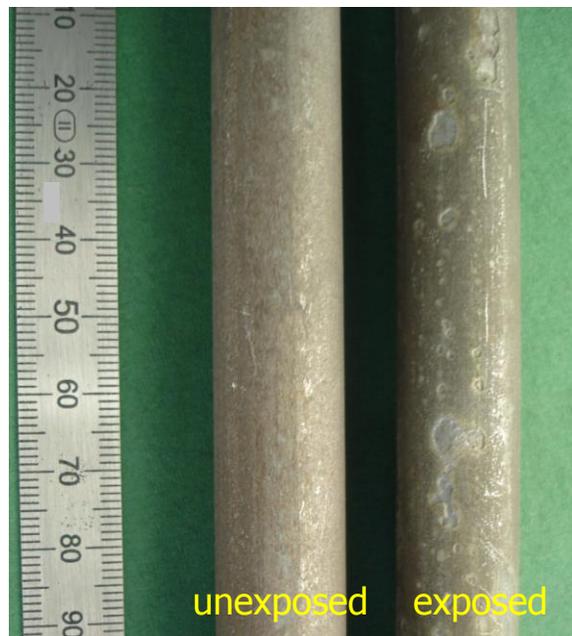
FIGURE 10: Cleaned surface of full-length coupon showing only minor corrosion after 1 year' exposure.

the authors for wind foundations comprising a full-length cylindrical corrosion coupon covering the height from the service platform to 0.5 m deep into the mud zone. This approach simulates the localized corrosion observed on the vertical MP wall, focusing on the risk of mud line corrosion. In contrast to conventional coupons, the full-length coupon includes macro galvanic effects and provides a more detailed picture of the corrosive conditions. The full-length coupon is supplied as a kit for easy transport and assembly on-site. Figure 10 shows close-up photos of an unexposed and an exposed coupon after 1 year's exposure. At this site, only superficial corrosion was observed.

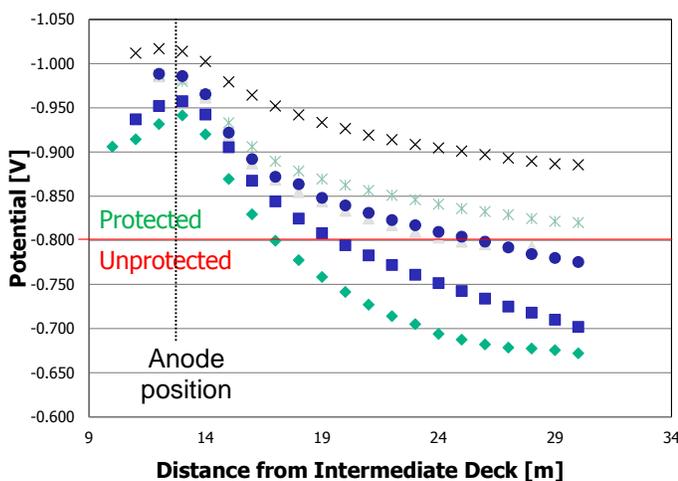
FIGURE 11: Example of drop-cell measurements obtained in a wind farm, where some of the foundations initially were under-protected.

Drop-cell measurements have frequently been used for assessing the CP system protecting the external side of monopile foundations. Figure 11 shows an example of such data obtained in a wind farm, where some of the foundations initially were under-protected near the seabed. This issue was related to inadequate CP design guidelines that account for the particularly harsh conditions, which apply to monopile foundations located in shallow waters with high tidal variation.^{9,10}

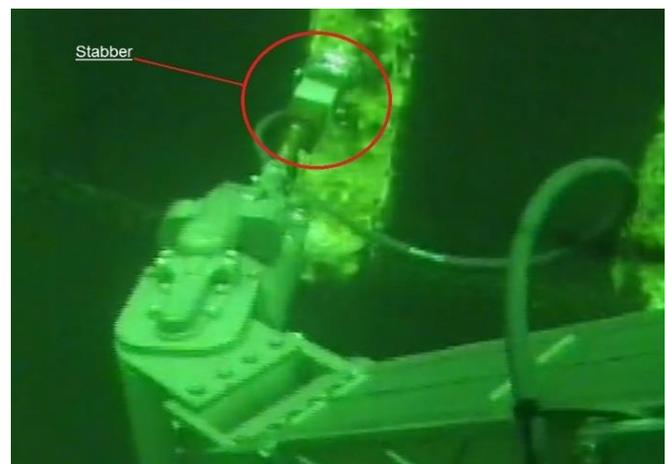
FIGURE 12: Potential measurement using a stabber (contact reference cell) mounted on a ROV.

In some cases, drop-cell surveys performed by non-experienced staff have produced odd results that questioned the validity of the entire campaign. Such errors are often related to poor electrical connections. Consequently, it is advisable that a corrosion specialist either supervises or performs such surveys. In case of any doubt, verification must be performed by contact/stab measurements, which represents a safer but more costly method than drop-cell surveys, Figure 12.

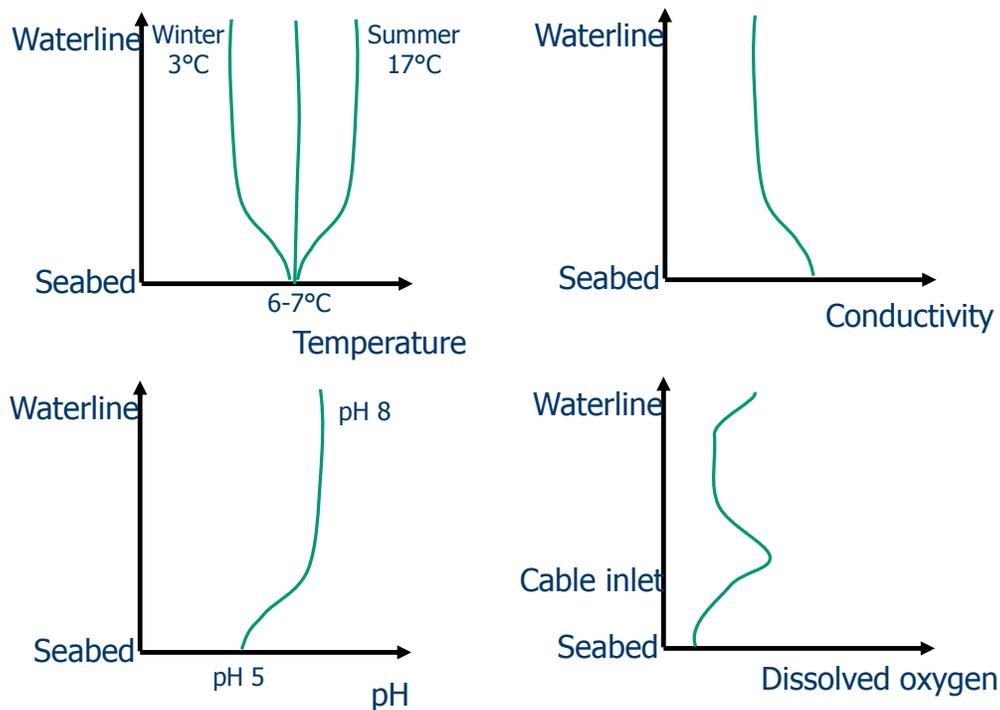
FIGURE 13: Trends observed using a drop-cell rack for environmental monitoring inside monopiles.

Figure 13 shows some trends observed using a lowerable rack of probes for environmental monitoring inside monopiles. When CP is installed, such surveys also include measurement of the protection potential with a drop-cell.

Seasonal variations in temperature are seen during a year in the water column, whereas the temperature just above the seabed remains fairly constant. Similar to inland lakes, such temperature variations may cause stratification (layering) or promote convection at sudden temperature shifts. It is also thinkable that slight heating from the power cables may cause local convection. Moreover, ingress of seawater through the cable entry will promote such variations depending on the water exchange rate from tidal variations.

Generally, a fairly constant conductivity is expected within the water column. However, the water temperature strongly influences this parameter. In one project, the conductivity had more than doubled in the period from winter to summer. In another project, a local high conductivity was observed in the water between the seabed and vent holes for forced exchange of seawater.

Dissolved oxygen (DO) has a strong influence on corrosion or the current demand when applying CP. Large variations have also been observed for this parameter. Without CP, the DO level is largest at the cable entry (in case of a leaking gasket) and at the waterline. For foundations having CP installed, the variations in DO are more complex.

The pH of fresh seawater is usually fairly constant at a level of approximately 8.0. In foundations without CP, an inspection has shown that the pH remains at this level throughout the entire water column.

However, the pH may be affected in foundations with CP where installation of aluminum anodes may cause acidification down to pH 4.5-5.0.^{12,13}

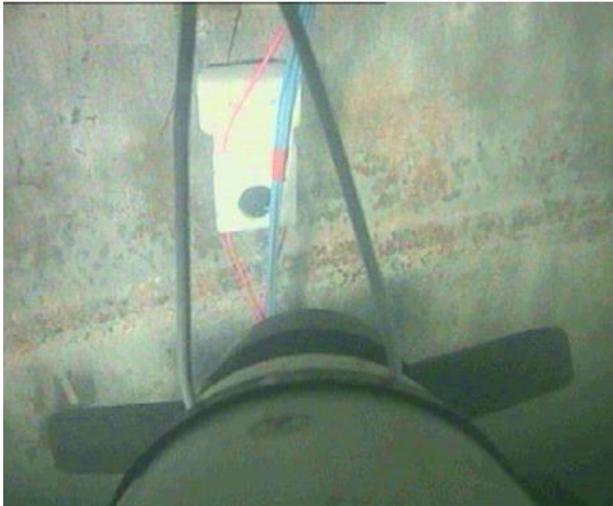
FIGURE 14: Magnet mounted zinc reference electrode seen from the actuator used for installing the probe inside the monopile.

In one project, a large number of sensors were mounted with magnets at different levels in the closed compartment that is being protected with galvanic anodes, Figure 14. The recorded data included potential, pH, DO, anode current and temperature. Quite large variations were observed with depth similar to the data presented in the previous section. But most importantly, the monitoring system showed the time dependent performance of the CP system, thereby facilitating adjustments and optimization of the CP system.^{14,15}

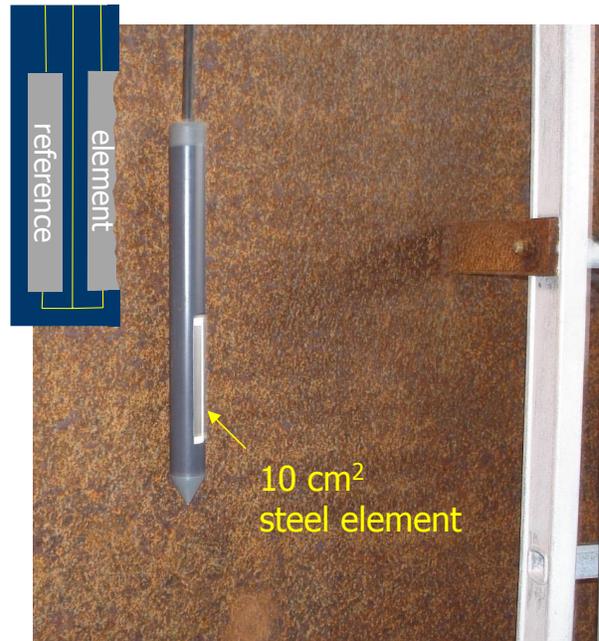
FIGURE 15: Principle and photo of ER-probe used for real-time corrosion rate measurement inside a monopile.

The ER probe is another type of fixed sensor for real-time corrosion rate measurement. It measures the change in electrical resistance (ER) over a steel element with temperature compensation by a non-exposed reference element, Figure 15. The sensitivity and resolution depend on the element dimensions

and instrumentation. It may be as low as 0.006 mm/yr at daily readings with a 100 μm element. Apart from the corrosion rate, the ER probe also provides the current density in structures protected by CP.

Monitoring systems based on ER probes have been used successfully to verify correct operation of the CP system in the closed compartment. In one project, the probes were initially left freely corroding. During this period, a constant corrosion rate of 60 $\mu\text{m}/\text{year}$ was measured with all probes. When the probes were connected to the CP-protected structure, the corrosion rate dropped immediately to a level below 10 $\mu\text{m}/\text{year}$.
