Corrosion problems in seawater pump caissons. Practical solutions.

Svenn Magne Wigen
FORCE Technology Norway AS
Hornebergveien 7
7038 Trondheim, Norway

ABSTRACT

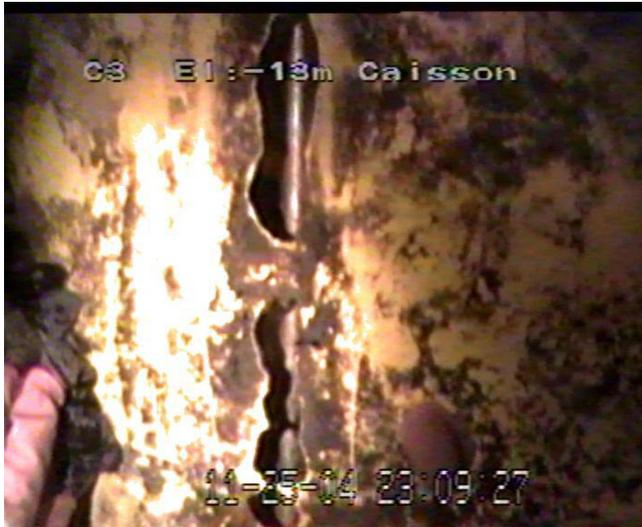
A subsea inspection on a relatively new platform located in the North Sea revealed substantial corrosion damage on a carbon steel seawater lift pump caisson. At approximately 13 meters depth divers found corrosion damages on one of the 2 caissons big enough to see directly into the stainless steel seawater pump, only 4 years after commissioning. The visible corrosion damage covered an area of approximately 10 x 70cm. The detected corrosion damage seen from outside of the caisson are shown in figures 1 and 2, while a sketch showing the extent of the damage is shown in figure 3.

Figure 1 Corroded area after cleaning off the shells and growth

From the pictures taken of the corrosion damage, (figures 1-3) the damage seems to occur in the longitudinal direction rather than around the circumference. This might indicate that the damage occurred on the pipe longitudinal weld, and that scratches have been introduced on the coating when the pump was installed for commissioning and after an inspection where the pump had been withdrawn.

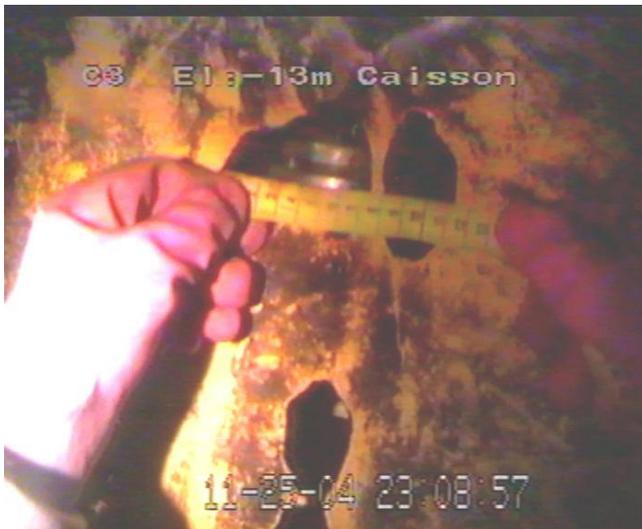
Figure 2 Measured extent of the corroded area
