IQPC – 14.03.2018 - Bremen

Challenges in using bolted connections for large subsea wind structures

Jens Schiersing Thomsen - Siemens Gamesa
Troels Mathiesen, Ditte Bilgrav Bangsgaard
FORCE Technology

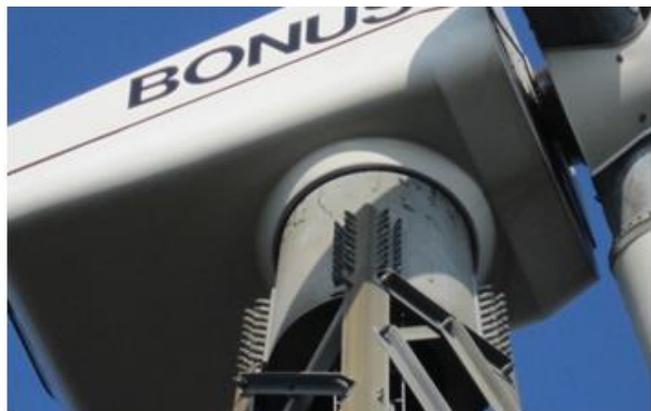
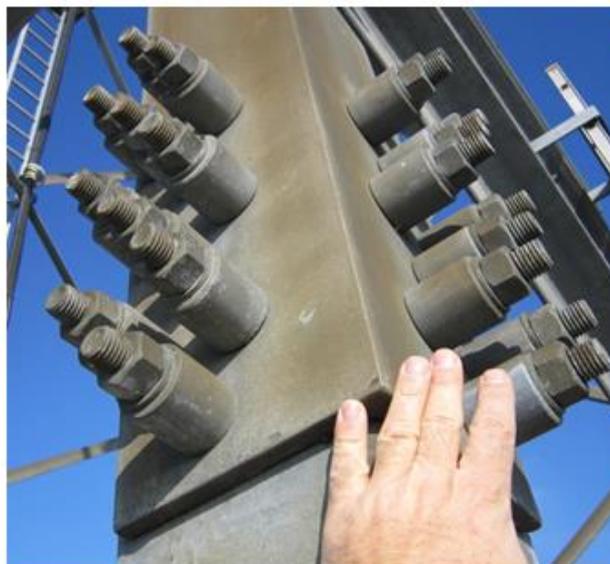
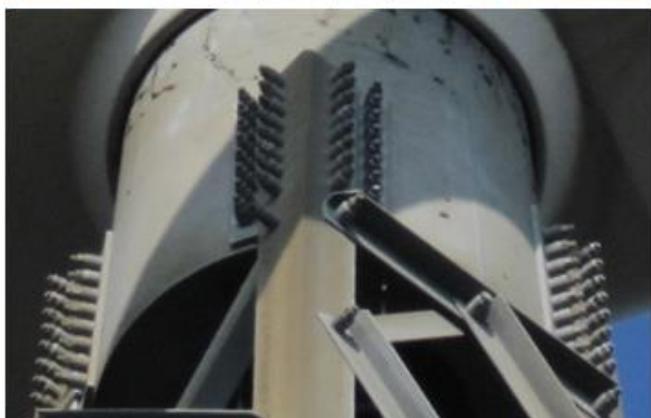
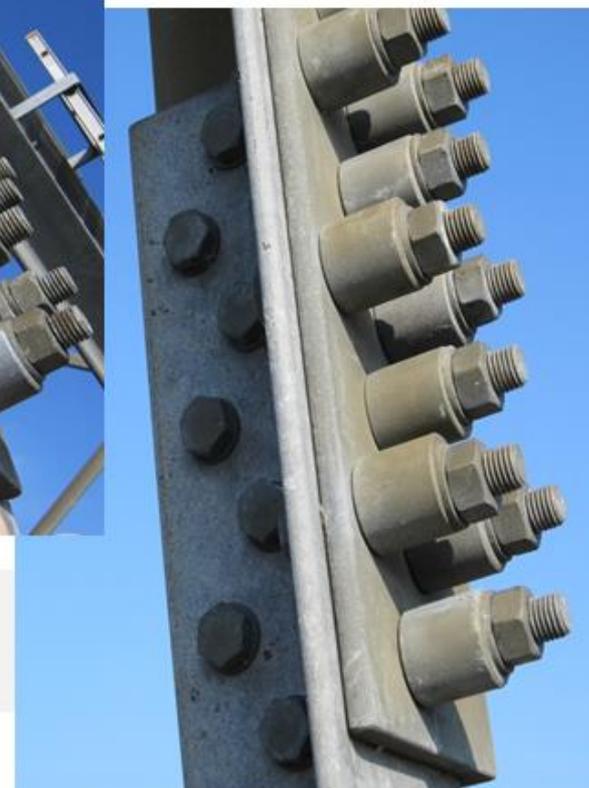
Successful use of bolting of onshore towers

**Bolts M24 – now
standard ISO 4014.**

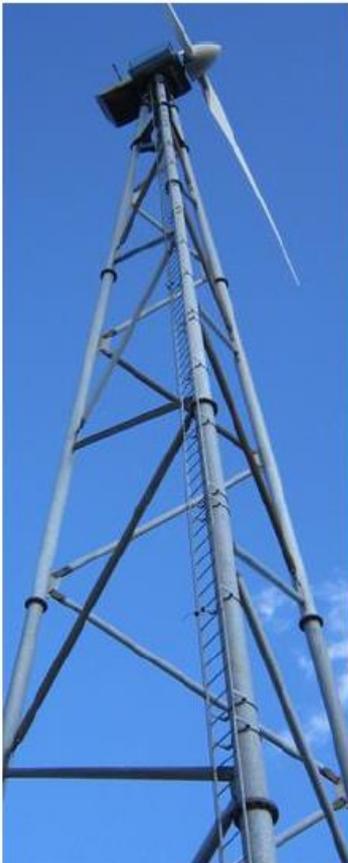
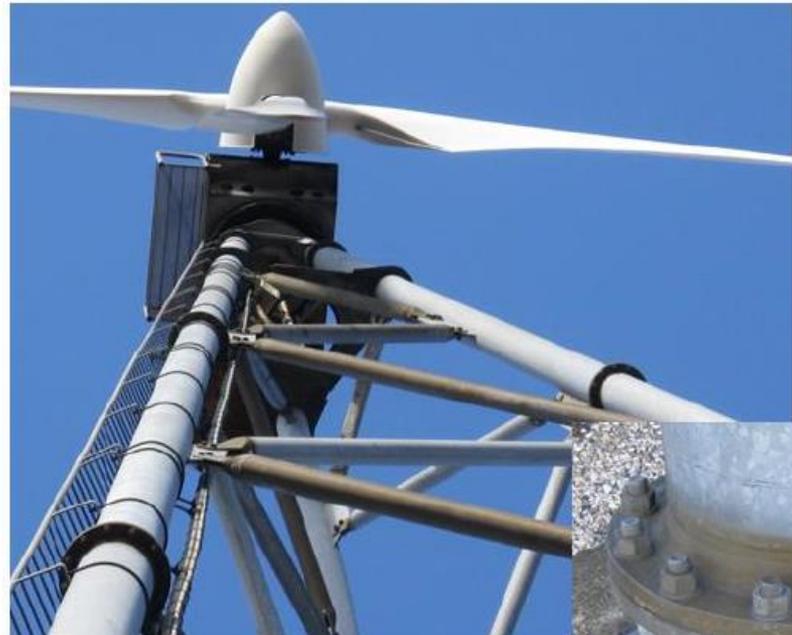
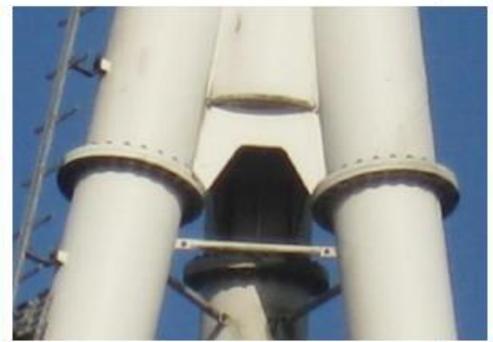
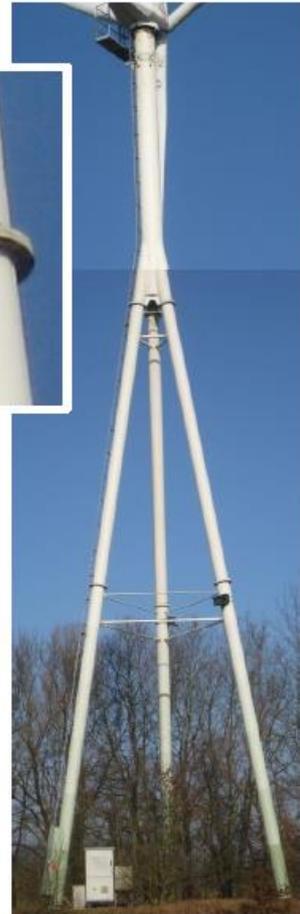
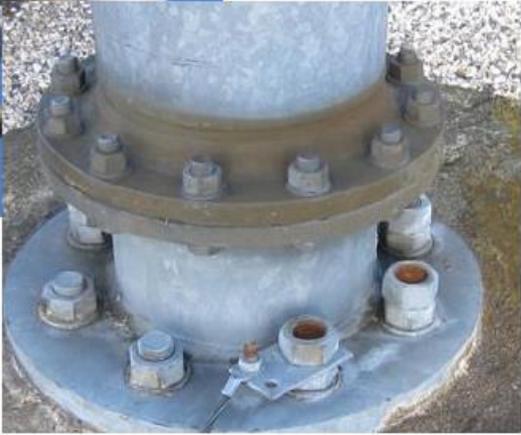
3 – legged flanged wind turbine > 30 years of operation

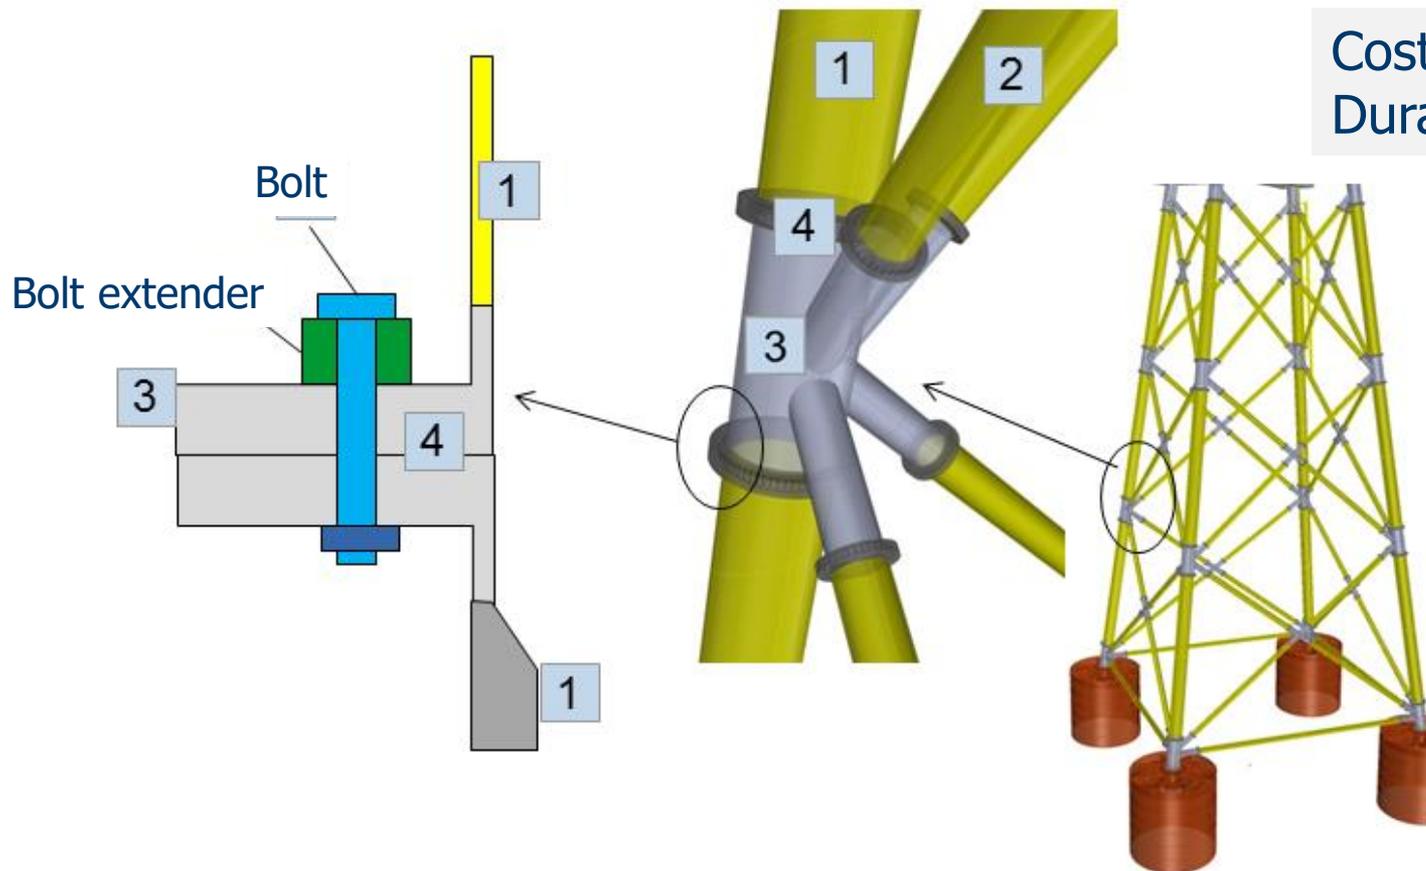
Nodes and tube elements of bracings and legs will ideally be assembled with bolted joints as flange connections

Cost savings
Durable FBE coating

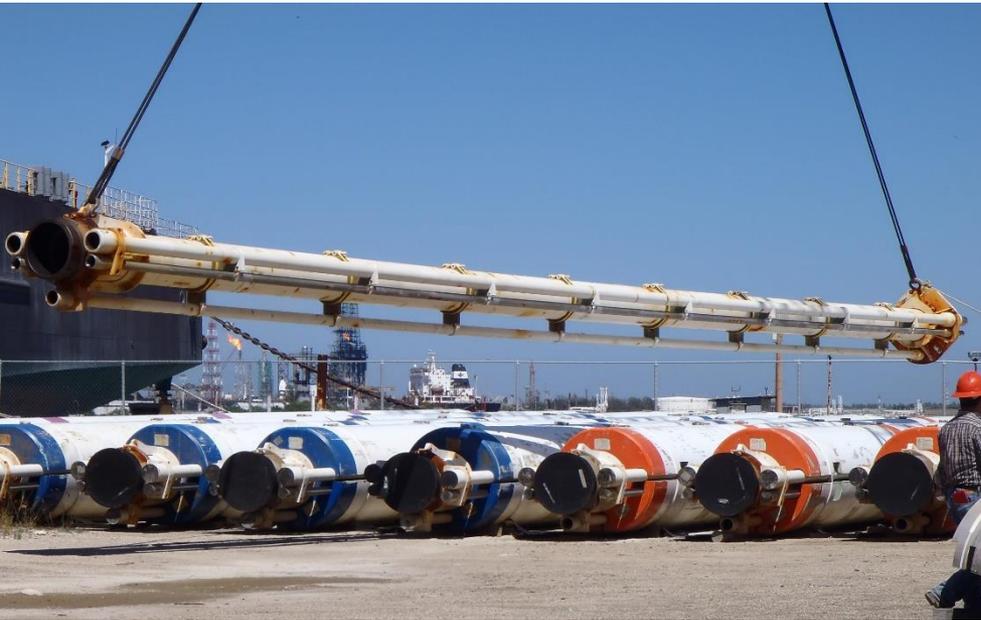
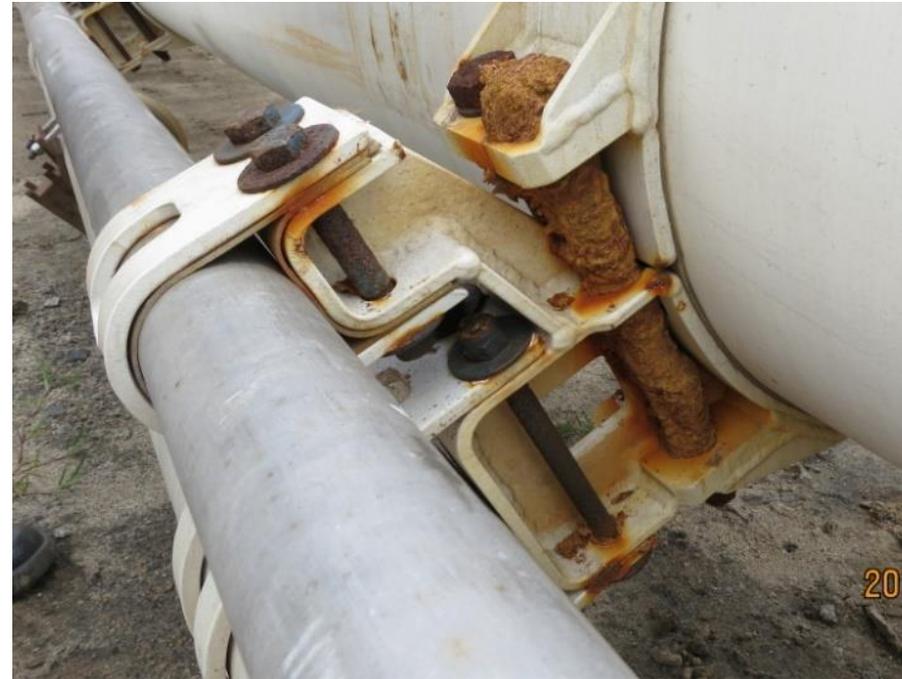
Personal experience - drilling risers for deep water oil production

- Large scale corrosion investigation
- 150 riser joints from 9 different projects in 4 oceans
- Galvanic corrosion due to stainless steel

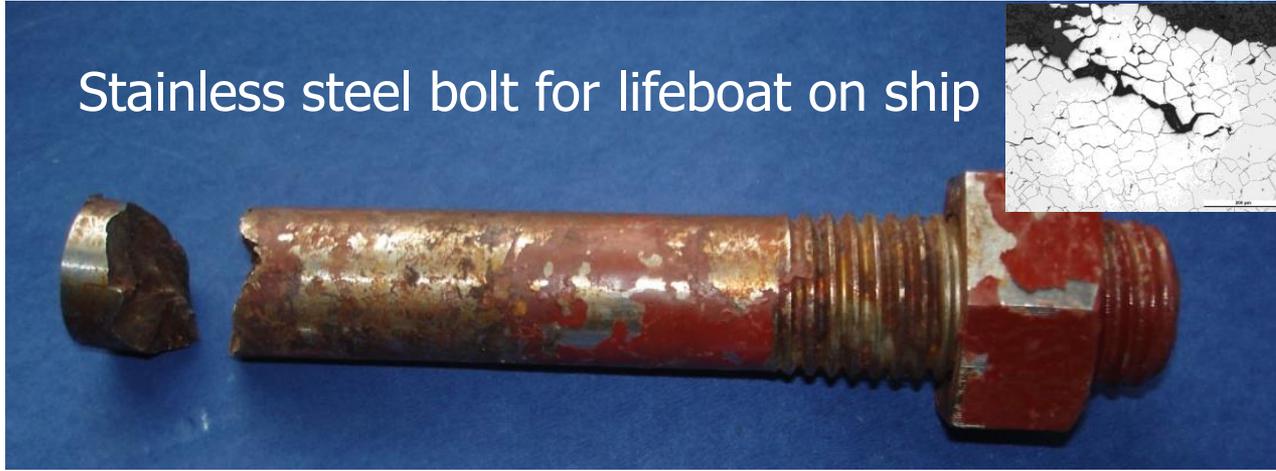
Stainless steel bolt for lifeboat on ship

Insufficient alloy grade and poor heat treatment

intergranular corrosion and fracture

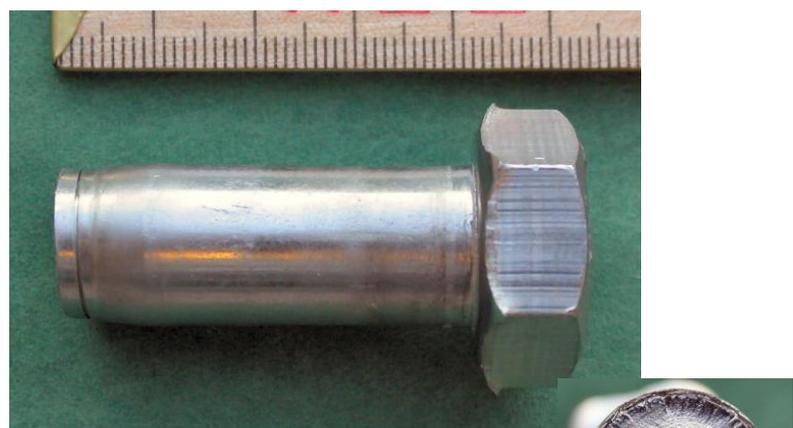
Stainless bolt suffering corrosion fatigue due to poor tightening

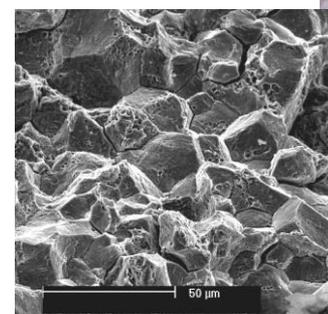
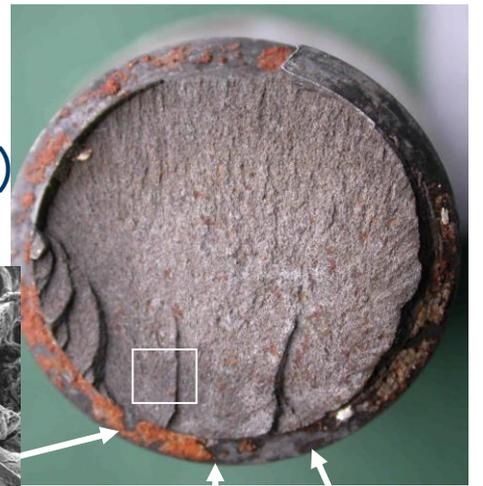
High-strength bolt suffering hydrogen induced cracking (HISC)

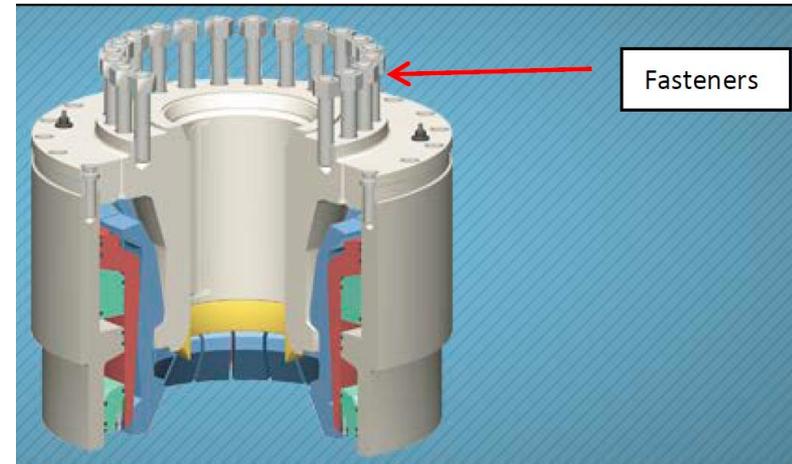
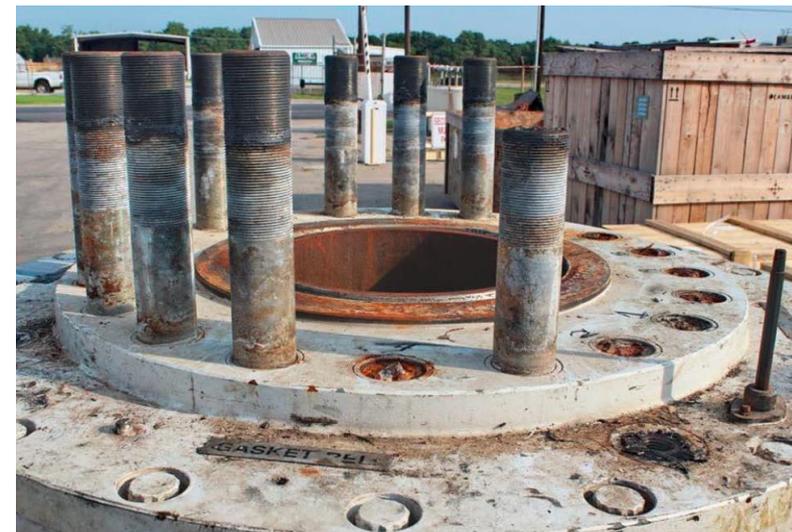
- Bolting for BOPs in Gulf of Mexico.
Hydrogen related fractures
- 2003: HRC >34, ICCP potential too low, TSA coating
 - 2012: HRC >34, issue with heat treatment
 - 2014: HRC >34, issues with casting and heat treatment

2014 incident. Source: bsee.org

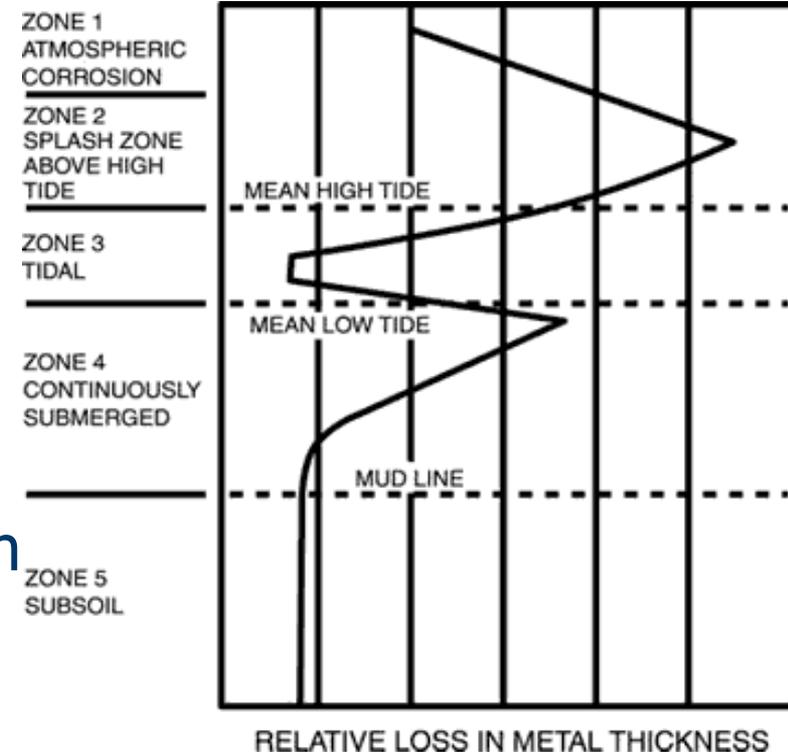
Corrosion of steel in marine environment

- Bare CS has highest corrosion rate in this zone
- CP is only working while immersed
- Sun & evaporation
- Marine fouling
- Welded joints is the first option
- CRA or encapsulated bolts are evaluated as second option

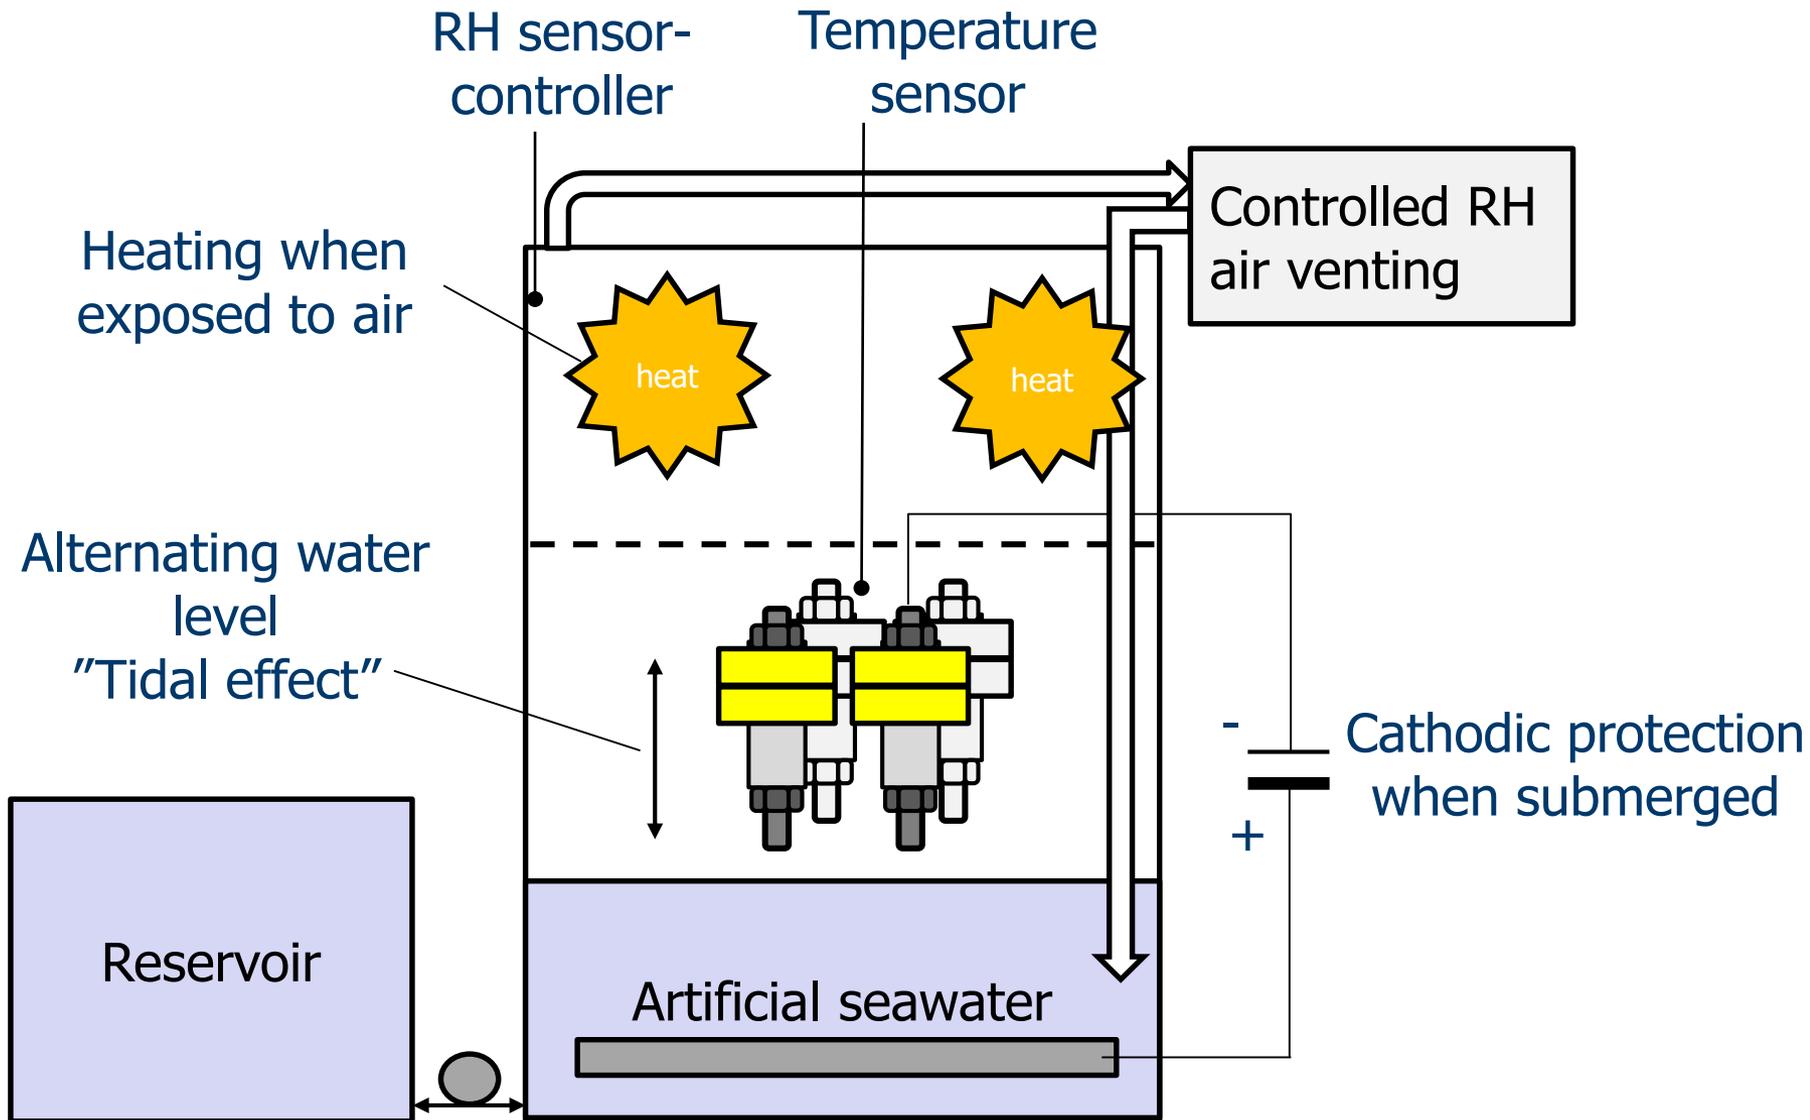
Splash-zone testing of CRA bolting alloys

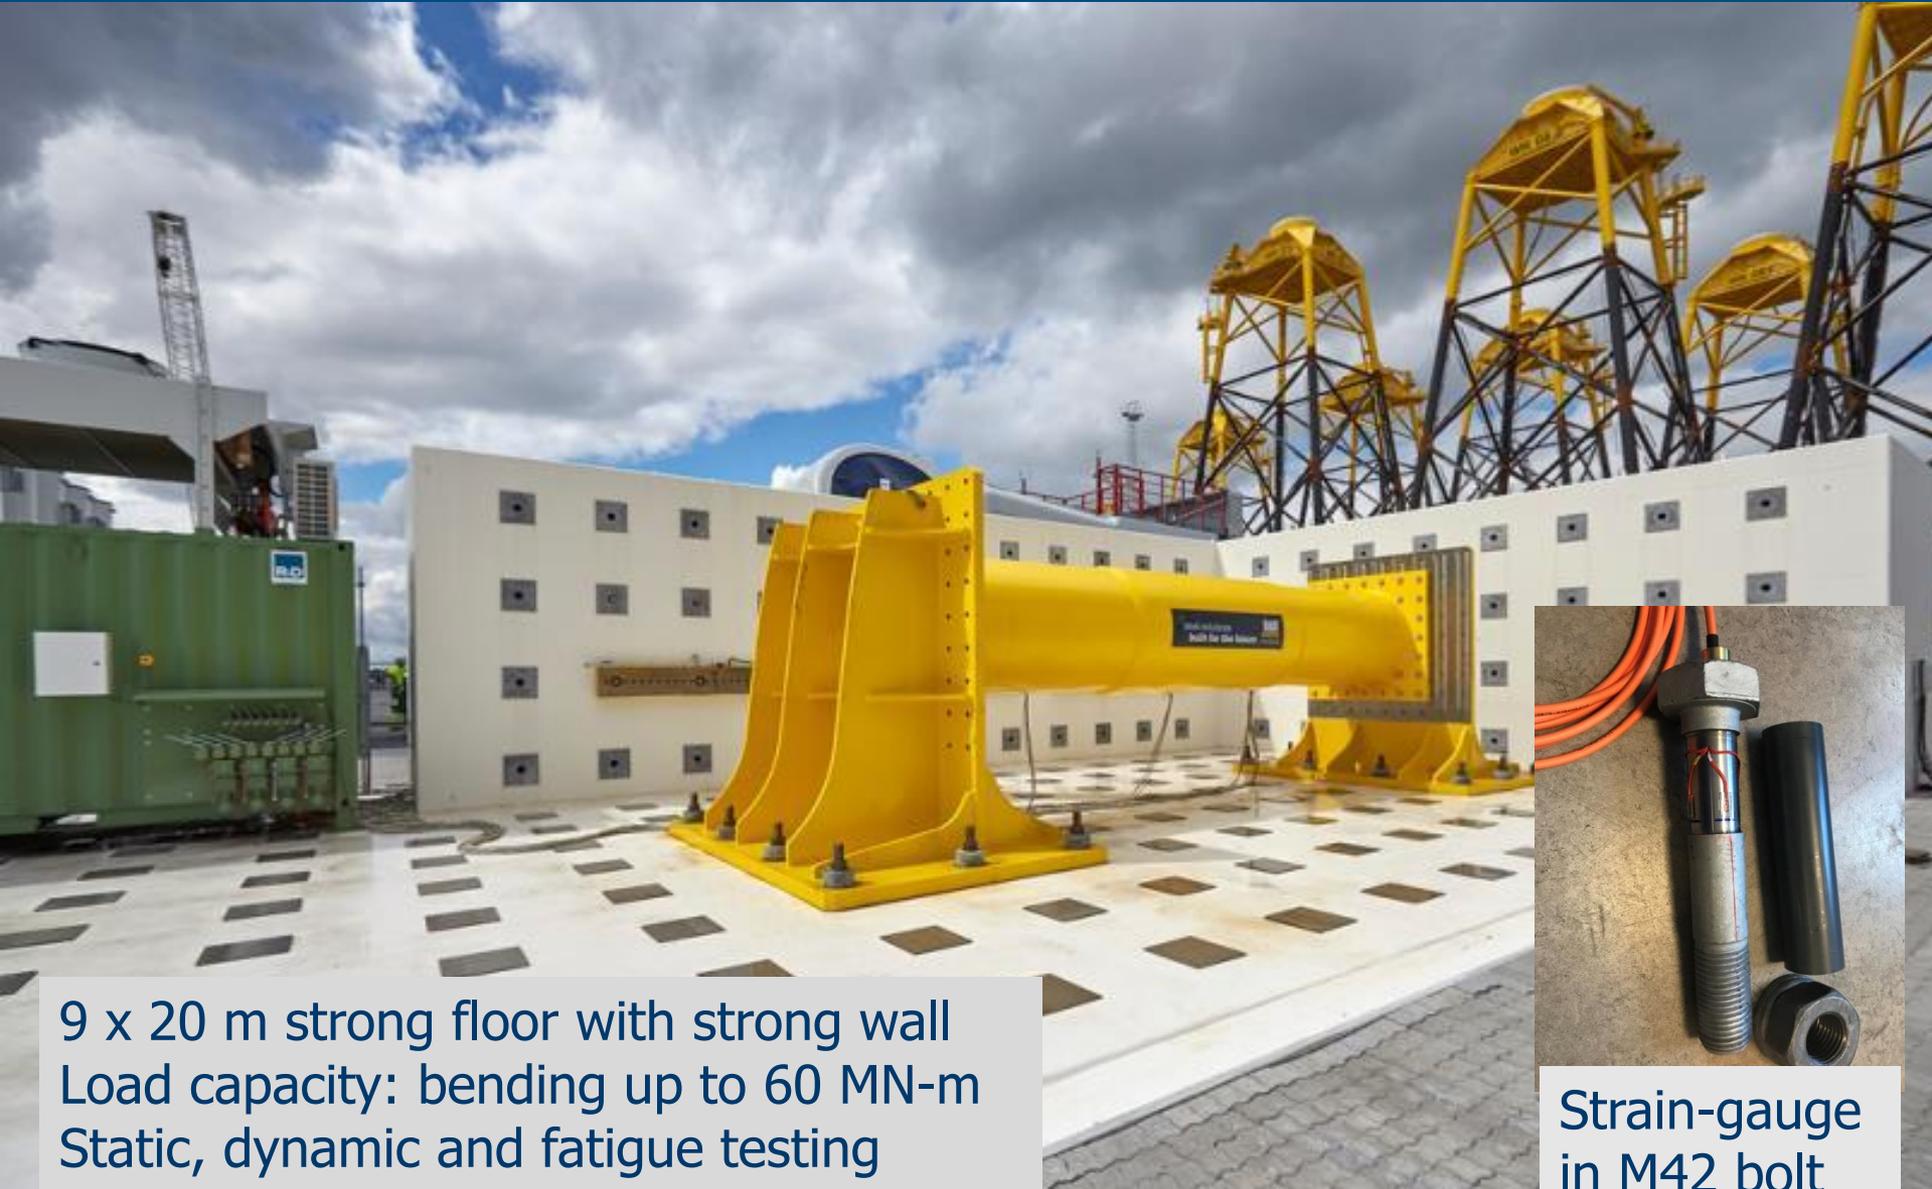
Full-scale test bench at Lindøe - DK

9 x 20 m strong floor with strong wall
Load capacity: bending up to 60 MN-m
Static, dynamic and fatigue testing

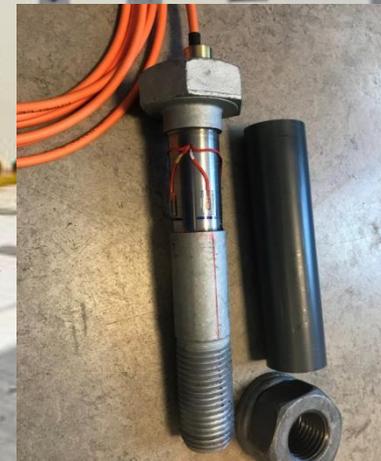
Strain-gauge
in M42 bolt
