Customized testing of bolted connections for large subsea wind structures

by Mikkel Østergaard Hansen, Troels Mathiesen (FORCE Technology) and Jens Schiersing Thomsen (SiemensGamesa)

Customised testing of bolted connection for large subsea wind structures

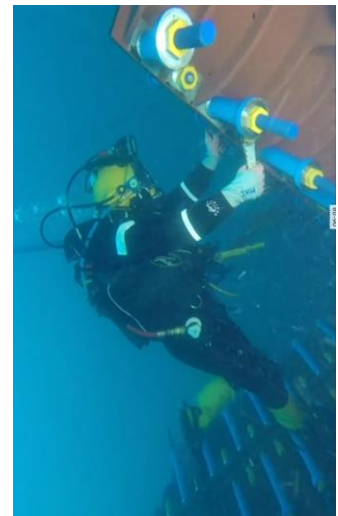
Special bolt extenders to ensure min. clamping length 10 times the bolt diameter

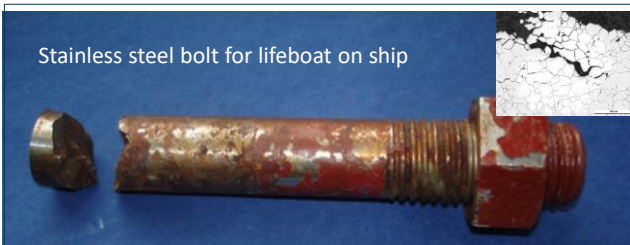
Insufficient alloy grade and poor heat treatment

intergranular corrosion and fracture

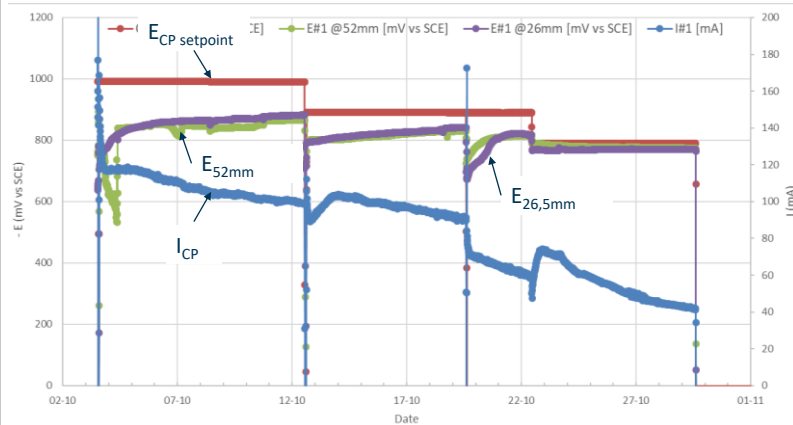
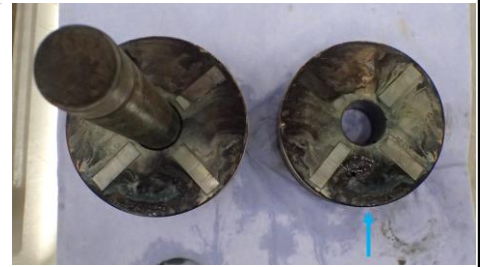
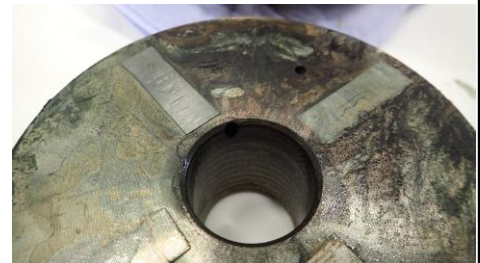
Summary of test. All values reported as V vs Ag/AgCl/seaw.

Econtrol vs Ag/AgCl/seaw.	Test specimen #1 Min. potential		Test specimen #2 Min. potential	
		@26mm	@52 mm (bolt)	@26mm	@52 mm (bolt)
0-9 days	-1.00 V	-0.89 V	-0.88 V	-0.86 V	-0.88 V
9-19 days	-0.9 V	-0.83 V	-0.82 V	-0.81 V	-0.83 V
19-28 days	-0.8 V	-0.78 V	-0.78 V	-0.78 V	-0.79 V
28-138 days	-0.9 V	-	-	-0.89 V	-0.84 V

- Test set up to produce worst case scenario, including effects of e.g. no surface coating, 200 μm gap, water flow into the gap and prolonged exposure.
- **The test showed good protection of the flange gap, bolts and internal surfaces** of the flange parts and bolt extenders, even in at the minimum criterion for cathodic protection (-0.8 V vs Ag/AgCl/seaw.) Supportet upon disassembly of the test specimens.
- The prolonged exposure of test specimen #2 for a further 110 days, **did not show any differences in corrosion** of the inner surfaces of the test specimen assemblies.

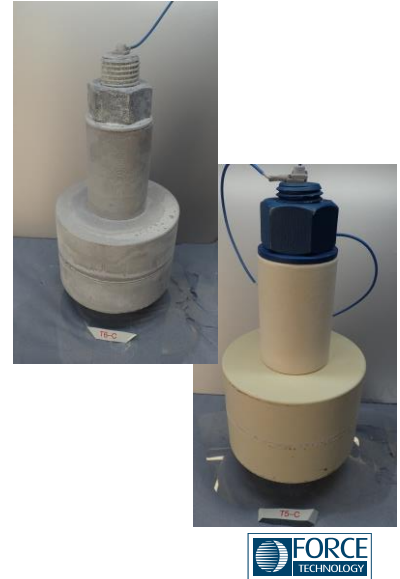
- **Calcareous deposits build-up** on the outer surfaces of the test specimens – decrease in currents consumption.
- Water ingress, but the exchange of water is low, **the internal conditions stagnant, air-depleted and non-corrosive.**
- **No cracks** in the stud and nut base metal of the three different types of coated mechanical fasteners
- Superficial corrosion and discoloration on the TSM treated flange surfaces.
Corrosion depth is shallow – **no depletion of TSM**

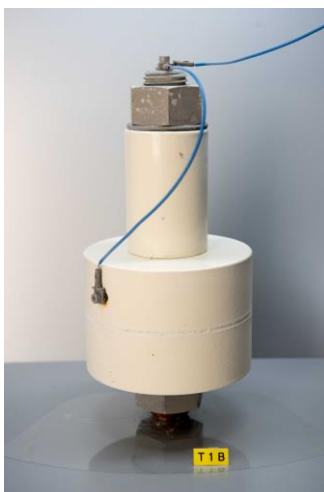
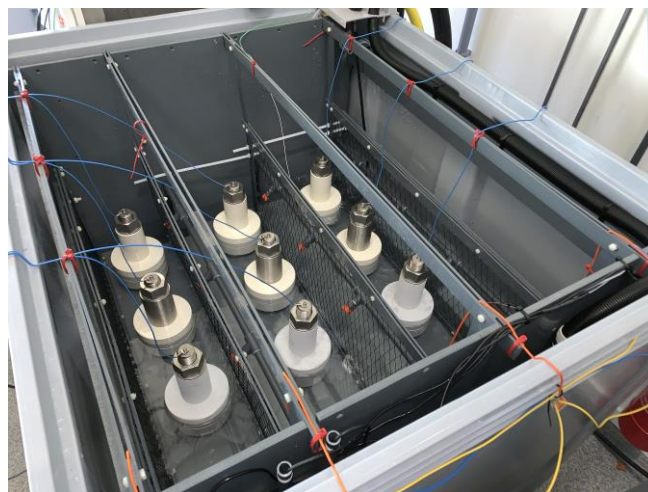
Developed test-concept

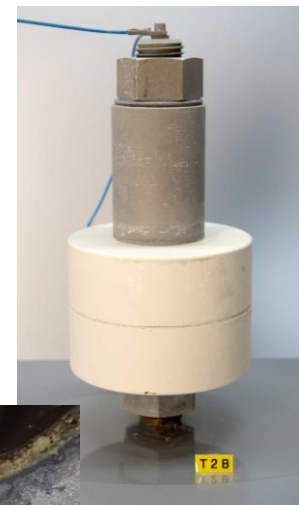
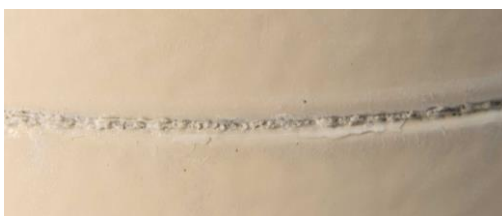
- After an initial stabilisation period, **calcareous deposits build-up on the outer surfaces** of the test specimens with a resulting decrease in currents consumption.
- For the different material combinations tested, **no pitting, crevice corrosion or cracks** in stud and nut base of stainless BUMAX 8.8 fasteners and stainless bolt extenders
- Superficial corrosion and discoloration were observed on the TSM treated flange surfaces, with some variation in affected area.
Corrosion depth is shallow – No depletion
