New developments in coatings for extended lifetime for offshore wind structures

Claus Erik Weinell
FORCE Technology
345 Park Allé
DK-2605 Brøndby
Denmark

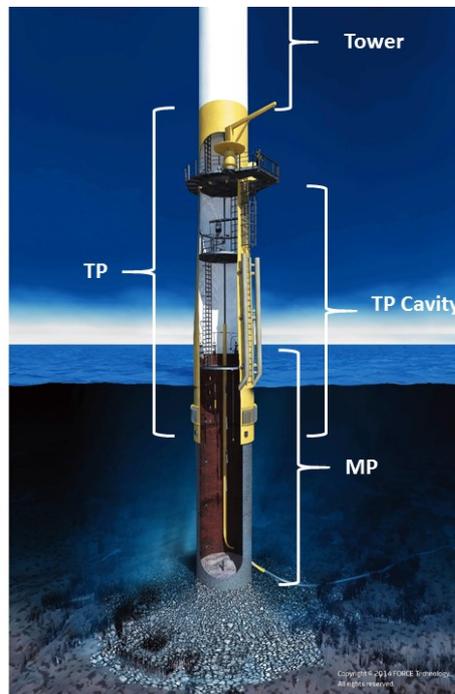
Figure 1: Offshore wind turbine construction, model: Tower, TP (Transition Piece), TP Cavity (The inner void of the TP), and MP (Monopile: The underwater support of the TP and Tower).
