Offshore Wind Farms Successful Corrosion Protection and Effective Quality Management

From *JPCL*, December 2016

By Peter Kronborg Nielsen, FORCE Technology

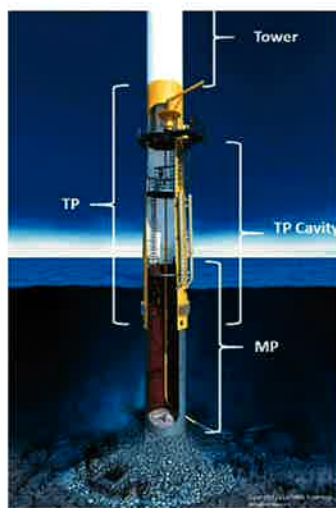
Fig. 1: Offshore wind turbine construction showing the tower, transition piece (TP), transition piece cavity and the monopile (MP) which is the underwater support of the tower and TP. Photo courtesy of FORCE Technology
