Offshore windfarms – successful corrosion protection combined with effective quality management

Article presented in *The Journal of Protective Coatings & Linings, JPCL*, December 2016

Following an uncertain start, the present offshore coating systems for windfarms have shown fine durability against the aggressive marine environment. Positive features from the first windfarms with more than 15 years of service are described, and the importance of quality management is explained.

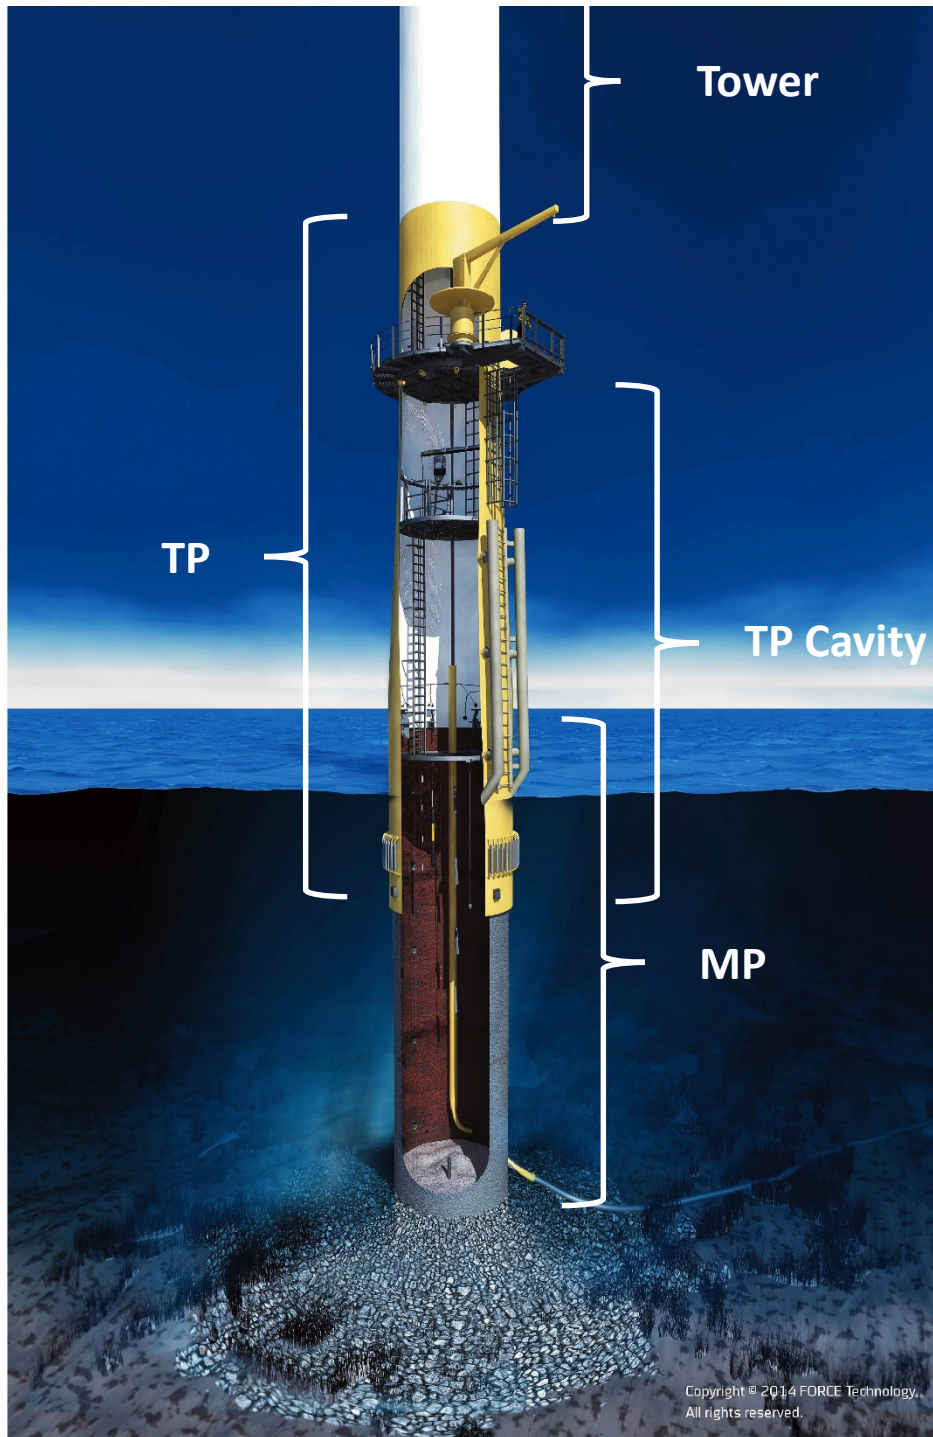
Figure 1. Offshore wind turbine construction, model: Tower, TP (Transition Piece), TP Cavity (The inner void of the TP), and MP (Monopile: The underwater support of the TP and Tower). © FORCE Technology.
