# Durability of coating repair systems for offshore service

*A. R. Black, P. K. Nielsen, FORCE Technology, Brøndby/Denmark*

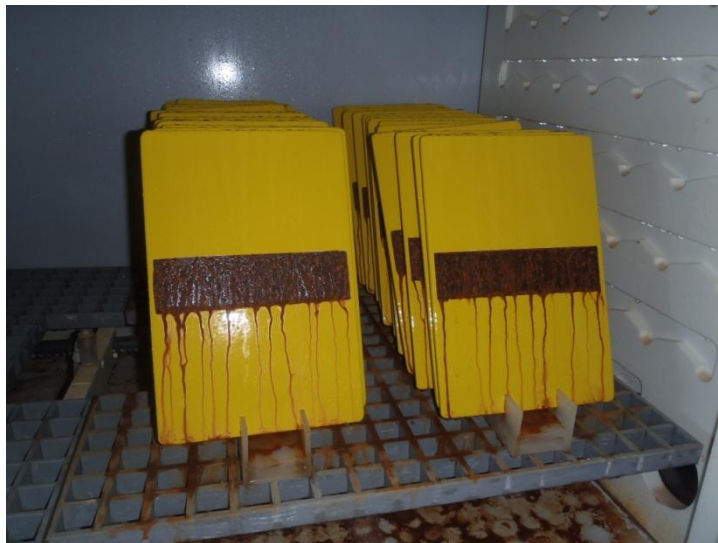
Figure 1: Panels in neutral salt spray chamber during pre-rusting.

In order to simulate a coating damage offshore, the panels were pre-corroded in the uncoated area, 50x200 mm, in a neutral salt spray chamber according to ISO 7253 for 3 days until rust grade C according to ISO 8501-1 was achieved (slight pitting). In order to simulate realistic application conditions offshore the panels were fresh water rinsed only once after salt spray exposure in order to remove soluble salts.

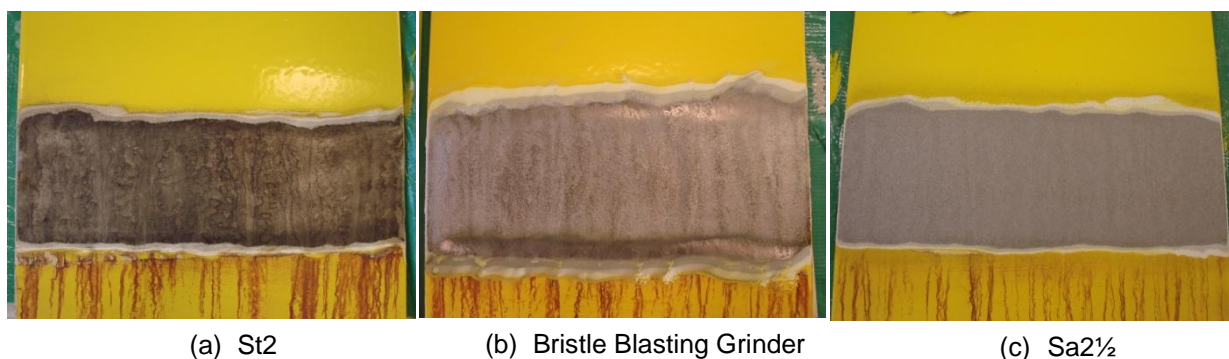
Figure 2: Examples on pre-treatment qualities before coating application.

After pre-treatment and before coating application all edges to existing coating were feathered to a smooth transition and dust removed.

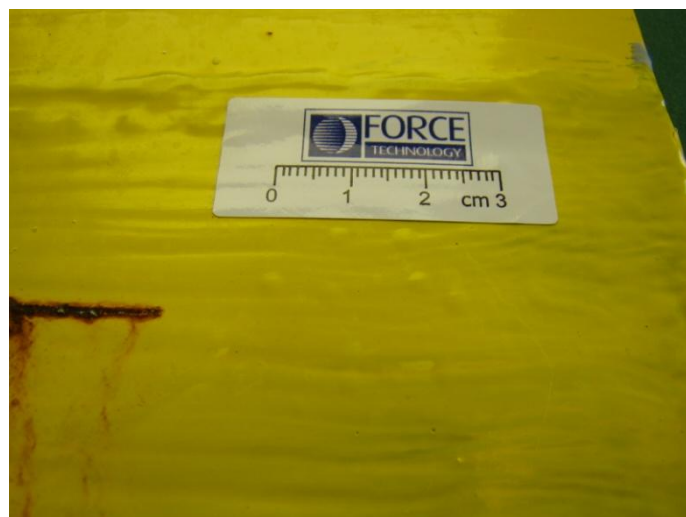
Figure 3: Example of blistering after neutral salt spray test. Result: 3(S4) (St2, System C2).

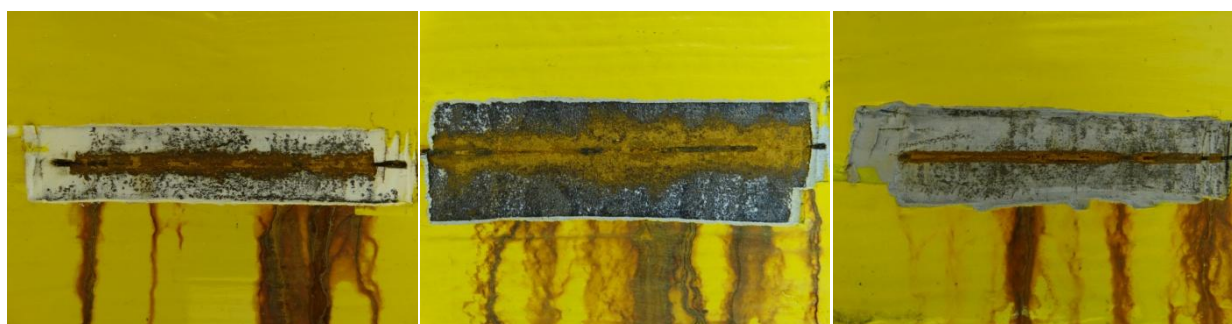
(a) St2, System B2

(b) Bristle, System A2

Figure 4: Examples of rust from scribe after neutral salt spray test.

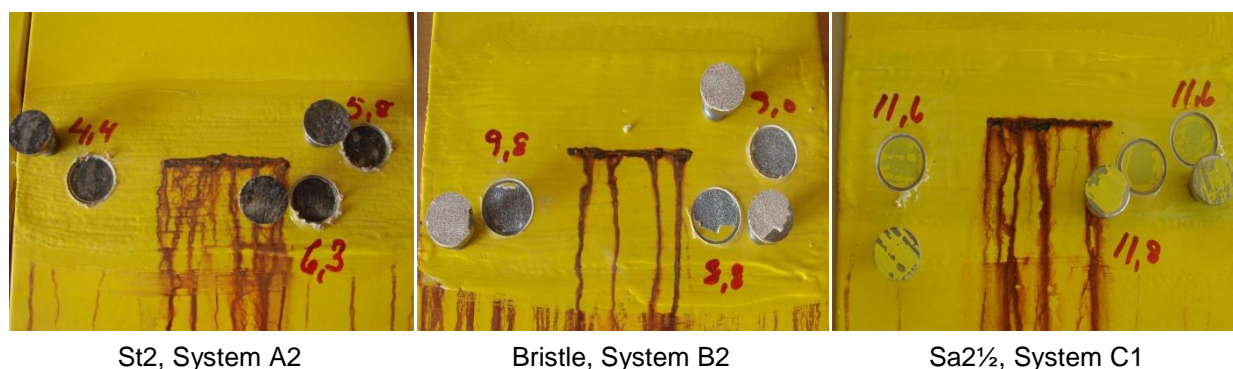
Figure 5: Examples of adhesion test results including dollies after neutral salt spray test.
